FULL-SCALE CRASH TESTS  
OF  
MOTORIST AID CALL BOX SYSTEM

Prepared for  
Delaware Department of Transportation  
DDOT Contract No. IR-95-2(67)C  
Dover, Delaware

Texas Transportation Institute  
Safety Division  
College Station, Texas

May 1986

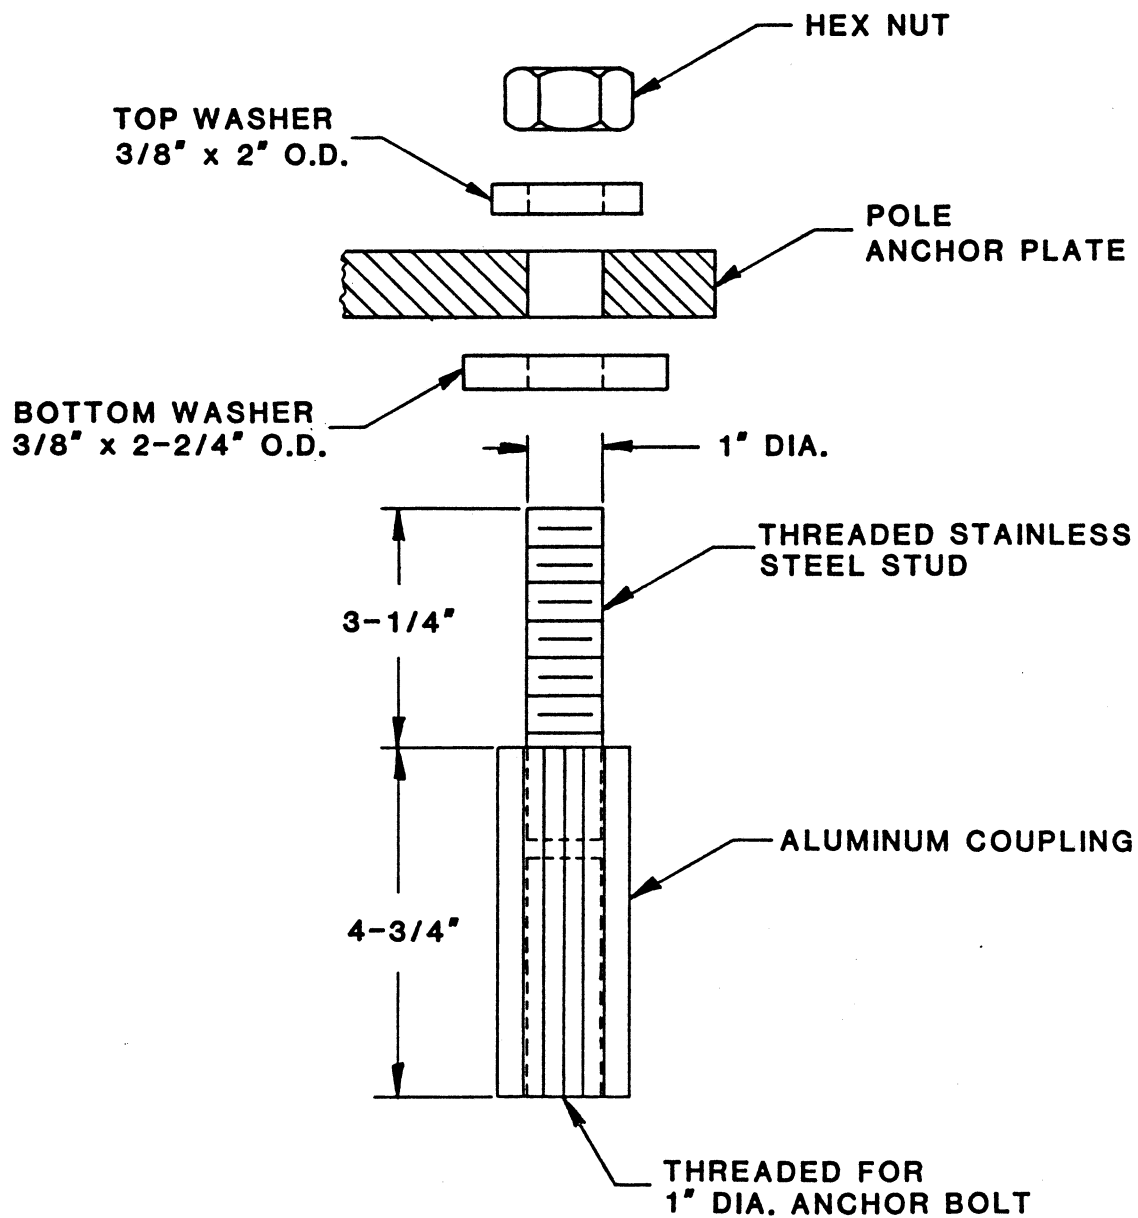
Figure 1. Transpo Pole-Safe breakaway coupling.

The test article consisted of a motorist aid call box installation. The installation included a Signal Communications user powered call box, an aluminum sign, a 5 in (13 cm) O.D. aluminum pole, an antenna, four Transpo Pole-Safe breakaway couplings, shown in figure 1, four 1 in (2.5 cm) by 40 in (102 cm) anchor bolts, and a 24 in (61 cm) diameter by 48 in (122 cm) deep concrete base, shown in figure 2. The call box and sign were mounted on the aluminum pole. The top-of-call box mounting height was 54 in (137 cm) above ground level. The pole was connected to the concrete anchor bolts through the breakaway couplings.

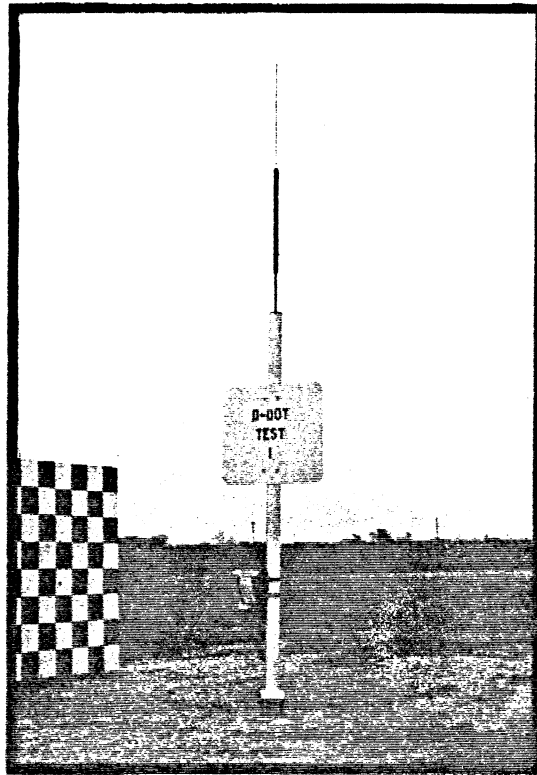
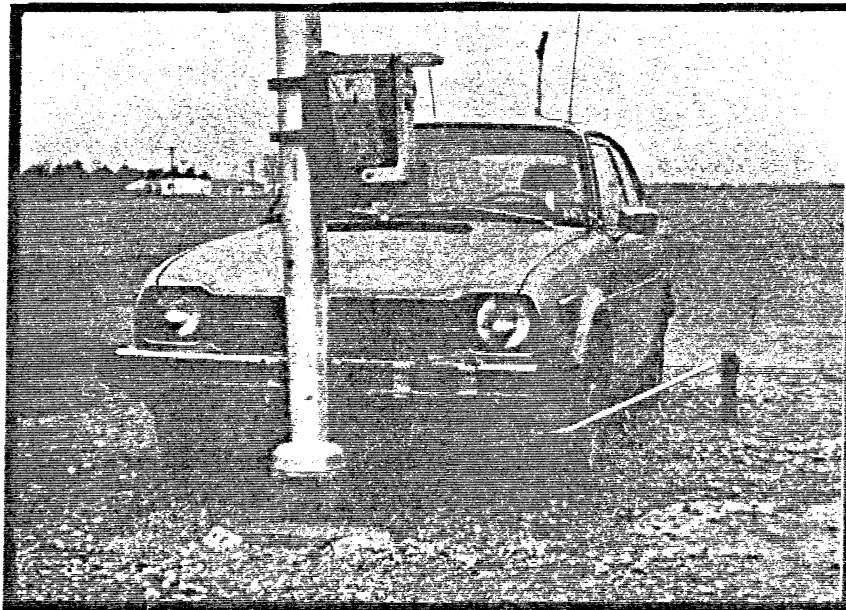
Figure 7. Call box installation before test 0335-1.

Test 0335-1, performed on February 11, 1986, followed guidelines for breakaway and yielding supports described in Test 62 of NCHRP Report 230<sup>1</sup>. The test installation is shown in figure 7. The 1979 Honda shown in figure 8 was directed into the call box installation using a cable reverse tow and guidance system. The Test Inertia Mass of the vehicle was 1,783 lb (809 kg) and its Gross Static Mass was 1,953 lb (887 kg). Vehicle mass properties and geometry are shown in figure 9. The point of impact was such that the center of the vehicle bumper contacted the call box support pole. The vehicle bumper height was 17.6 in (44.8 cm). The test vehicle was released from the tow and guidance system just prior to impact, thus it was free-wheeling and unrestrained at impact. The velocity of the vehicle at impact was 18.2 mi/h (29.3 km/h).

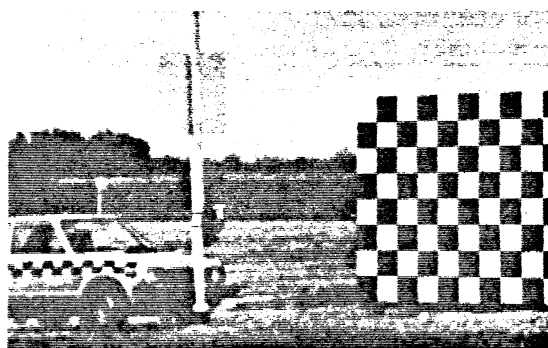
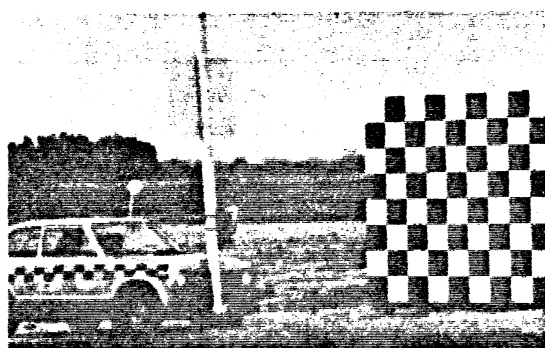
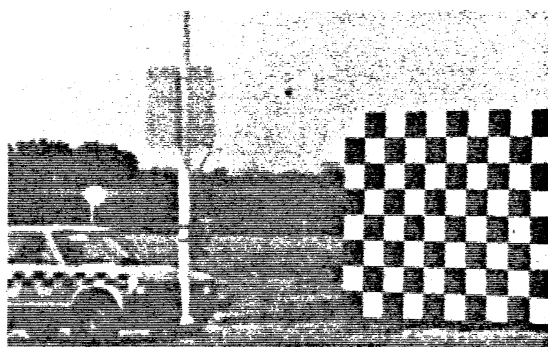
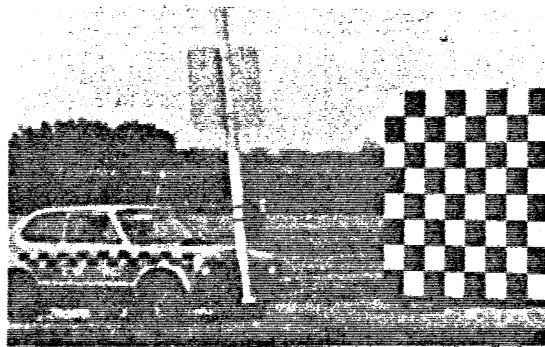
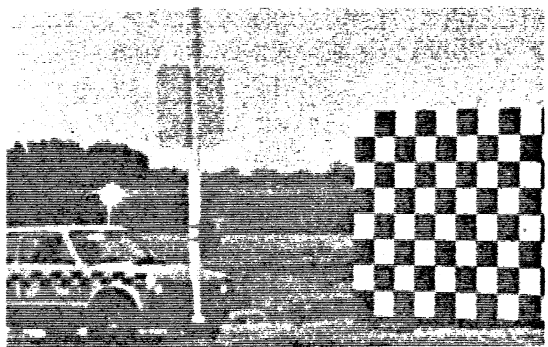
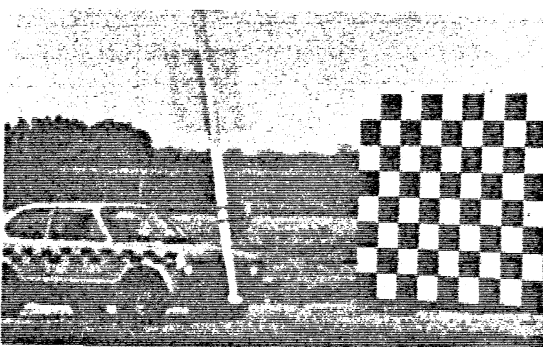
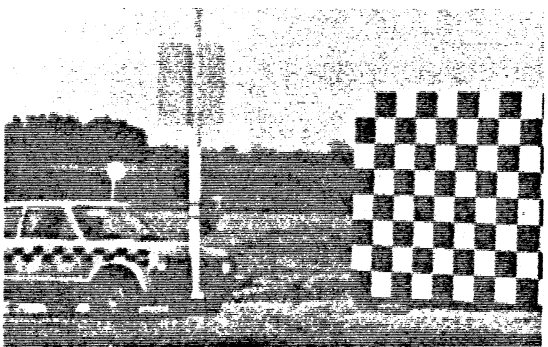
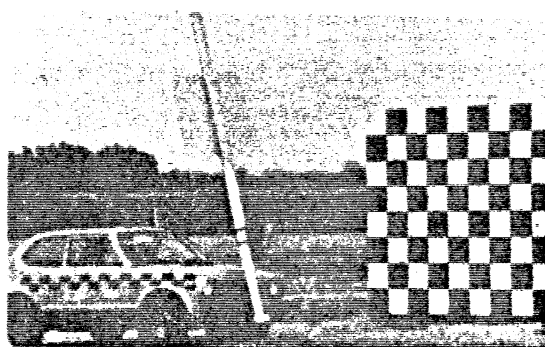
Figure 10. Sequential photographs for test 0335-1.

As the center of the vehicle bumper impacted the call box pole, the pole pushed the bumper inward. The vehicle hood and grill then contacted the pole. As the hood and grill crushed inward, the breakaway couplings began leaning away from the vehicle. The pole flange began to break out at the coupling connections. As the flange broke out, the anchor bolts on three couplings sheared. The pole then began to rotate about a lateral axis with the lower end of the pole moving forward in the direction of vehicle travel. The couplings, with attached flange pieces, began tumbling forward. As the pole assembly moved forward, the call box housing began to separate from the mount, falling open while remaining attached by its hinge. The pole then parted from the vehicle as both the pole assembly and the vehicle continued to move forward. The pole dropped as it rotated about a lateral axis and somewhat about a vertical axis. The pole again contacted the hood at a point on the pole above the call box. The sign, still attached to the pole, then slapped the upper half of the vehicle windshield and the front of the roof. The assembly slowly slid forward and down the vehicle until the lower end of the pole contacted the ground. The vehicle brakes were applied. Table 2 presents the significant events of this test by time.

The vehicle broke into two major pieces. The lower portion of the coupling remained on the anchor bolt. The upper part traveled with the pole attached to the remaining pole flange. Sequential photographs of the test are shown in figure 10. Figure 11 shows the installation after test 0335-1.

The installation readily activated by breaking away. The manner of activation was not completely expected, however, due to the nature of breakaway devices. The flange and anchor bolts at three of the four supports fractured rather than the breakaway couplings. A similar activation would be predicted in a duplicate test. The detached elements from the test article did not penetrate nor show potential for penetrating the passenger compartment, nor presented undue hazard to other traffic due to the off-road location of the elements. The vehicle remained upright during and after the collision. The calculated longitudinal occupant impact velocity against the vehicle interior was below the limit of 15 ft/s (4.6 m/s). The absolute value of the measured maximum 0.010-second average longitudinal occupant ridedown acceleration was below the limit of 15 g. After collision, the vehicle trajectory and final stopping position was such that the vehicle did not intrude into adjacent traffic lanes. The vehicle trajectory behind this test article was acceptable.

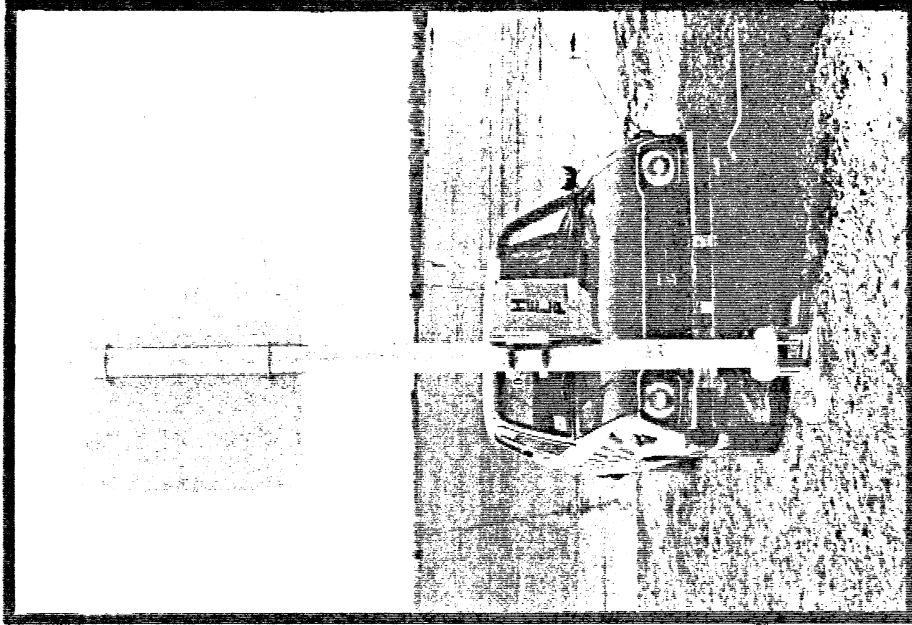
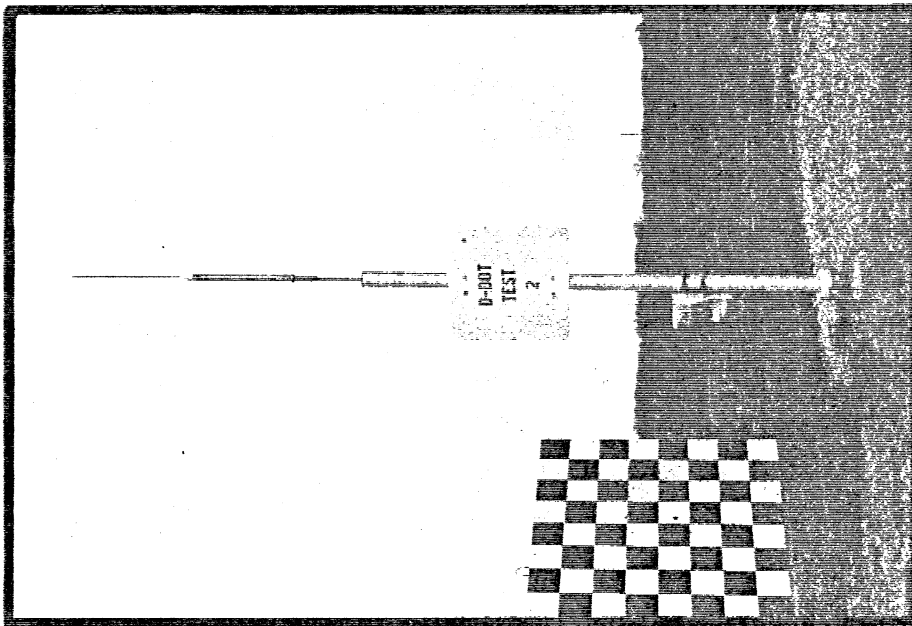
Figure 14. Call box installation before test 0335-2.

Test 0335-2, performed on February 12, 1986, followed guidelines for breakaway and yielding supports described in Test 63 of NCHRP Report 230<sup>1</sup>. The test installation is shown in figure 14. The 1979 Honda shown in figure 15 was directed into the call box installation using a cable reverse tow and guidance system. The Test Inertia Mass of the vehicle was 1,750 lb (795 kg) and its Gross Static Mass was 1,917 lb (870 kg). Vehicle mass properties and geometry are shown in figure 16. The point of impact was such that the right quarter point of the vehicle bumper contacted the call box support pole. The vehicle bumper height was 17.6 in (44.8 cm). The test vehicle was released from the tow and guidance system just prior to impact, thus it was free-wheeling and unrestrained at impact. The velocity of the vehicle at impact was 64.6 mi/h (103.9 km/h).

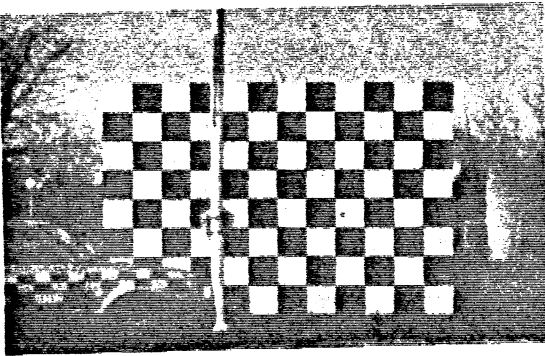
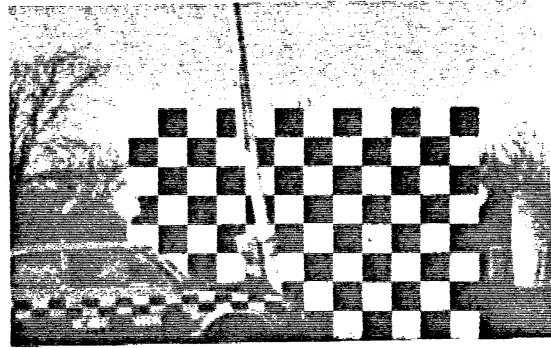
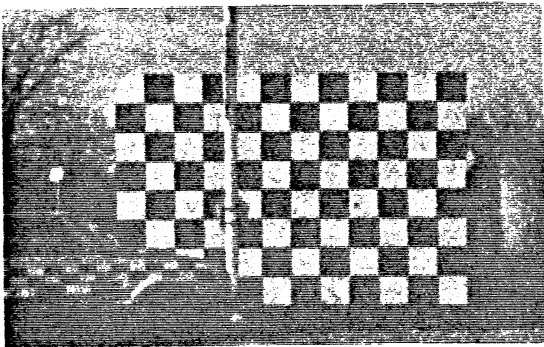
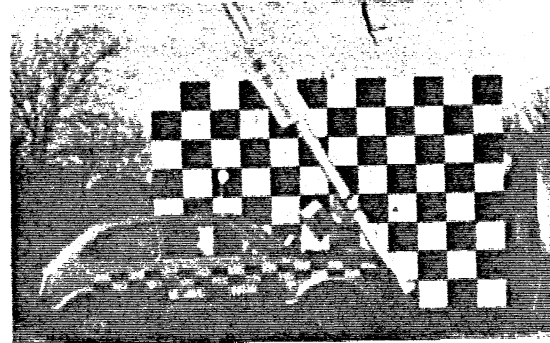
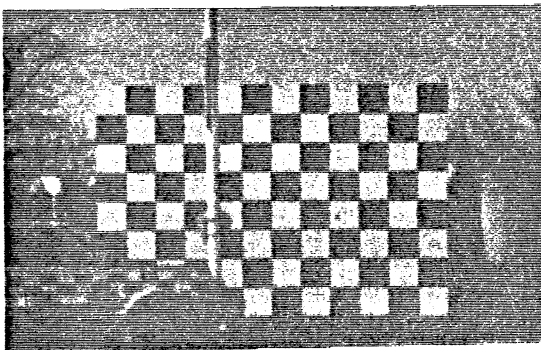
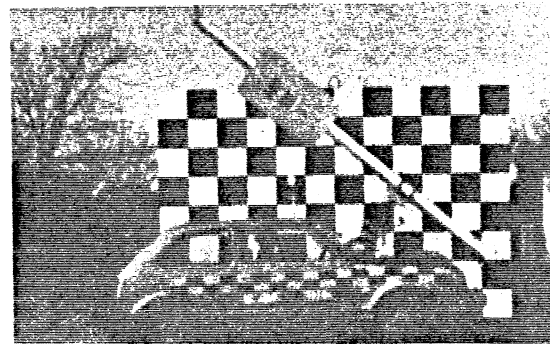
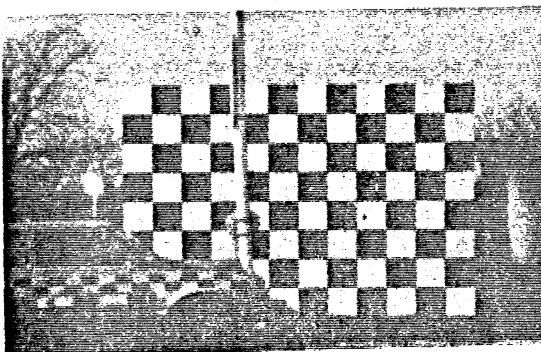
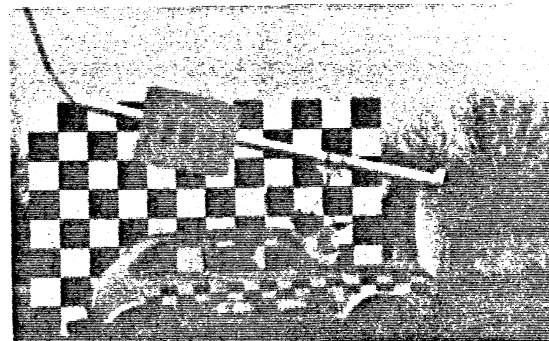
Figure 17. Sequential photographs for test 0335-2.

As the right quarter point of the vehicle bumper impacted the call box pole, the pole pushed the bumper inward. The vehicle hood and grill then contacted the pole. As the hood, grill and bumper crushed inward, the breakaway couplings began leaning away from the vehicle, and the pole flange began to break out at the coupling connections. As the flange broke out, the anchor bolts on the couplings sheared. The pole then began to rotate about a lateral axis with the lower end of the pole moving forward in the direction of vehicle travel. The couplings, with attached flange pieces, began tumbling forward. The pole also began to rotate counterclockwise about a vertical axis and rise upward. As the pole assembly moved forward, the call box housing separated from the mount. The vehicle then lost contact with the pole as both the pole assembly and the vehicle continued to move forward. The handle on the detached call box housing contacted the lower portion of the vehicle windshield just as the housing struck the middle of the windshield. The housing partially penetrated the windshield. The call box generator came out of the housing and began to rise upward. One of the couplings and a flange fragment were propelled forward ahead of the vehicle. Another coupling rose upward about 2 ft (0.6 m) as it came out from

The center of gravity of the vehicle at final rest was approximately 225 ft (68.6 m) in the longitudinal direction and 43 ft (13.1 m) to the right of the pole base. The pole landed approximately 21 ft (6.4 m) from the base. Two of the four breakaway couplings that separated from the base by the shearing of the anchor bolts came to rest approximately 60 ft (18.3 m) from the base. These two couplings were connected by one piece of the broken flange. Another coupling came to rest about 35 ft (10.7 m) from the base. The fourth coupling was not located. The call box housing was found 125 ft (38.1 m) from the base. The call box generator was located 65 ft (19.8 m) from the base. The antenna landed 3 ft (0.9 m) from the base. Sequential photographs of the test are shown in figure 17. Figure 18 shows the installation after test 0335-2.

The installation readily activated by breaking away. The manner of activation was not completely expected, however, due to the nature of breakaway devices. The flange and anchor bolts at the four supports fractured rather than the breakaway couplings. A similar activation would be predicted in a duplicate test. The test article displayed structural inadequacy as detached call box housing penetrated the occupant compartment. The detached elements did not show potential for presenting undue hazard to other traffic due to the off-road location of the elements. The vehicle remained upright during and after the collision. The calculated longitudinal occupant impact velocity against the vehicle interior was below the limit of 15 ft/s (4.6 m/s). The absolute value of the measured maximum 0.010-second average longitudinal occupant ridedown acceleration was below the limit of 15 g. After collision, the vehicle trajectory and final stopping position was such that the vehicle did not intrude into adjacent traffic lanes. The vehicle trajectory behind this test article was acceptable.

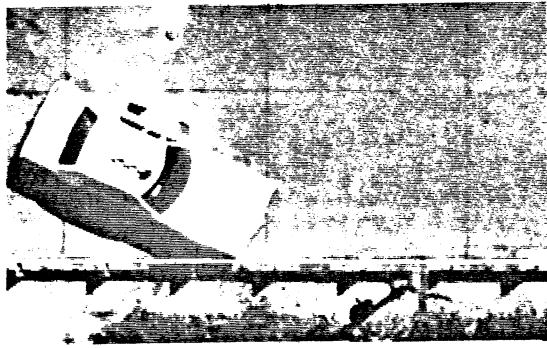
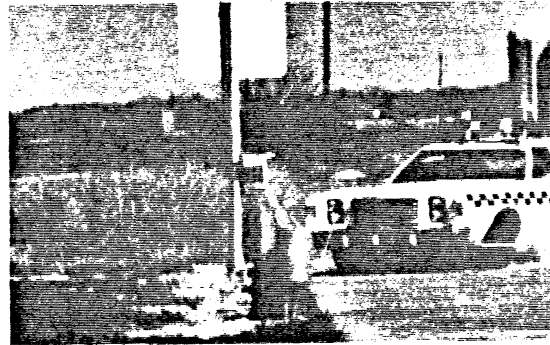
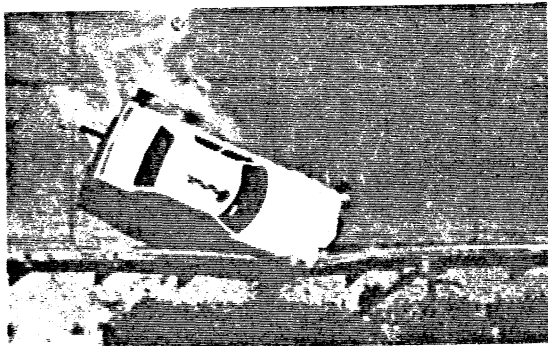
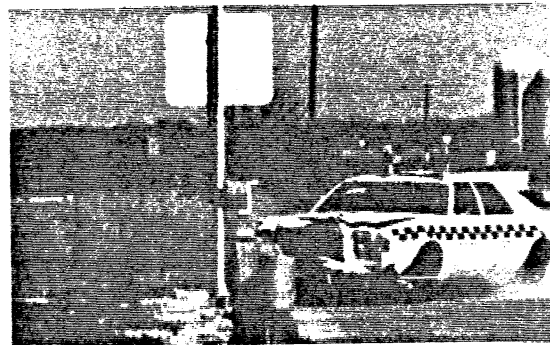
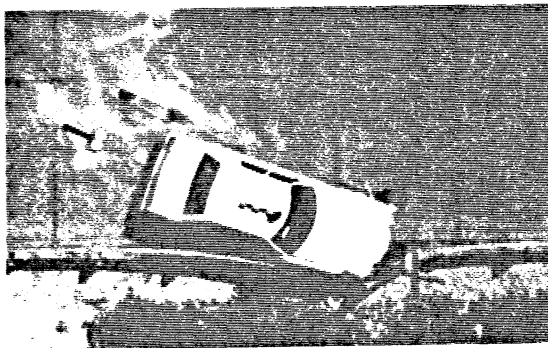
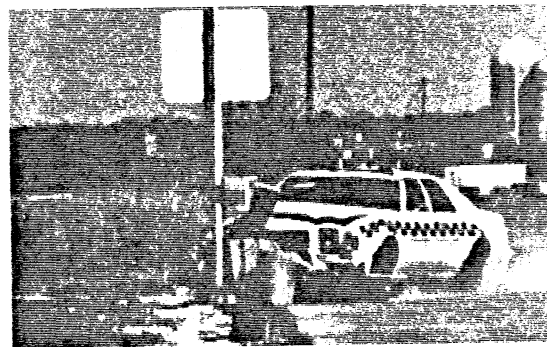
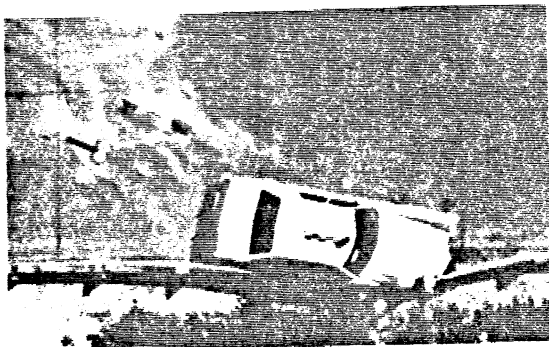
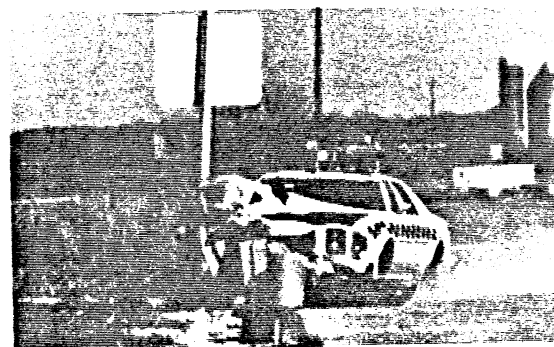
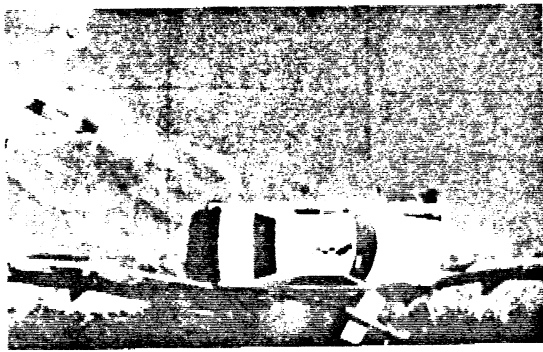
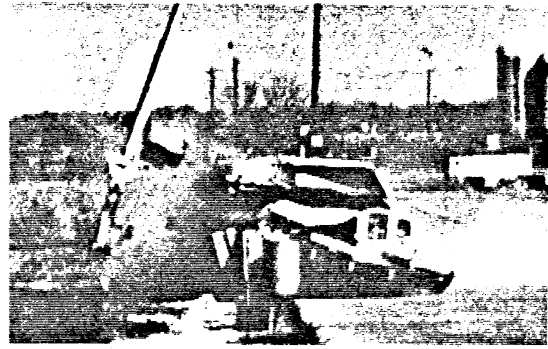
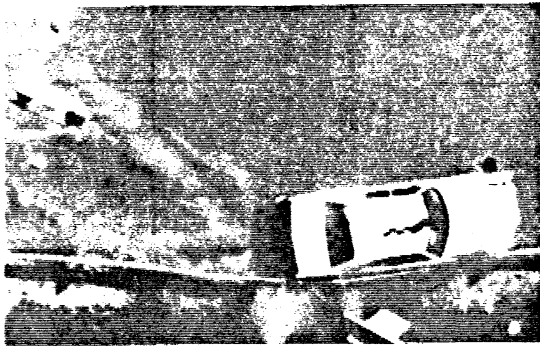
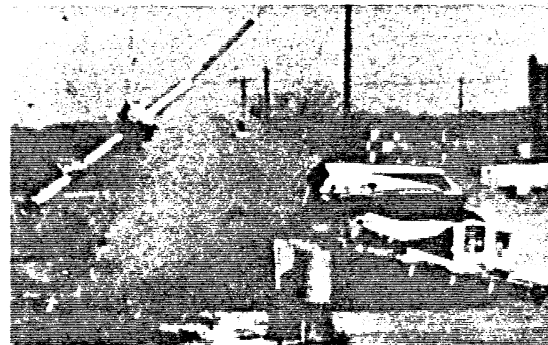
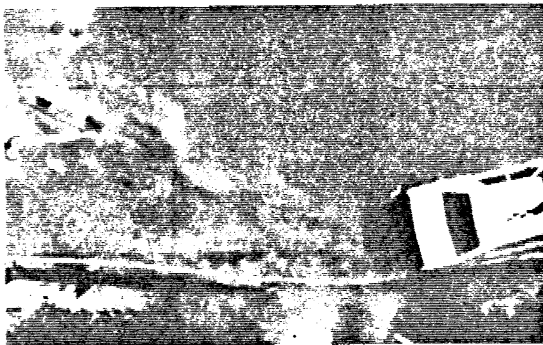
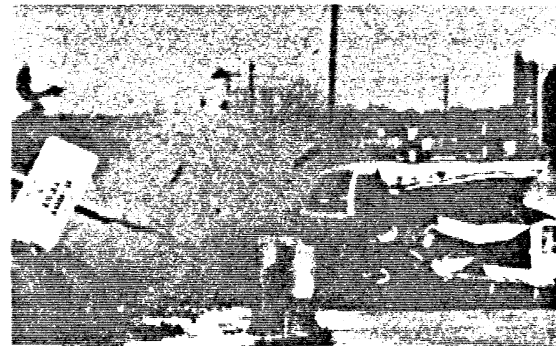
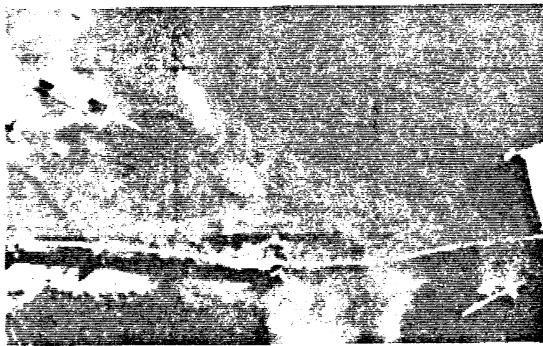
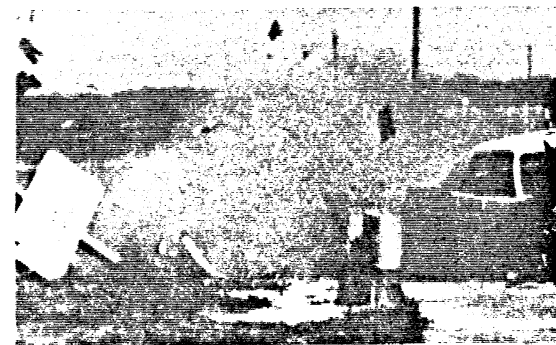
Figure 24. Sequential photographs for test 0335-3.

As the vehicle impacted the W-beam rail, the bumper began to shift toward the left, the rail and post 7 began to displace to the right, and the vehicle began to rotate counterclockwise. The front corner of the vehicle crushed inward, popping out the grill and causing the hood to raise. The grill swept upward striking the call box. The rail contacted the call box pole. The breakaway couplings began to lean just before the couplings and the pole flange broke away. The call box housing began to open as the pole began to rotate about longitudinal and lateral axes with the bottom end of the pole moving forward and to the right. The partially raised hood contacted the call box housing. The pole then began to rotate about its vertical axis. The hood began buckling as the housing separated from the mount. The hood lost contact with the housing, projecting the housing forward and to the right. The call box generator separated from the housing. As the vehicle redirected to an exit angle of 14.7 degrees to the rail, the vehicle lost contact with the rail. The upper end of the pole contacted the ground after approximately 45 degrees of longitudinal, 110 degrees of lateral and 90 degrees of vertical rotation. The vehicle brakes were applied. Table 4 presents the significant events of this test by time.

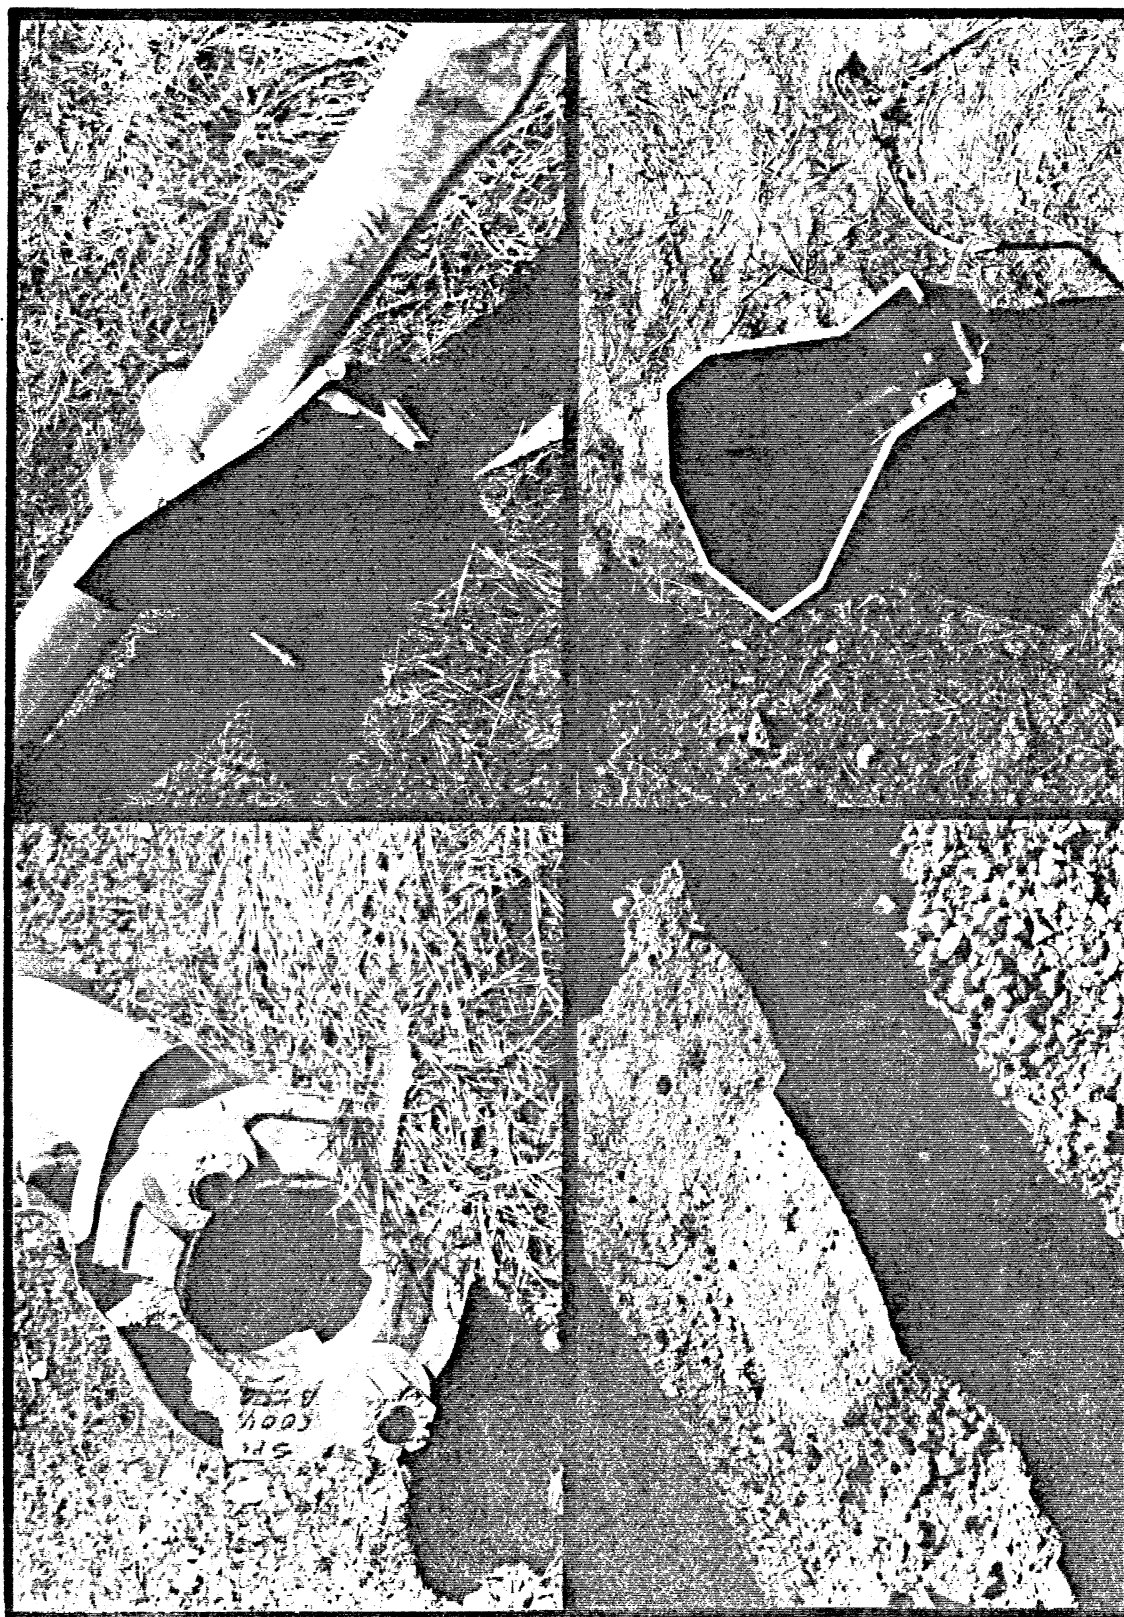
Figure 25. Call box installation after test 0335-3.

the left of the pole base. The pole came to rest 9 ft (2.7 m) to the right of the rail with the upper end of the pole aligned with post 11 and the lower end of the pole aligned with post 12. All four breakaway couplings separated from the base by the shearing of the anchor bolts. Two of the couplings also sheared with the upper portions remaining fastened to the pole flange. One of the lower portions landed 14 ft (4.3 m) from the base and the other portion landed 21 ft (6.4 m) from the base. The third coupling with attached flange piece came to rest 35 ft (10.7 m) from the base. The fourth coupling landed with the call box housing and generator approximately 83 ft (25 m) from the base. Sequential photographs of the test are shown in figure 24. Figure 25 shows the call box installation after test 0335-3.

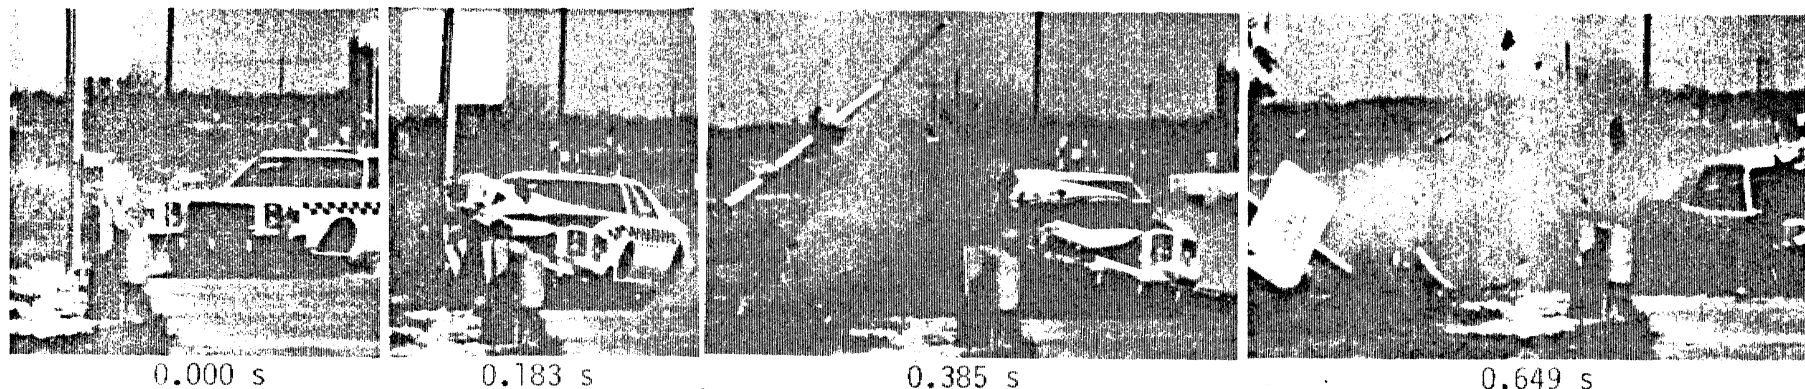
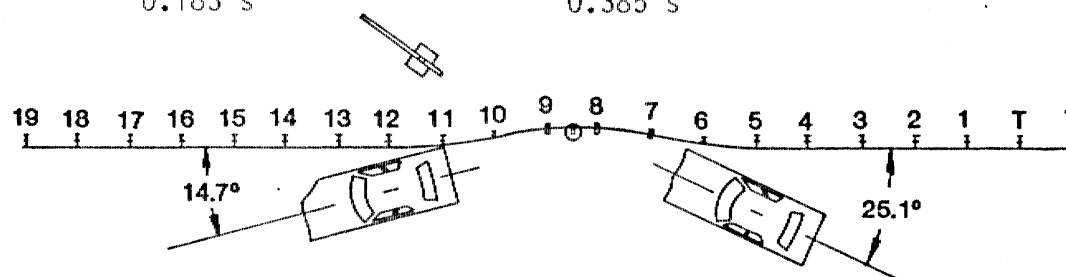
Test No. . . . . 0335-3  
 NCHRP Report 230 Test No. . 10  
 Date . . . . . 2/25/86  
 Test Article . . . . . Motorist call box  
                     with 54 in (137 cm) height  
                     behind "W" section guardrail  
 Length of Guardrail. . . . 125 ft (38 m)  
 Rail Deflection  
     Permanent. . . . . 22.3 in (56.5 cm)  
     Dynamic. . . . . 38.5 in (97.8 cm)  
 Vehicle. . . . . 1979 Ford LTD II  
 Vehicle Weight  
     Test Inertia . . . . . 4,500 lb (2,043 kg)  
     Gross Static . . . . . 4,500 lb (2,043 kg)  
 Vehicle Damage Classification  
     TAD. . . . . 1-FR-5 & 1-RD-4  
     SAE. . . . . 01FREK1 & 01RDES2

Impact Speed. . . . . 62.9 mi/h (101.2 km/h)  
 Impact Angle. . . . . 25.1 degrees  
 Exit Angle. . . . . 14.7 degrees  
 Change in Velocity. . . . 22.2 mi/h (35.7 km/h)  
 Change in Momentum. . . 4551 lb-s (2066 kg-s)  
 Vehicle Accelerations . (Max. 0.050-sec Avg)  
     Longitudinal. . . . . -6.1 g  
     Lateral . . . . . 8.0 g  
     Vertical. . . . . 2.4 g  
 Occupant Impact Velocity  
     Longitudinal. . . . . 23.7 ft/s (7.2 m/s)  
     Lateral . . . . . 19.4 ft/s (5.9 m/s)  
 Occupant Ridedown Accelerations  
     Longitudinal. . . . . -5.7 g  
     Lateral . . . . . 11.2 g  
 Maximum Vehicle Crush at  
     Bumper Height . . . . 26.5 in (67.3 cm)

This guardrail and call box installation met the evaluation criteria recommended in NCHRP Report 230<sup>1</sup> for Test 10 for structural adequacy, occupant risk and vehicle trajectory.

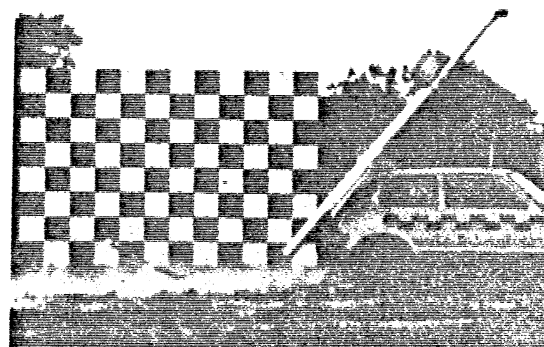
Figure 32. Sequential photographs for test 0335-4.

As the right quarter point of the vehicle bumper impacted the call box pole, the pole pushed the bumper inward. The vehicle hood and grill then contacted the pole. As the hood, grill and bumper crushed inward, the breakaway couplings began leaning away from the vehicle, the front two couplings sheared, and the pole flange began to break out at the back two coupling connections. As the flange broke out, the anchor bolts on the back two couplings sheared. The pole then began to rotate about a lateral axis with the lower end of the pole moving forward in the direction of vehicle travel. The two couplings, with attached flange piece, began tumbling forward. The vehicle then lost contact with the pole as both the pole assembly and the vehicle continued to move forward. The vehicle then passed under the pole assembly. The pole had reached a height of approximately 6 ft (1.8 m) while positioned parallel to the ground. The antenna separated from the pole.

After approximately 490 degrees of lateral rotation, the lower end of the pole contacted the ground. The vehicle brakes were applied. Table 5 presents the significant events of this test by time.
