CRASH TESTING A REUSABLE POLYETHYLENE NARROW IMPACT ATTENUATION SYSTEM

Project No. 472380
Polyethylene Cylinder Crash Cushion
Test 472380-6

Prepared for
Vanderbilt University
Nashville, Tennessee

Texas Transportation Institute
Texas A&M University System
College Station, Tx 77843

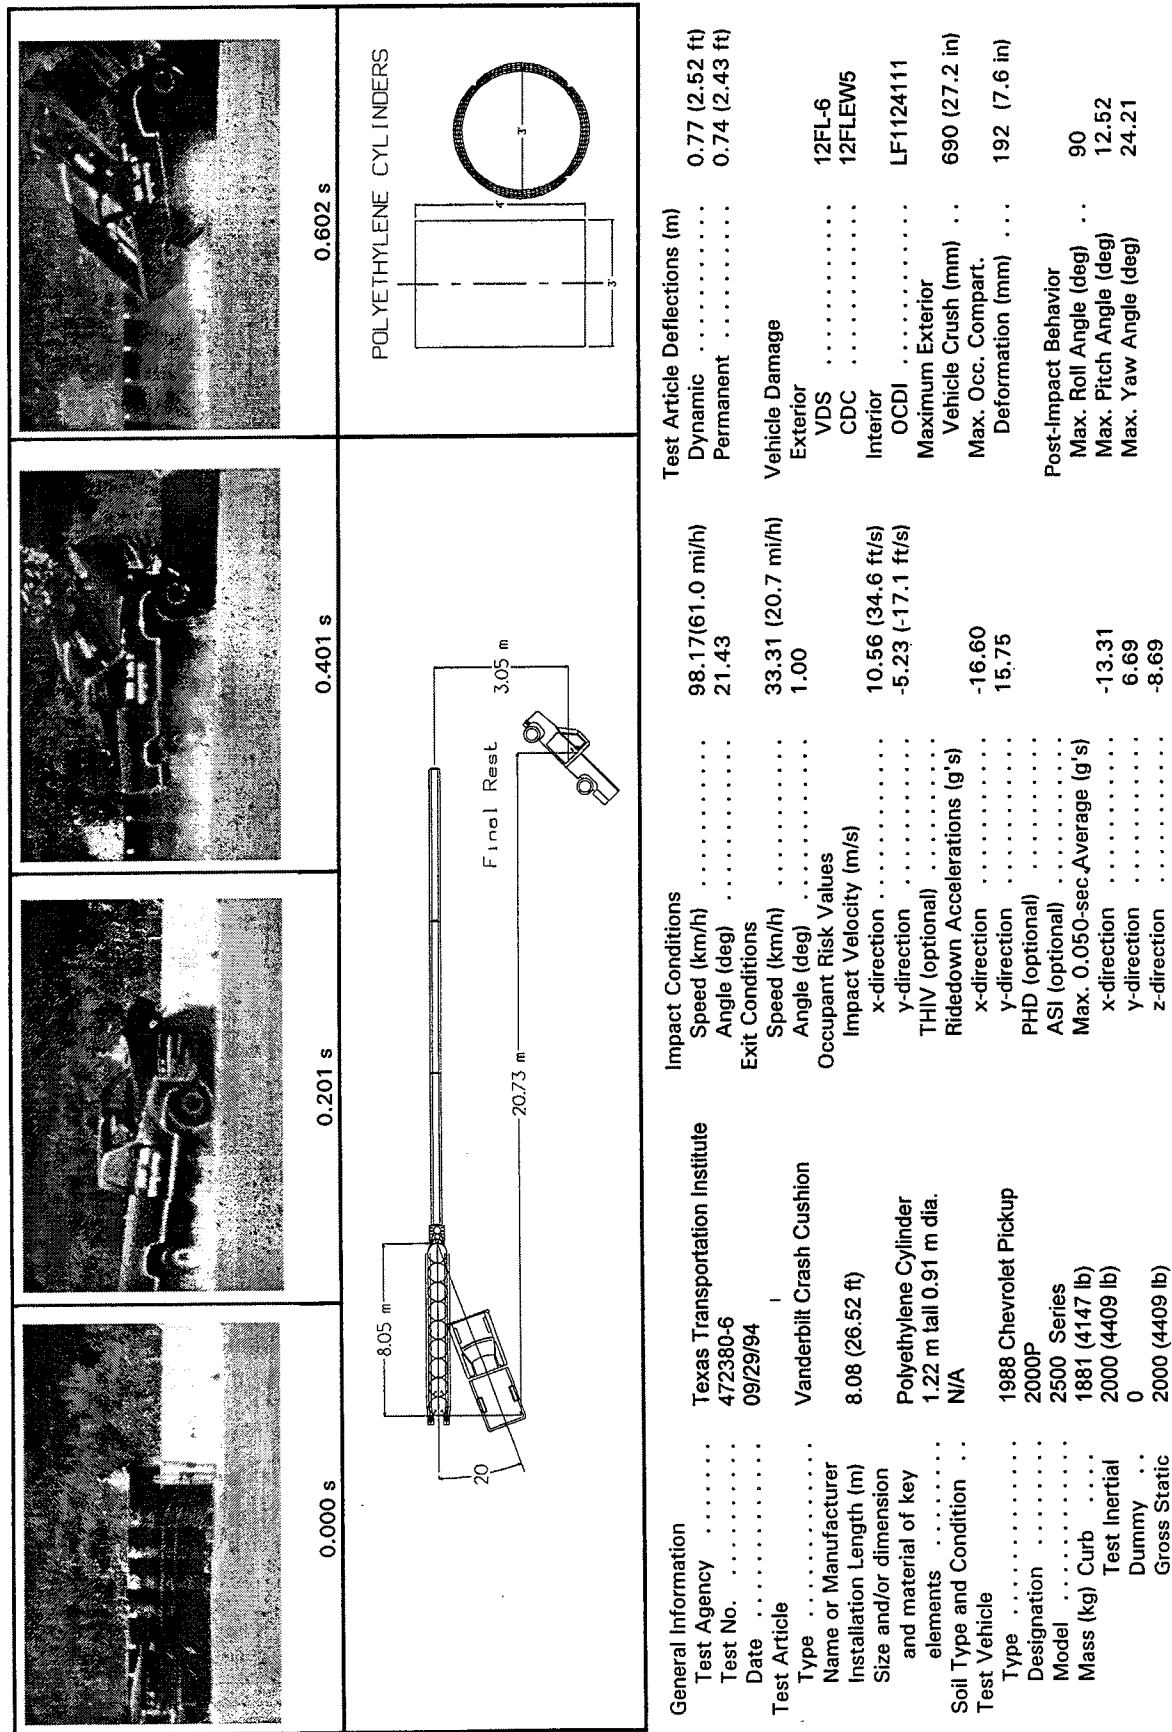
Figure 14. Summary of results for test 472380-6.

In the test, the Reusable Polyethylene Narrow Impact Attenuation System failed to function as intended. The vehicle was redirected, however, there was excessive deformation into the occupant compartment and the permanent backup assembly as well as one of the front anchors was damaged. After redirecting, the vehicle overturned onto the passenger side.

D. Detached elements should not penetrate the occupant compartment, or present an undue hazard to other traffic, pedestrians, or personnel in a work zone. Deformations of the occupant compartment that could cause serious injuries should not be permitted.		There were no detached elements from the CRNIAS. There was deformation into the occupant compartment.	Fail

F. The vehicle should remain upright during and after collision although moderate roll, pitching and yawing are acceptable.		The vehicle overturned after impact.	Fail
<u>Vehicle Trajectory</u>

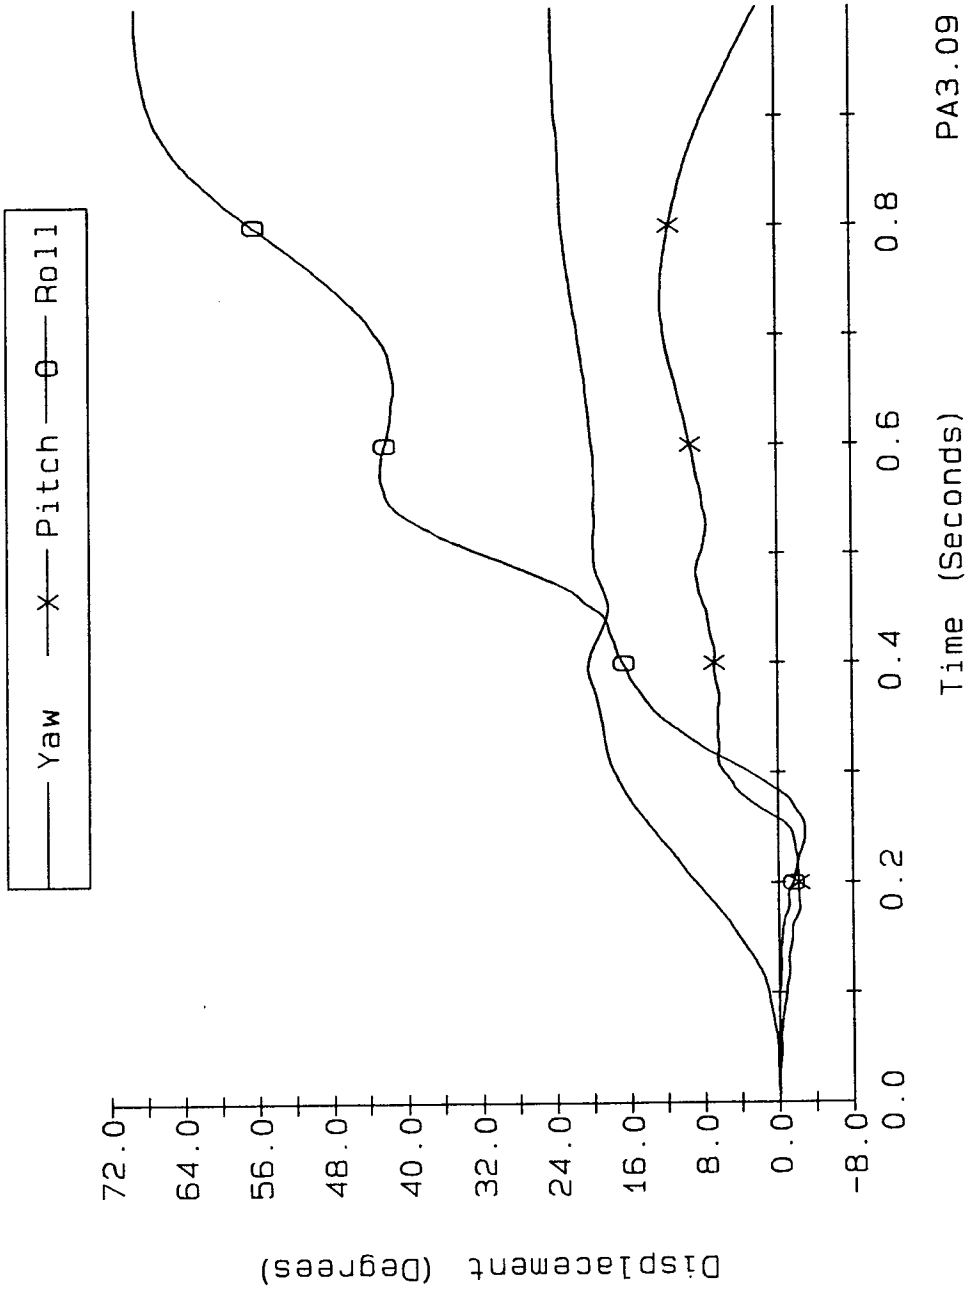
Figure 15. Vehicle angular displacements during test 472380-6.

Axes are vehicle fixed.
Sequence for determining orientation is:

1. Yaw
2. Pitch
3. Roll

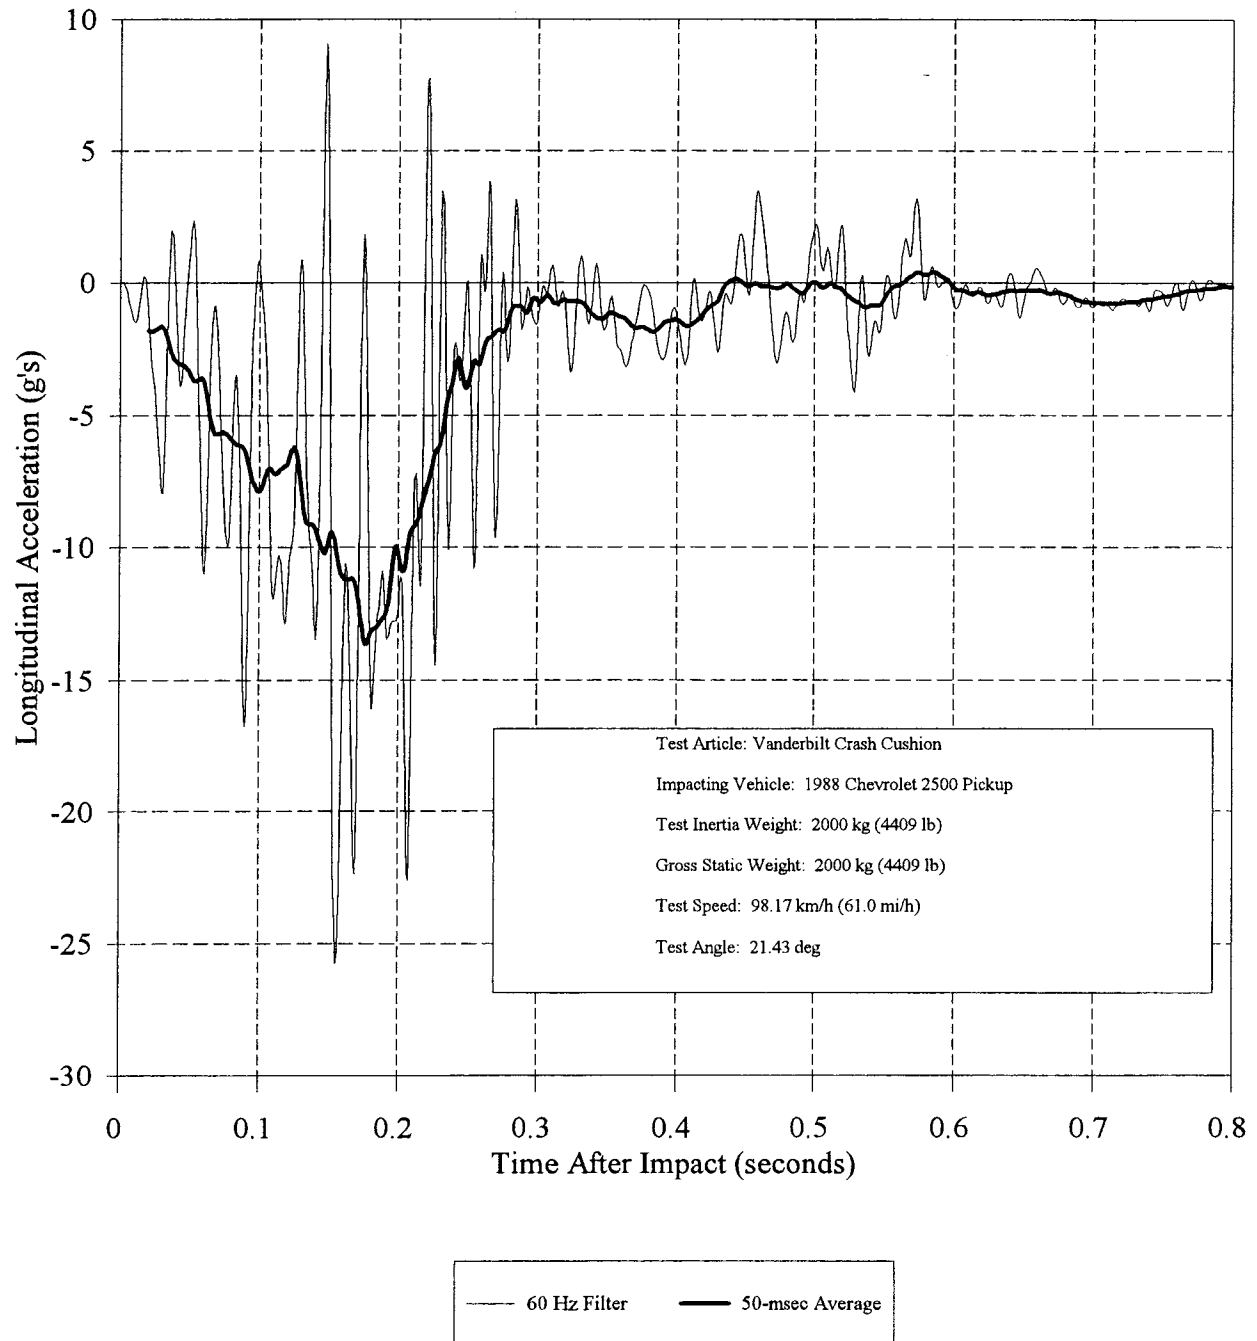
Figure 16 . Longitudinal accelerometer trace for impacting vehicle during test 472380-6.

Data from the accelerometers, located at the center-of-gravity, were digitized for evaluation and the occupant risk values were computed as follows. In the longitudinal direction, occupant impact velocity was 10.56 m/s (34.6 ft/s) at 0.173 s, the highest 0.010-s average ridedown acceleration was -16.60 g between 0.200 and 0.210 s, and the maximum 0.050-s average acceleration was -13.31 g between 0.152 and 0.202 s. Lateral occupant impact velocity was -5.23 m/s (-17.1 ft/s) at 0.160 s, the highest 0.010-s occupant ridedown acceleration was 15.75 g between 0.204 and 0.214 s and the maximum 0.050-s average acceleration was 6.69 g between 0.163 and 0.213 s. These data and other pertinent information from the test are summarized in Figure 14. Vehicular angular displacements are displayed in Figure 15. All vehicular accelerations versus time traces filtered digitally at 60 Hz are presented in Figures 16 through 18.
