**NCHRP REPORT 350 COMPLIANCE TESTS
OF THE ADIEM**

December 1995

1. Report No. FHWA-RD-95-		2. Government Accession No.		3. Recipient's Catalog No.	
4. Title and Subtitle NCHRP REPORT 350 COMPLIANCE TESTS OF THE ADIEM				5. Report Date December 1995

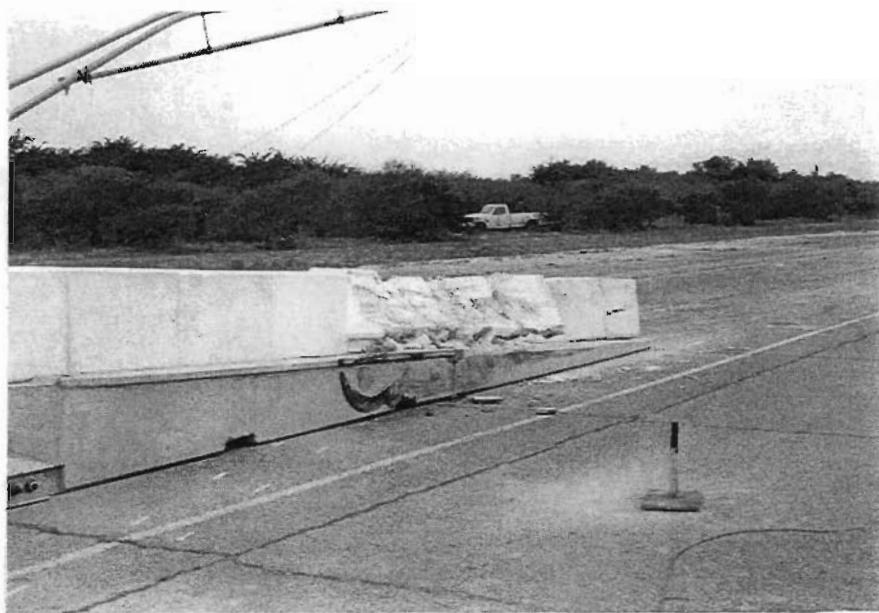
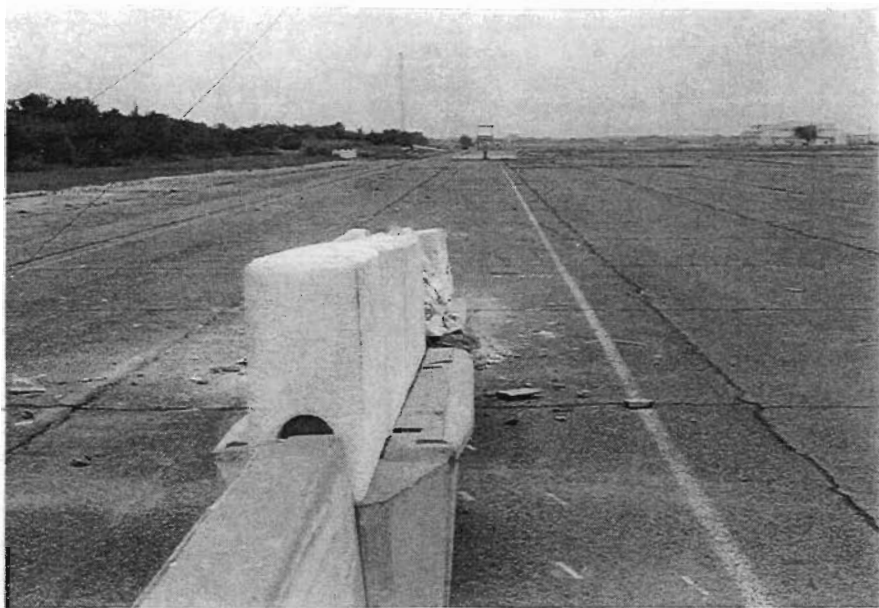
Figure 6. After impact trajectory for test 220517-8.

Modules 1 thru 6 were damaged in the reverse direction hit. Additionally, there was some concrete spalling adjacent to the square tubular member in the impact area. Structural integrity of the carrier arm base was not compromised. As can be seen in figures 6 and 7, there was contact to the base starting next to module 6 and continuing to the nose of the device.

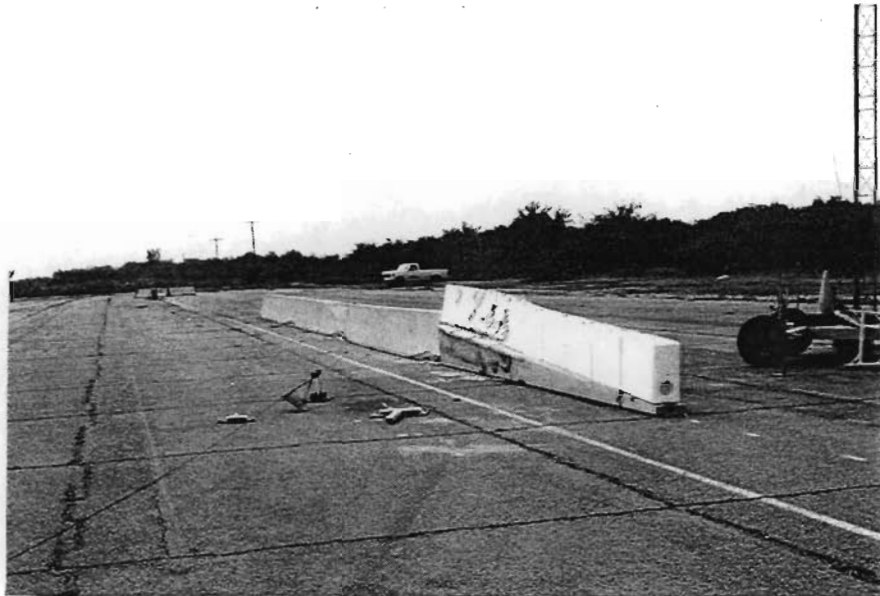
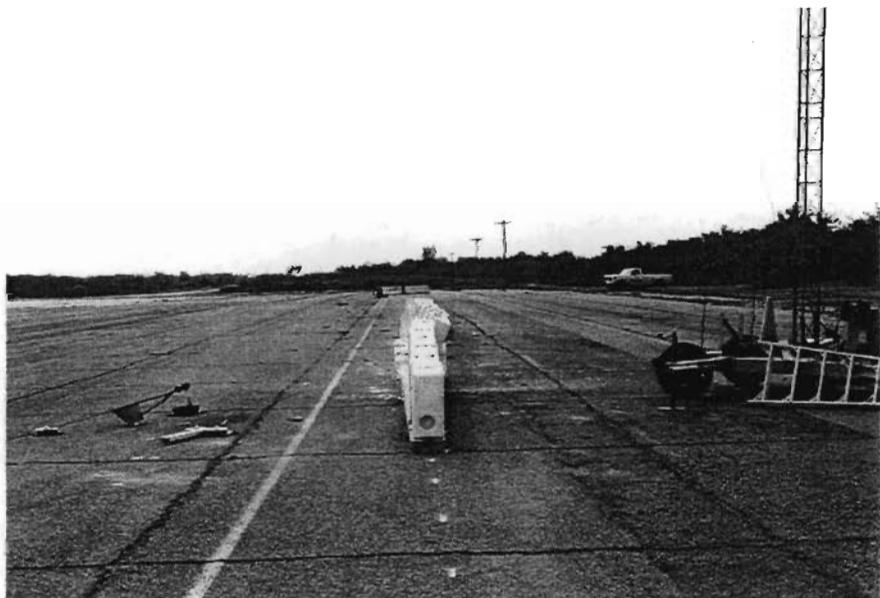
Figure 20. After impact trajectory for test 220538-10.

As can be seen in figures 20 and 21, modules 6 through 10 were damaged during the impact. Concrete adjacent to the base of several anchor pins was chipped when the installation rotated slightly due to impact. Structural integrity was not compromised. Additionally, some cosmetic damage was sustained on the concrete impact face of the base.
