WYOMING TEST LEVEL 4 BRIDGE RAILING

**Research Agreement No. 48251
TTI Project No. 472610
Bridge Railing Crash Test Program**

Wyoming Department of Transportation
Cheyenne, Wyoming 82003

January 1996

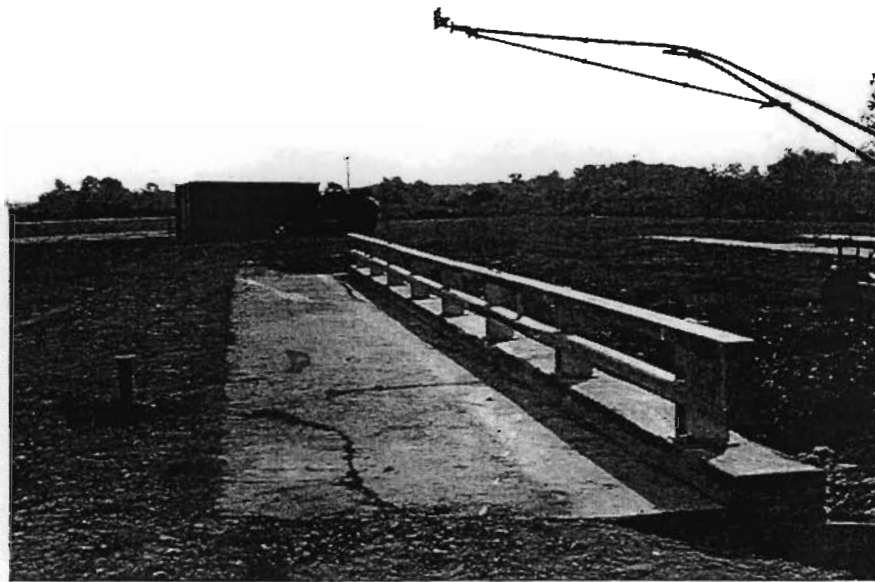
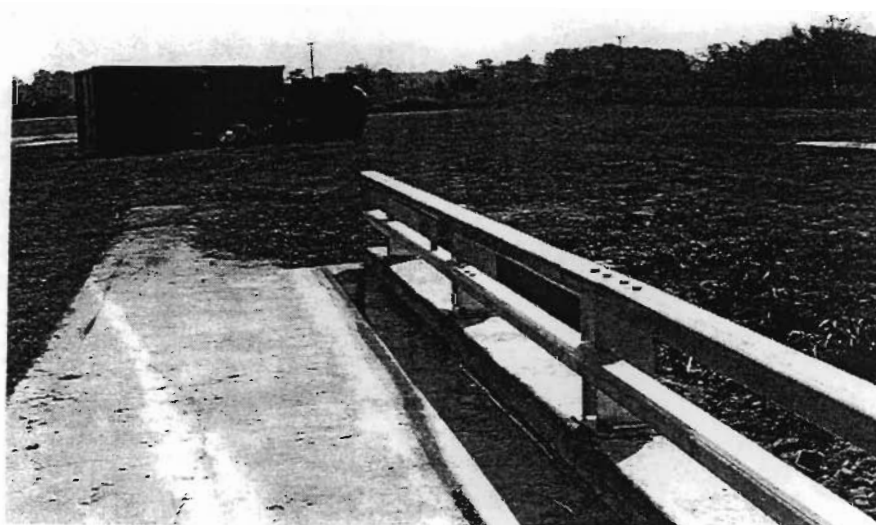
Figure 18. After impact trajectory for test 472610-3.

The bridge railing received minimal damage as shown in figures 18 and 19. There were tire marks on the upper and lower rail elements and the curb (1.2 m). The vehicle remained in contact with the rail from 279 mm downstream of post 2 until the end of the bridge railing. Maximum deformation of the upper rail element was 16 mm and the lower rail element was 22 mm. There was a gouge in the lower metal rail element near the point of initial impact and the spacer between post 2 and 3 was pulled up. A surface crack radiated from the right front bolt at post 2 and also from the center rear bolt at post 3.
