**Test Report No. 440822-01**

## **EVALUATION OF ATTACHMENTS TO CONCRETE BARRIER SYSTEMS TO DETER PEDESTRIANS**

Texas Department of Transportation  
<https://tti.tamu.edu/documents/0-7082-R1-Vol2.pdf>

| 4. Title and Subtitle<br>EVALUATION OF ATTACHMENTS TO CONCRETE BARRIER SYSTEMS TO DETER PEDESTRIANS—VOLUME 2: CRASH REPORT | | 5. Report Date<br>Published: August 2023 | |

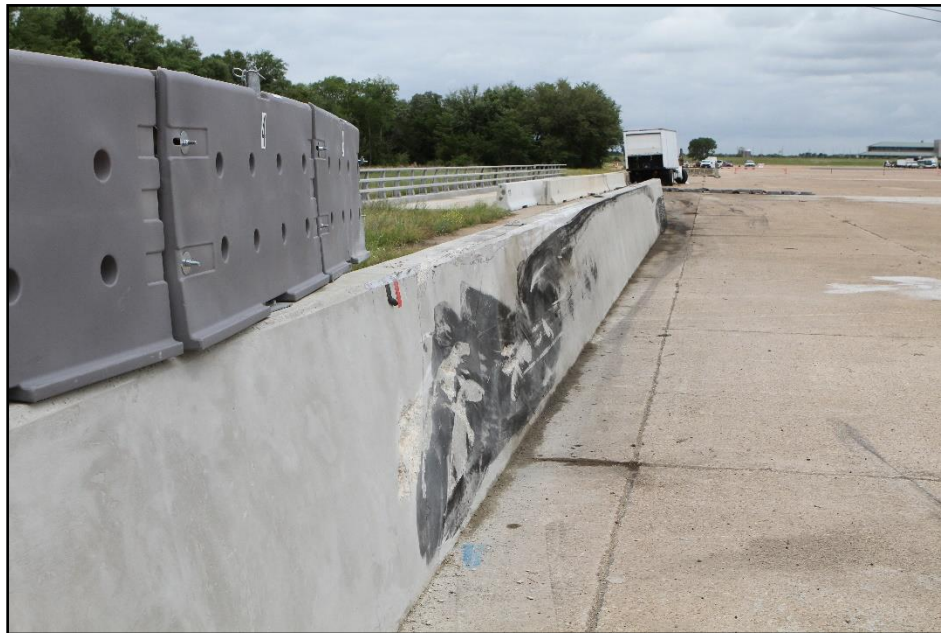
Table 5.6 describes the damage to the Armorcast<sup>®</sup> gawk screen on the single-slope barrier. Figure 5.6 and Figure 5.7 show the damage to the Armorcast<sup>®</sup> gawk screen on the single-slope barrier.

| Test Parameter | Measured |
|---|---|
| Working Width <sup>a</sup> and Height | Dislodged Screen panels at 129.9 inches, at a height of 27.7 inches |

**Figure 5.6. Armorcast® Gawk Screen on Single-Slope Barrier after Test at Impact Location, Test 440822-01-1.**

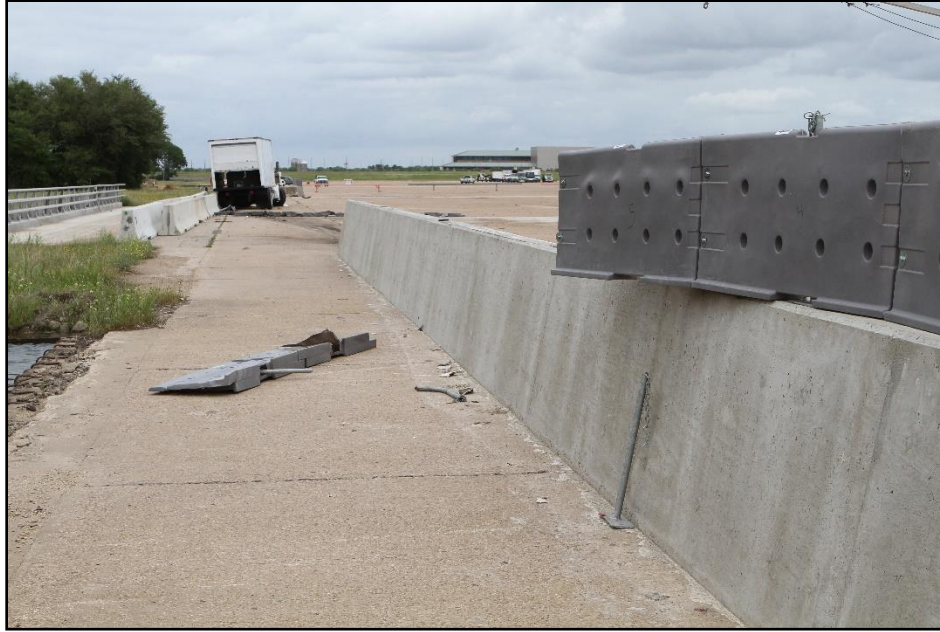
**Figure 5.7. Rear View of the Armorcast® Gawk Screen on Single-Slope Barrier Post Impact, Test 440822-01-1.**

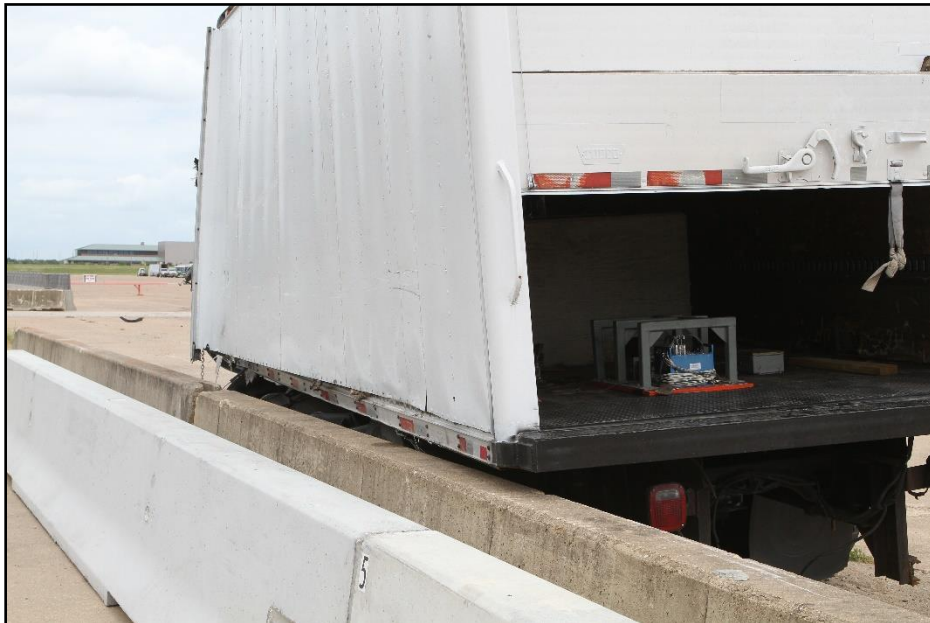
Figure 5.9 and Figure 5.10 show the damage sustained by the vehicle. Figure 5.11 and Figure 5.12 show the interior of the test vehicle. Table 5.7 and Table 5.8 provide details on the occupant compartment deformation and exterior vehicle damage.

**Figure 5.10. Rear Impact Side of Test Vehicle after Test 440822-01-1.**

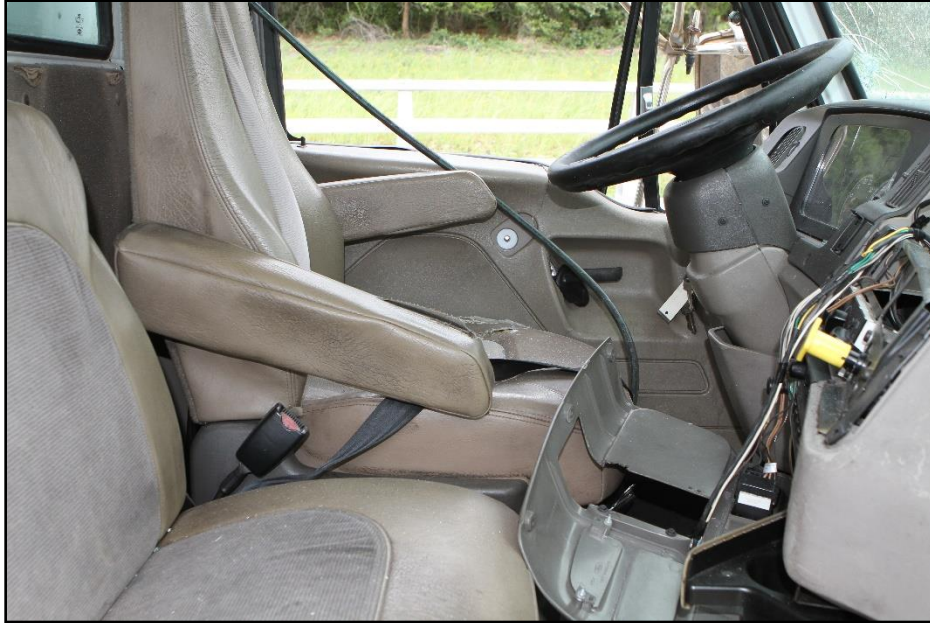
**Figure 5.11. Overall Interior of Test Vehicle after Test 440822-01-1.**

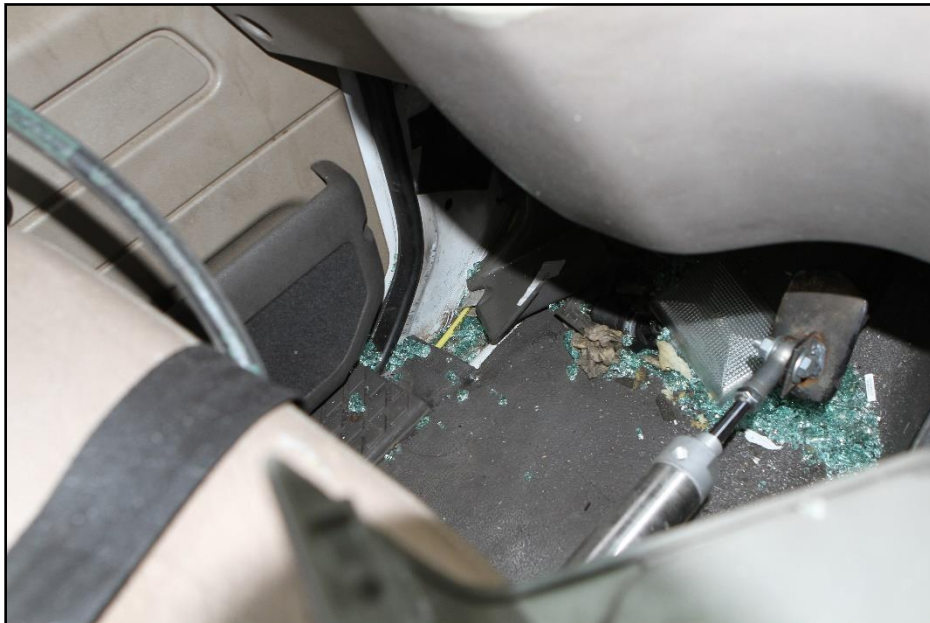
**Figure 5.12. Interior of Test Vehicle on Impact Side after Test 440822-01-1.**

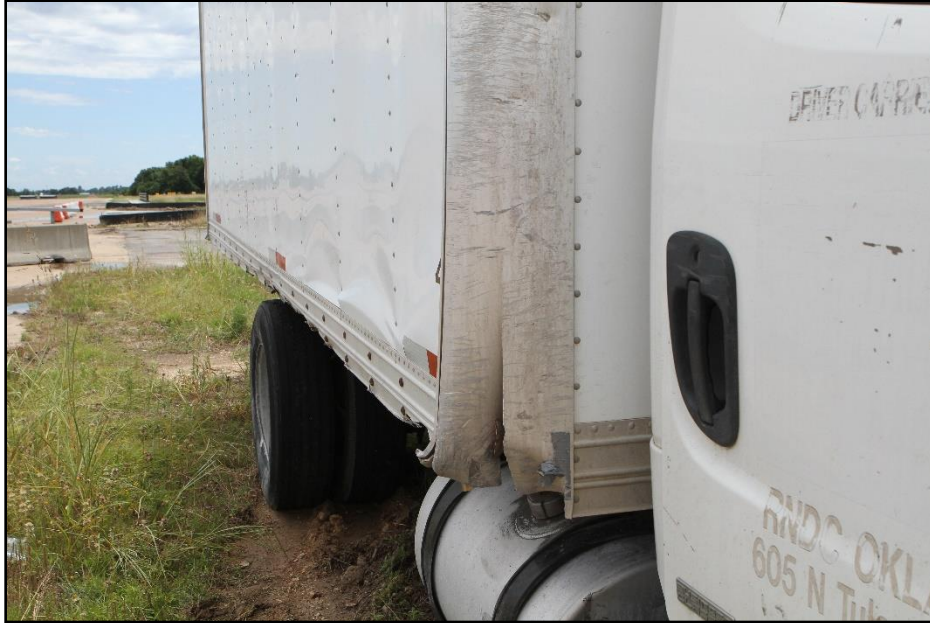
**Figure 6.9. Rear Impact Side of Test Vehicle after Test 440822-01-2.**

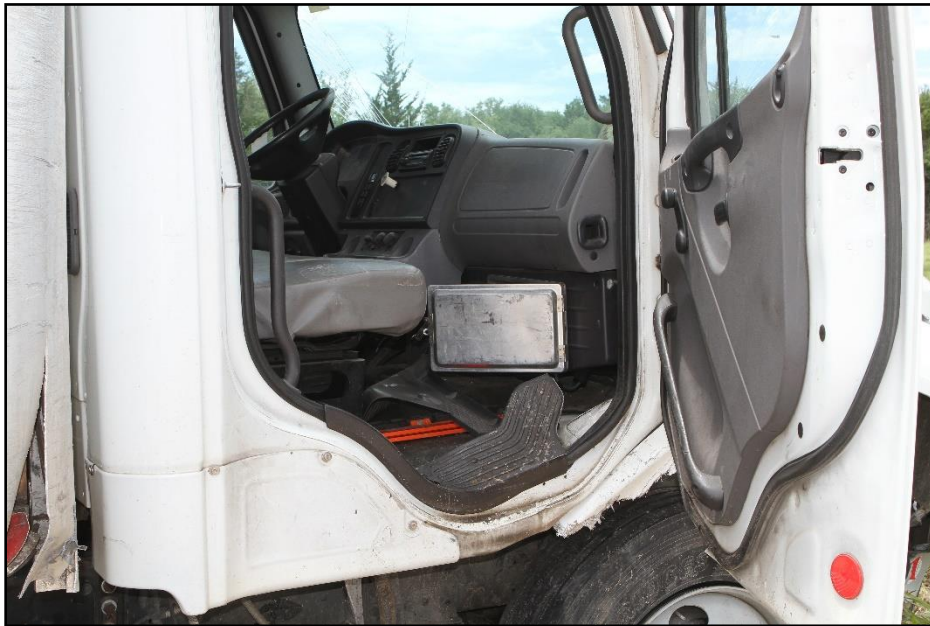
**Figure 6.10. Overall Interior of Test Vehicle after Test 440822-01-2.**

| Description of Damage to Vehicle: | The front axle of the box truck was knocked out. The right front bumper, right front tire and wheel, right front headlight and wheel, right side steps, right side diesel tank, right side mirror, and left front axle and bottom fender were all damaged. The right front corner of the box had a 1.5-inch × 12-inch tear, and there was a 1.5-inch × 1.5-inch hole in the right front corner 46 inches up. |

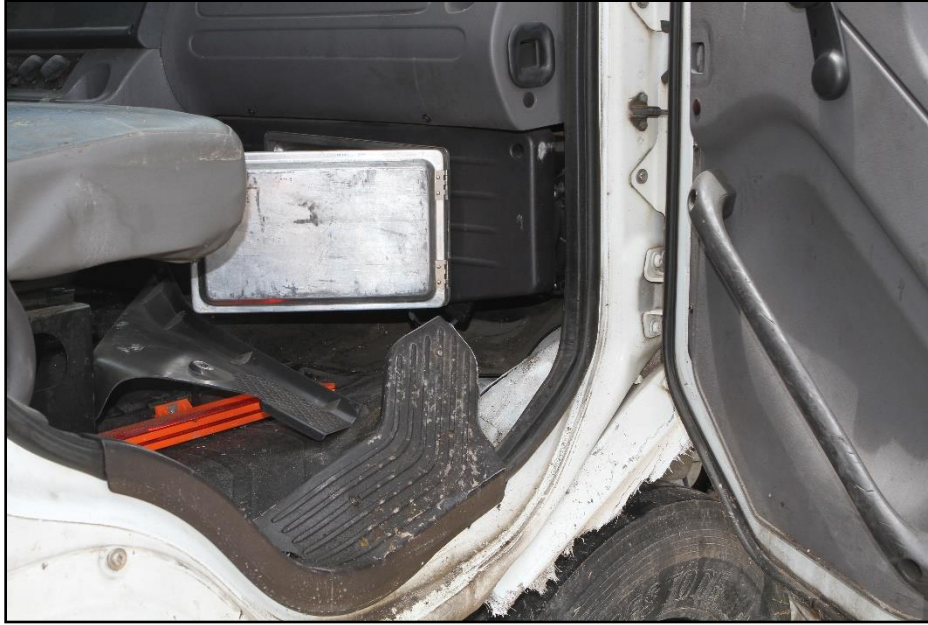
**Figure 6.11. Interior of Test Vehicle on Impact Side after Test 440822-01-2.**

| | Max. Occupant Compartment Deformation | 3.5 inches in the right front floor pan |

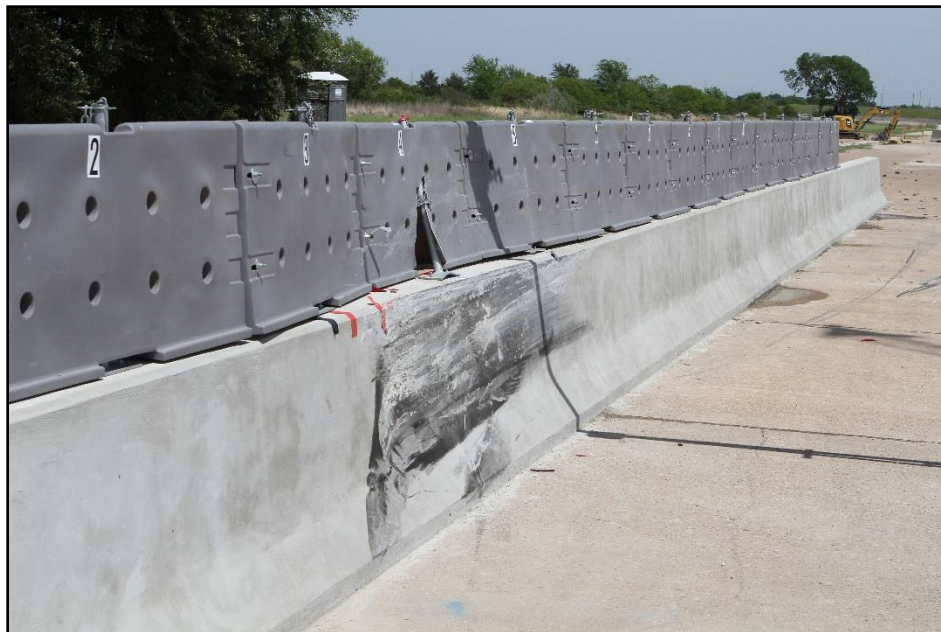
**Figure 7.6. Armorcast<sup>®</sup> Gawk Screen on F-Shape Barrier after Test at Impact Location, Test 440822-01-3.**

There was some scuffing and gouging at impact on the concrete barrier. Screen 4 was damaged and had a vertical tear at its post. The posts and baseplates of screens 3, 4, and 5 were all bent.

| Test Parameter | Measured |
|---|---|
| Working Width <sup>a</sup> and Height | 29.5 inches, at a height of 56 inches (barrier attachment) |

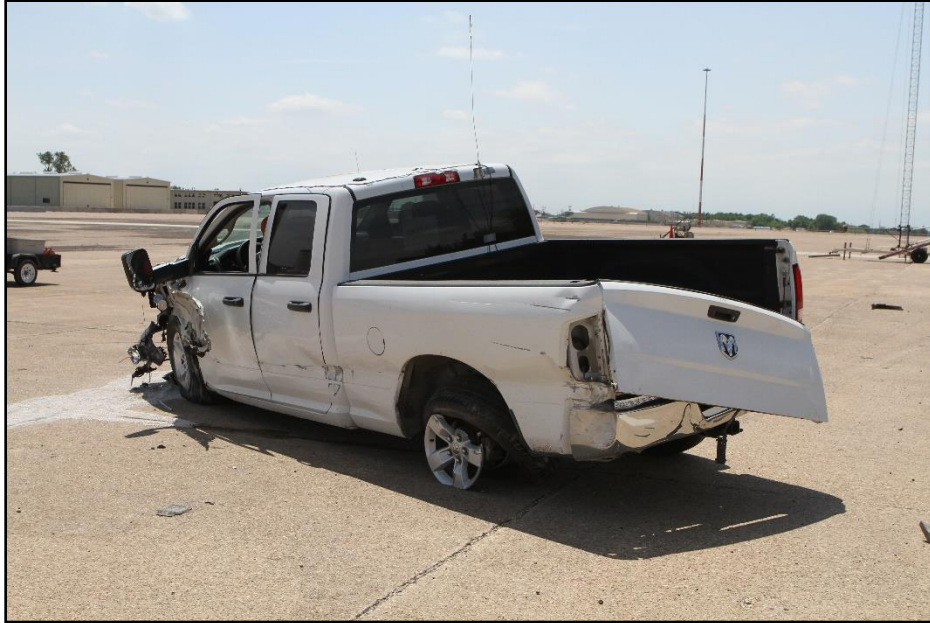
**Figure 7.9. Rear Impact Side of Test Vehicle after Test 440822-01-3.**

| Description of Damage to Vehicle: | The front bumper, hood and grill, radiator and support, left headlight, left front quarter fender, left front tire and rim, left rear door, left cab corner, left rear tire and rim, left taillight, and rear bumper were damaged. The windshield had a lateral crack on the left side as a result of the deformation of the vehicle, and the left front door had a 6-inch gap at the top. |

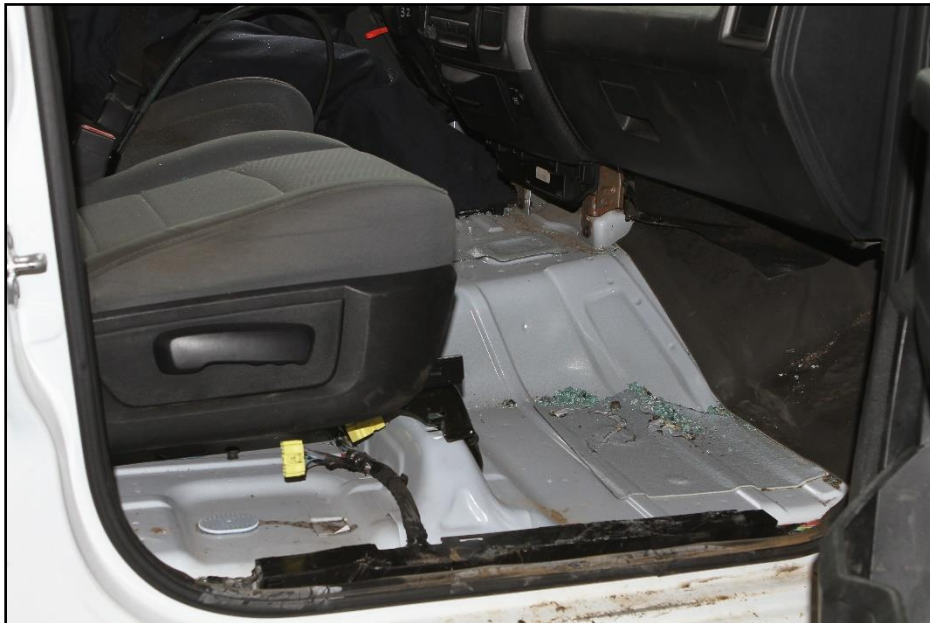
**Figure 7.10. Overall Interior of Test Vehicle after Test 440822-01-3.**

| Side Windows | The side window shattered due to the flex of the door and was not caused by the test article impacting or penetrating the vehicle. |

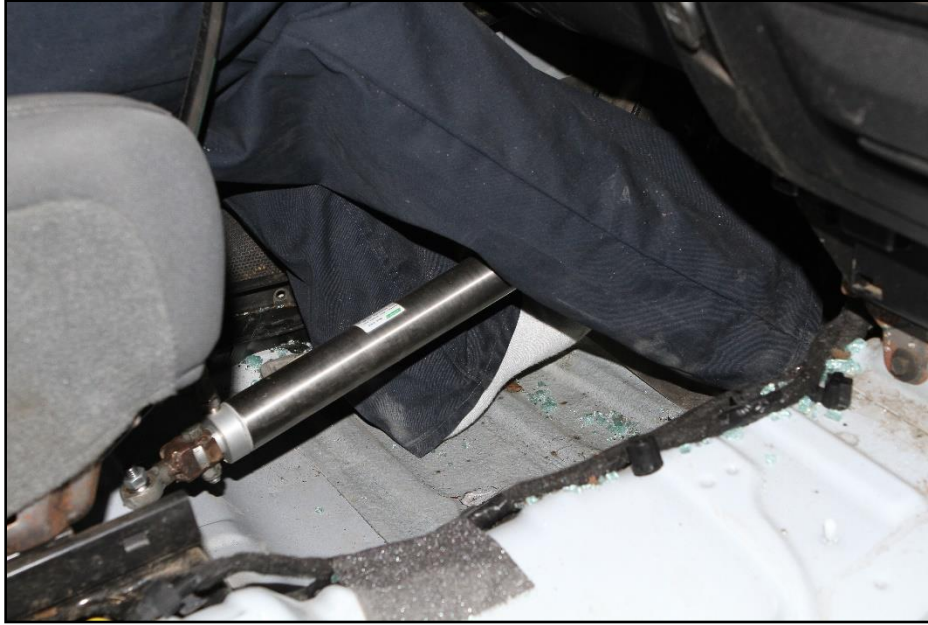
**Figure 7.11. Interior of Test Vehicle on Impact Side after Test 440822-01-3.**

| | Max. Occupant Compartment Deformation | 2 inches in the toe pan |

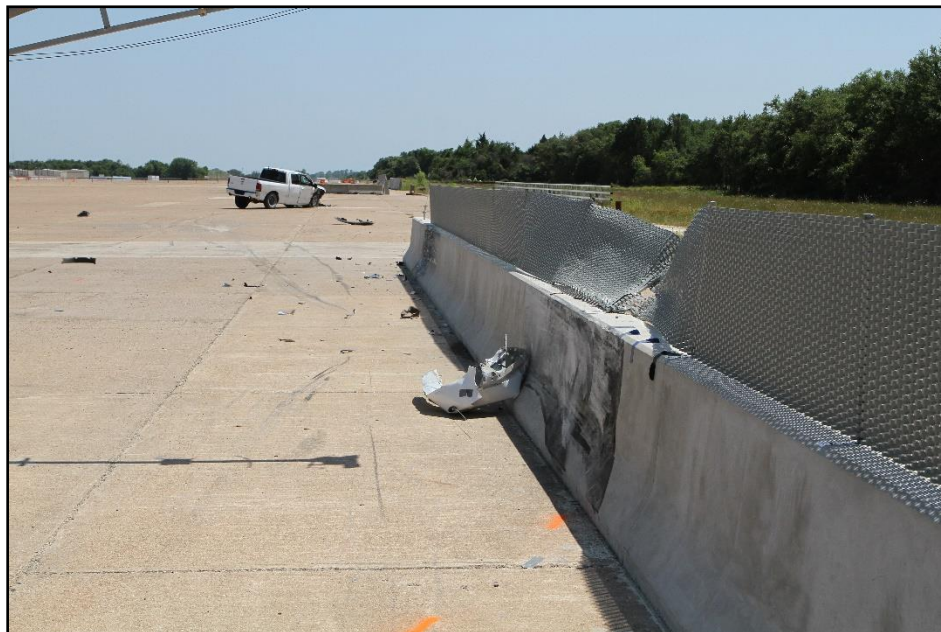
**Figure 8.6. Screen-Safe<sup>®</sup> Glare Screen on F-Shape Barrier after Test at Impact Location, Test 440822-01-4.**

| Test Parameter | Measured |
|---|---|
| Working Width <sup>a</sup> and Height | 36 inches, at a height of 56 inches (barrier attachment) |

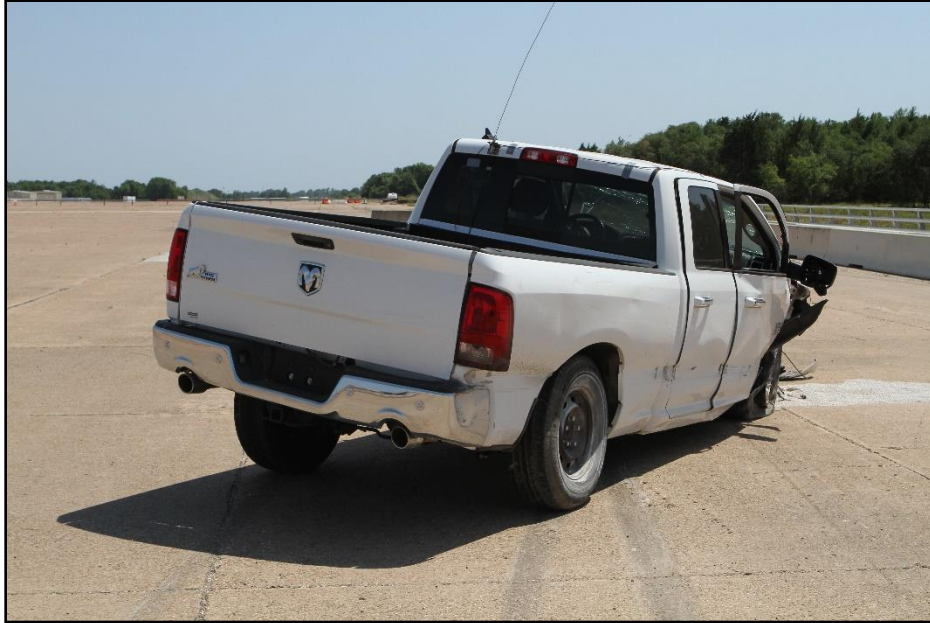
**Figure 8.9. Rear Impact Side of Test Vehicle after Test 440822-01-4.**

| Description of Damage to Vehicle: | The front bumper, hood, grill, radiator and support, right frame rail, right front tire and rim, right front quarter fender, right front door, right rear door, right cab corner, right rear quarter fender, right rear rim, and rear bumper were damaged. The windshield had some separation in the laminate due to the deformation of the vehicle. The right front door had a 6.75-inch gap at the top. |

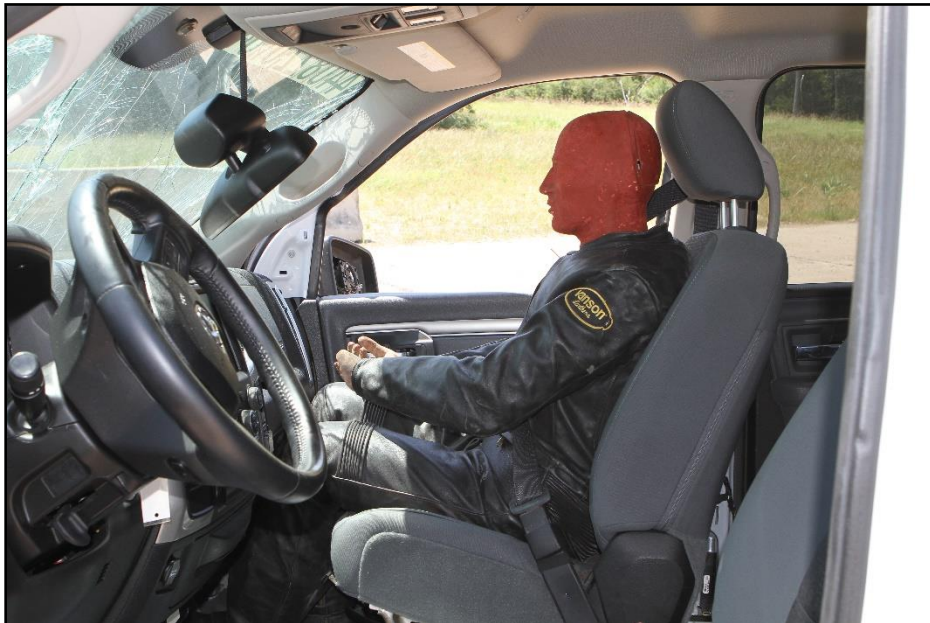
**Figure 8.10. Overall Interior of Test Vehicle after Test 440822-01-4.**

| Side Windows | The right passenger's side window shattered due to the deformation of the door and was not caused by penetration of the test article. |

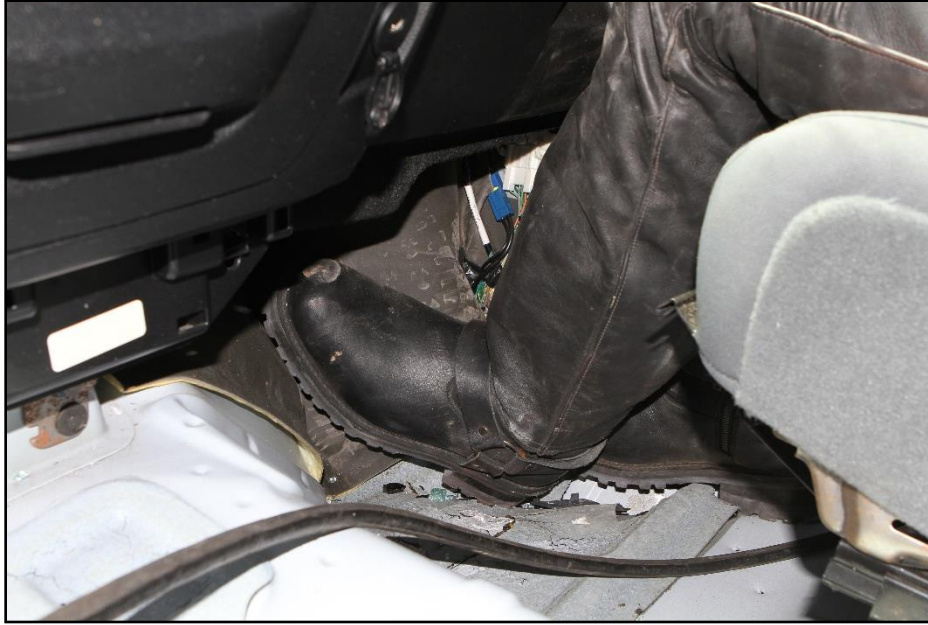
**Figure 8.11. Interior of Test Vehicle on Impact Side after Test 440822-01-4.**

| | Max. Occupant Compartment Deformation | 7 inches in the toe pan |

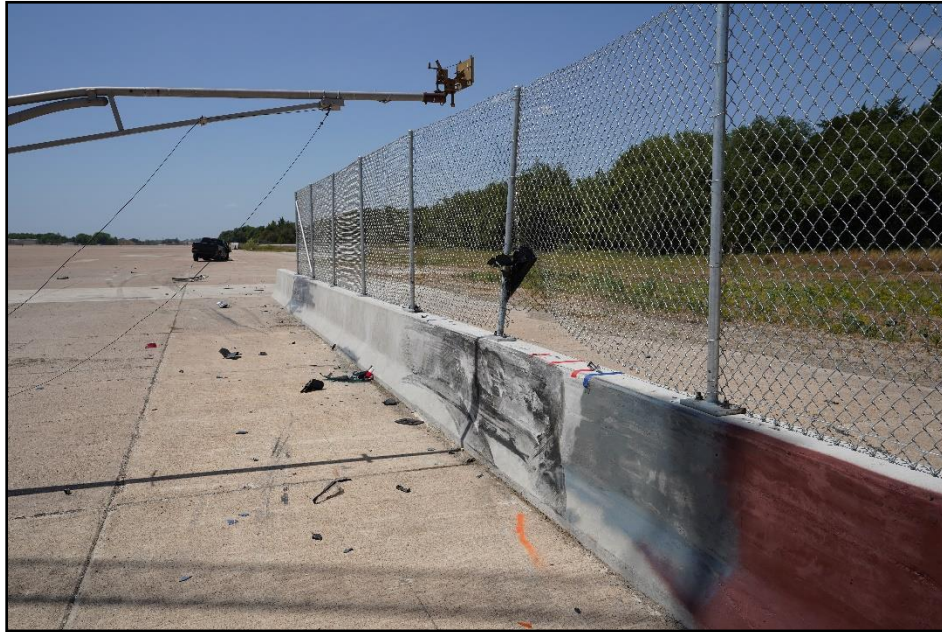
**Figure 9.6. Chain-Link Fence on F-Shape Barrier after Test at Impact Location, Test 440822-01-5.**

There was some scuffing and gouging at the impact location on the concrete barrier. The chain link was pulled loose from the bottom wire from post 5 to post 7. The chain link was pushed up 10 inches and back 12 inches just upstream of post 6. Post 6 was bent at 20 inches from the bottom, and the weld securing the pipe to the base plate failed ¾ of the way around the pipe.

Table 9.6 describes the damage to the chain-link fence on the F-shape barrier. Figure 9.6 and Figure 9.7 show the damage to the chain-link fence on the F-shape barrier.

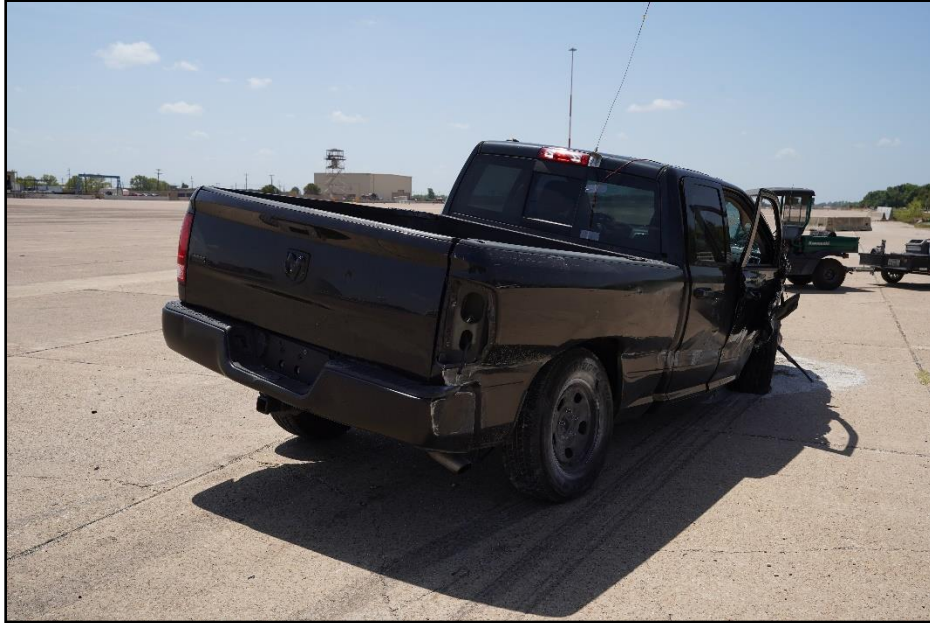
**Figure 9.9. Rear Impact Side of Test Vehicle after Test 440822-01-5.**

Figure 9.8 and Figure 9.9 show the damage sustained by the vehicle. Figure 9.10 and Figure 9.11 show the interior of the test vehicle. Table 9.7 and Table 9.8 provide details on the occupant compartment deformation and exterior vehicle damage. Figures E.2 and E.3 in Appendix E.2 provide exterior crush and occupant compartment measurements.

| Description of Damage to Vehicle: | The front bumper, hood, grill, radiator and support, right front tire and rim, right front quarter fender, windshield, right front door and glass, right rear door, right rear quarter fender, right taillight, and rear bumper were all damaged. The right front door had a 9-inch gap at the top of the door. |

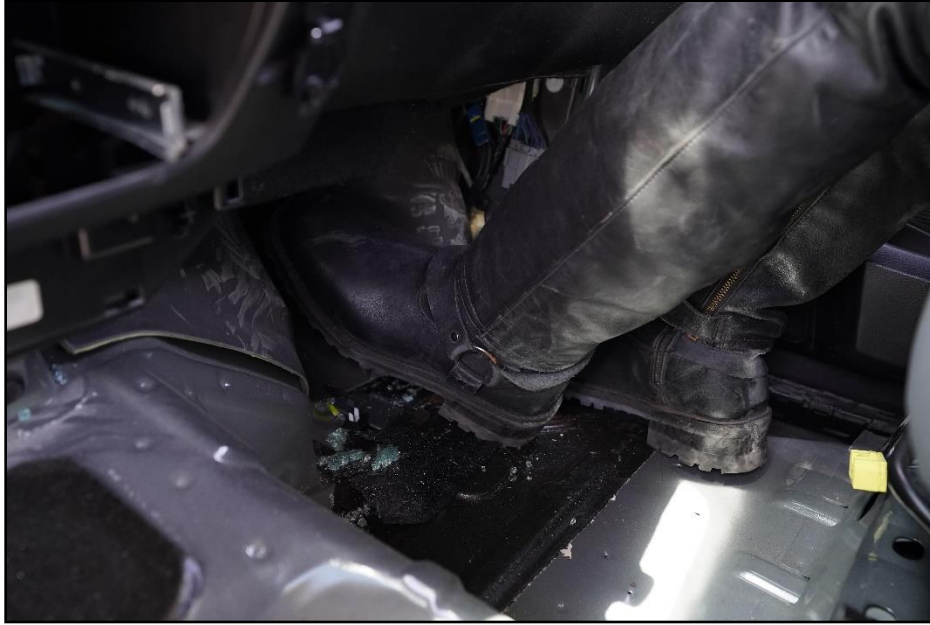
**Figure 9.11. Interior of Test Vehicle on Impact Side after Test 440822-01-5.**

| Side Windows | The right passenger's side window shattered due to the deformation of the door and was not caused by penetration of the test article. |
