TEST AND EVALUATION OF RURAL MAILBOX INSTALLATIONS

Research Report 0982-1
on
SDHPT Contract No. TTI (1981) 7

THE TEXAS STATE DEPARTMENT OF HIGHWAYS
AND PUBLIC TRANSPORTATION

TEXAS TRANSPORTATION INSTITUTE
Texas A&M University
College Station, Texas

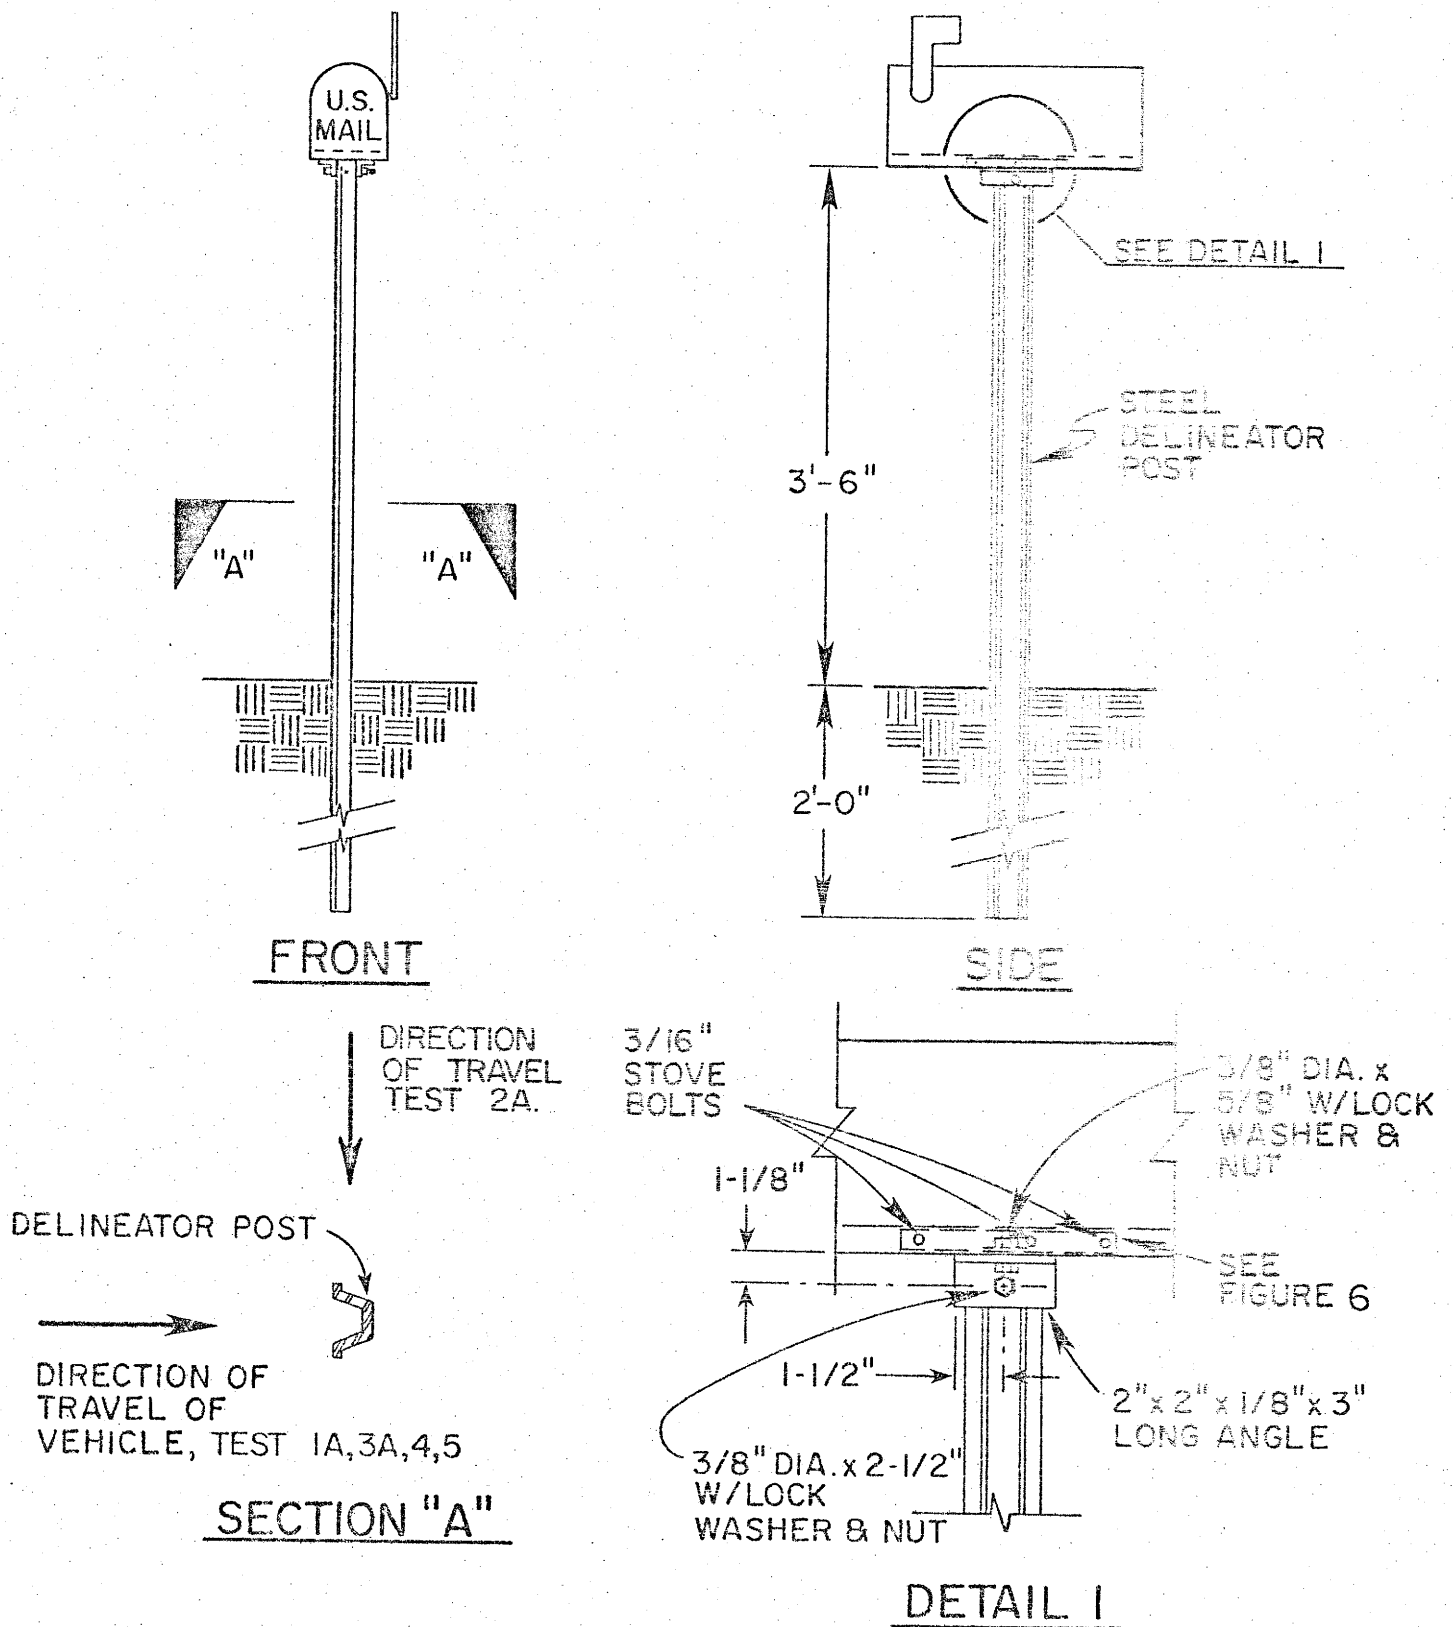
Figure 2. Mailbox Support Configuration Type A.

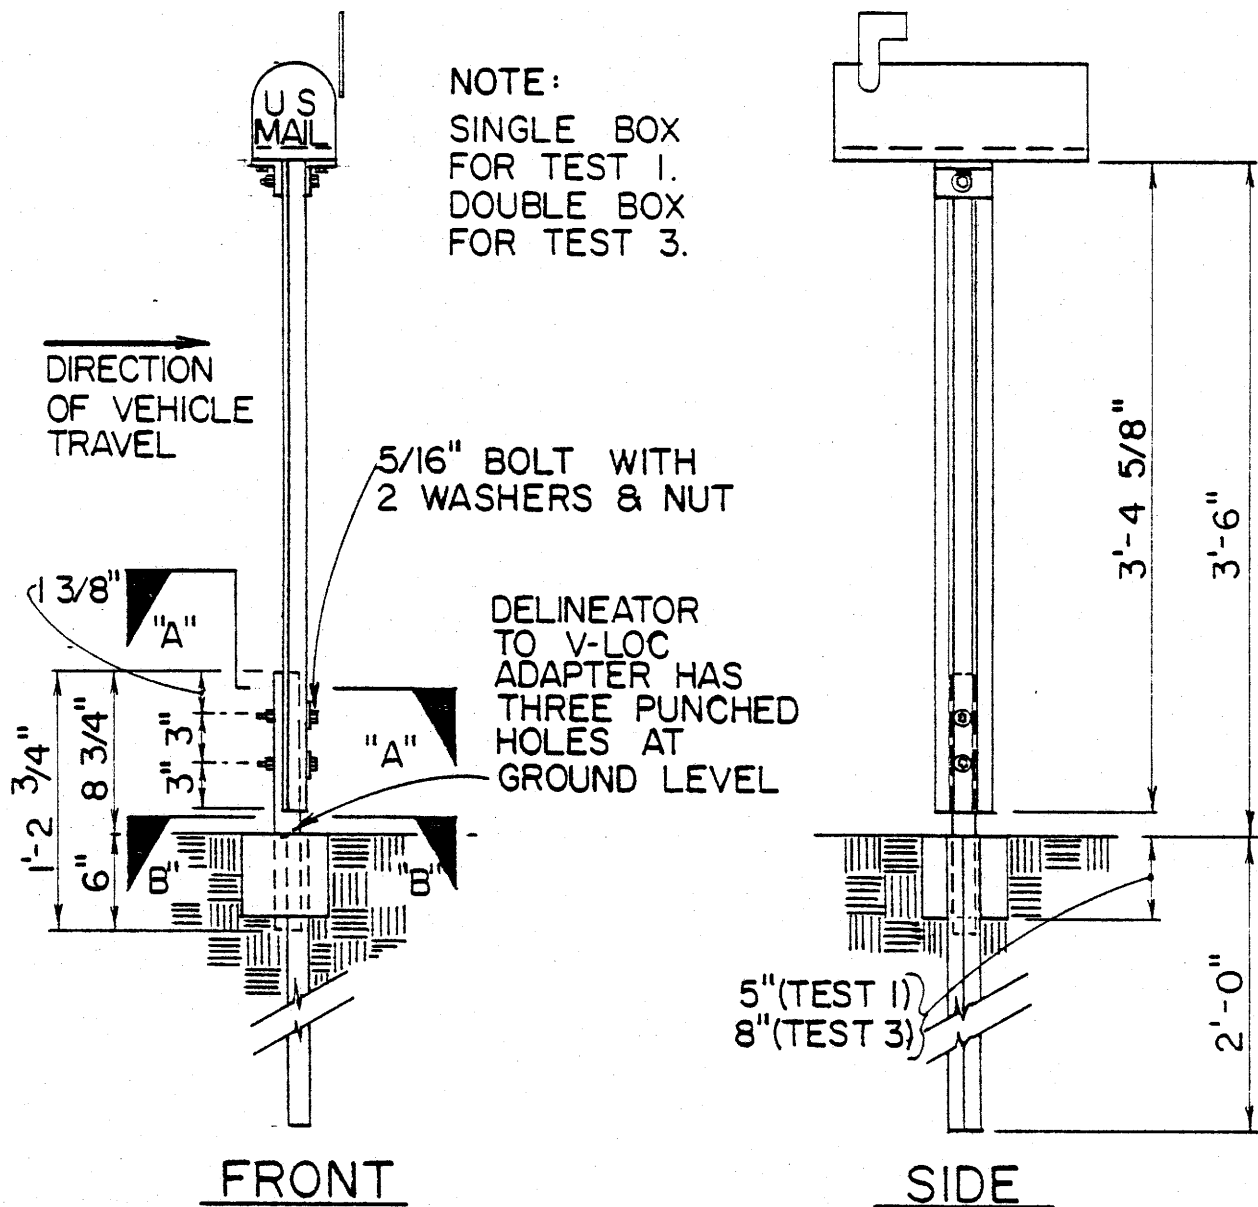
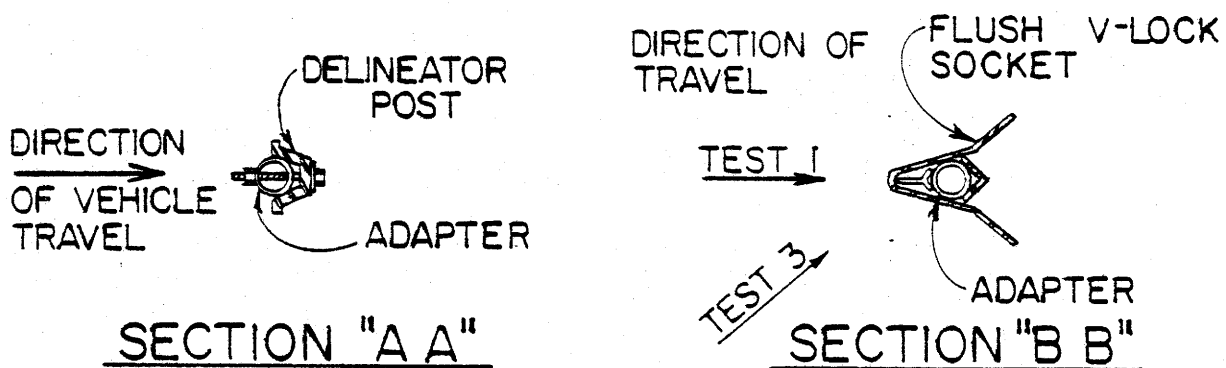
Figure 3. Mailbox Support Configuration Type B.

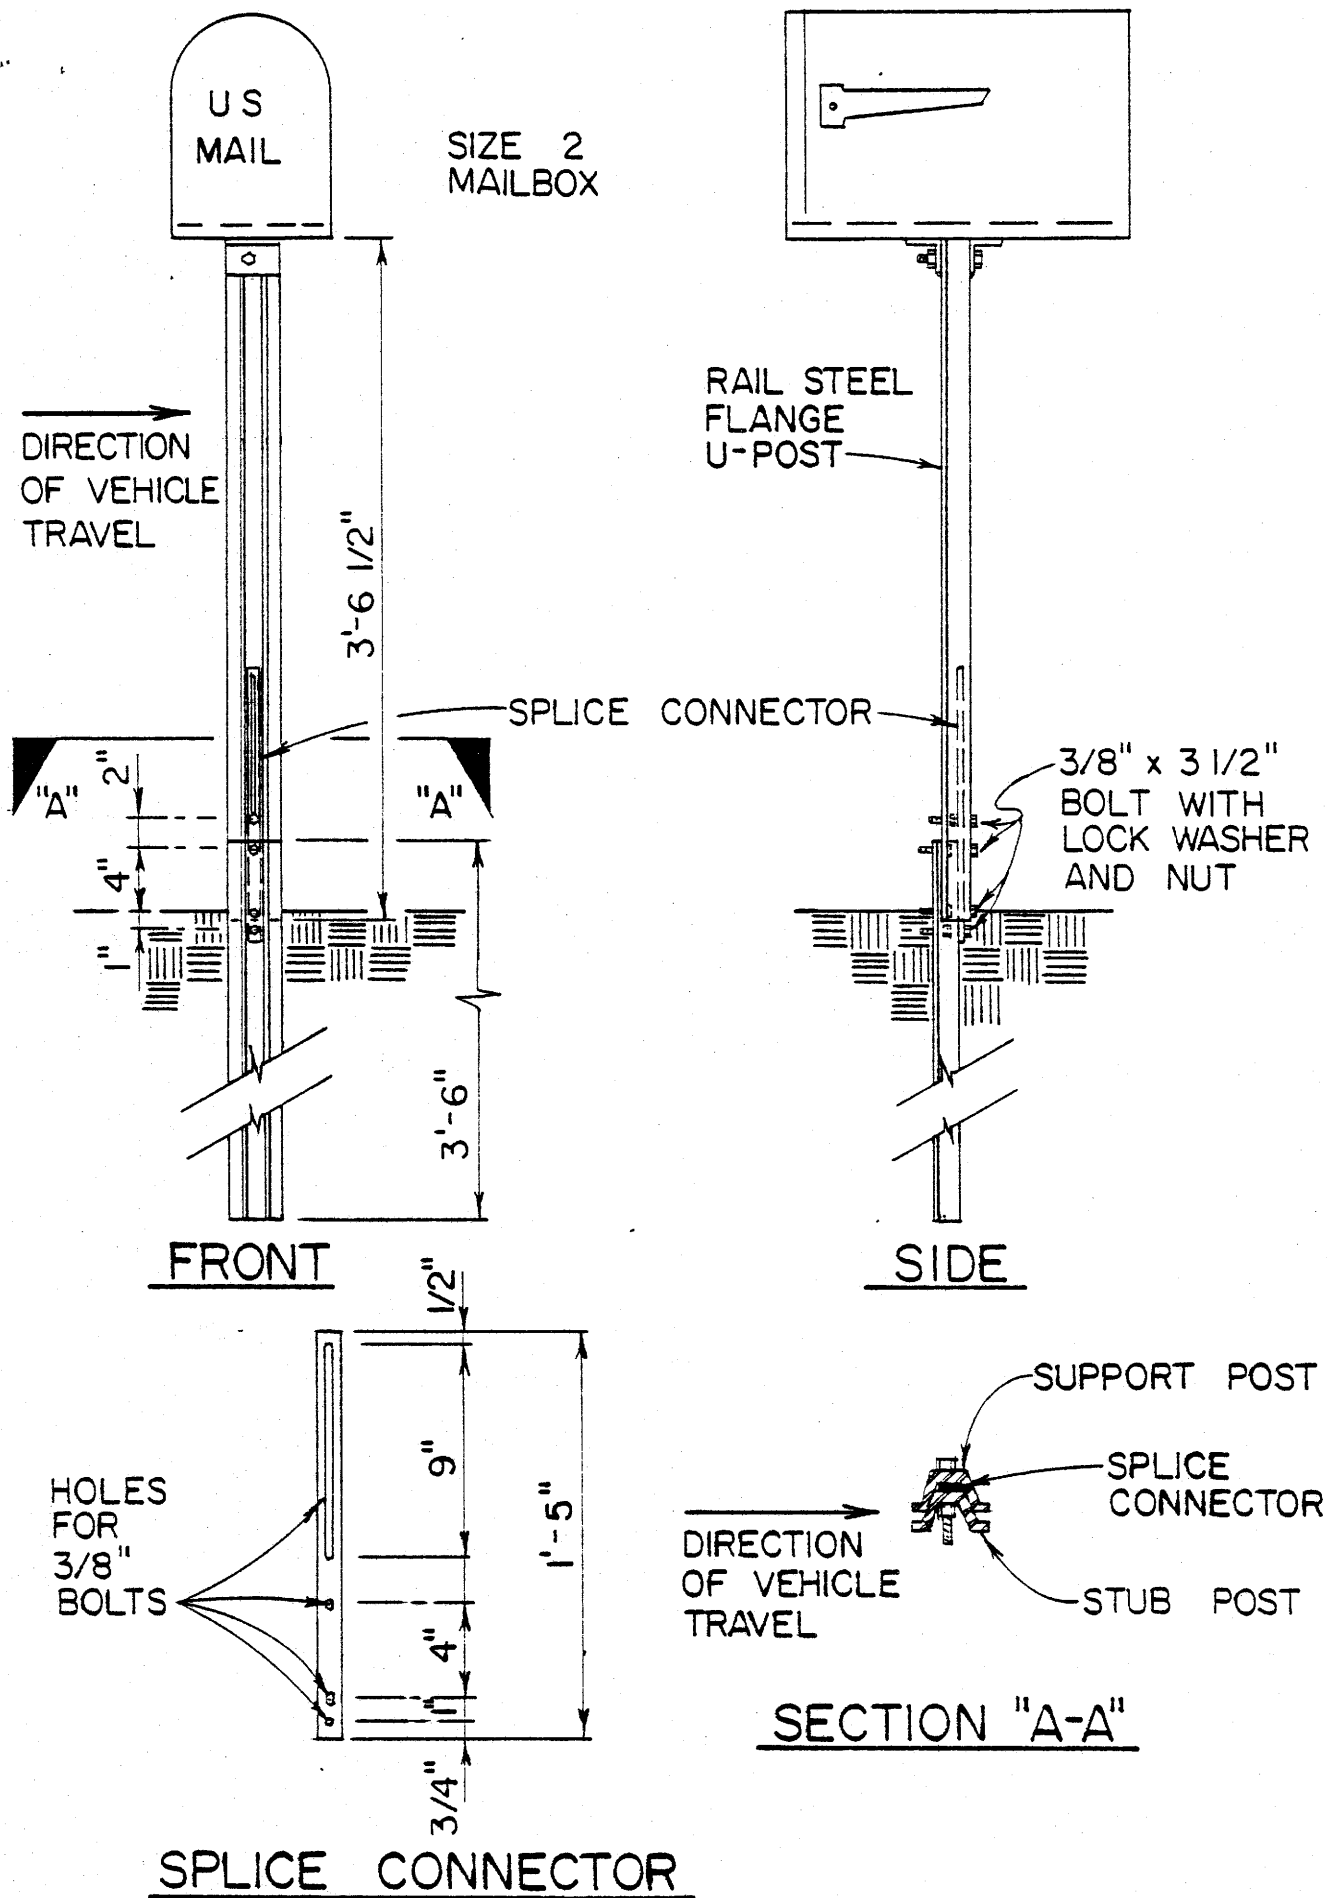
Figure 4 . Mailbox Support Configuration Type C.

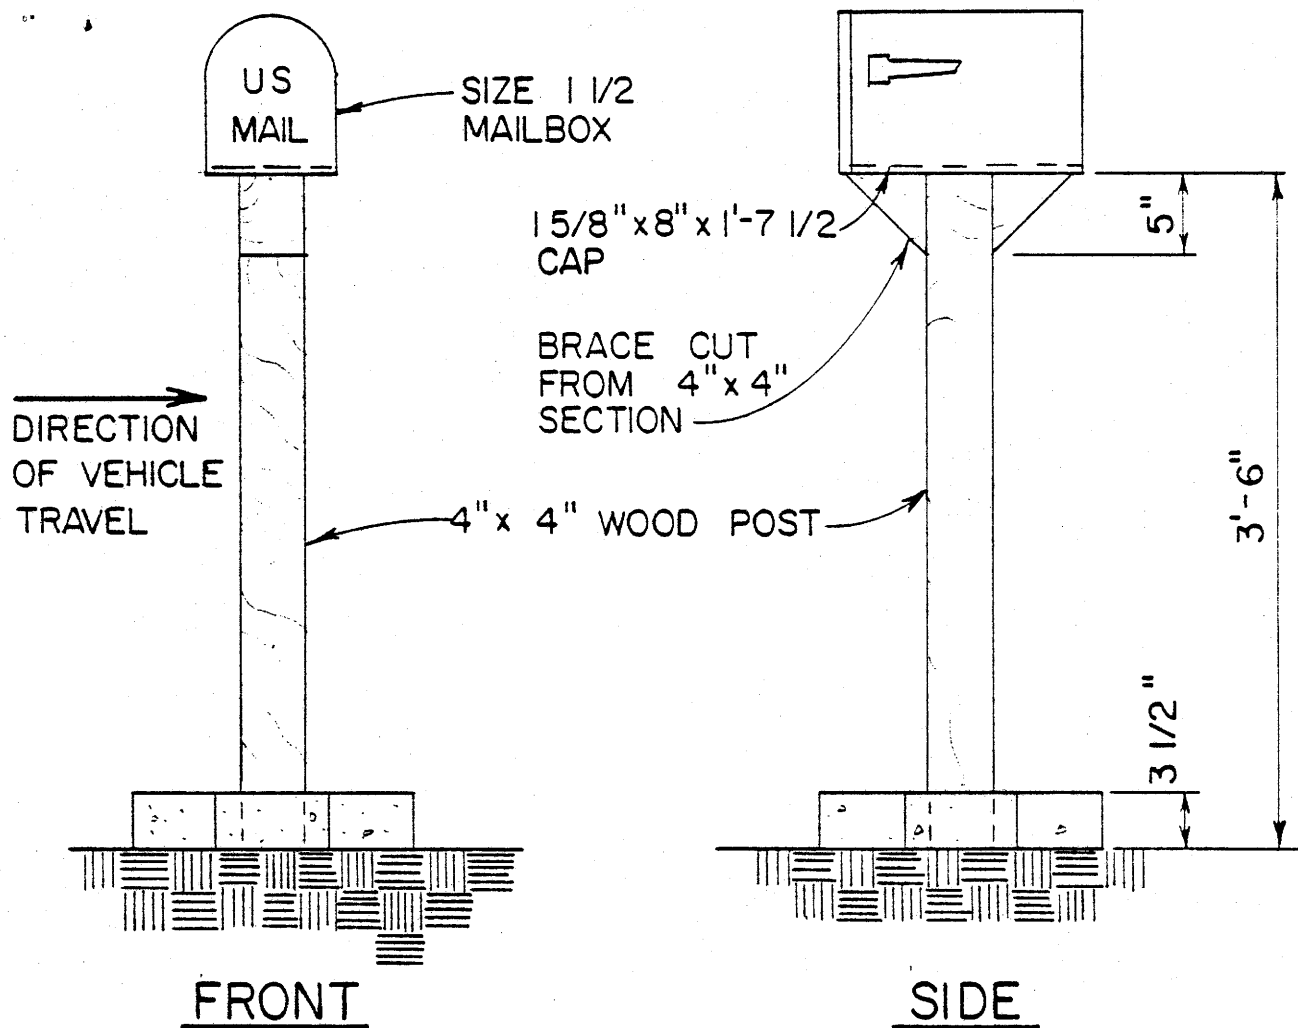
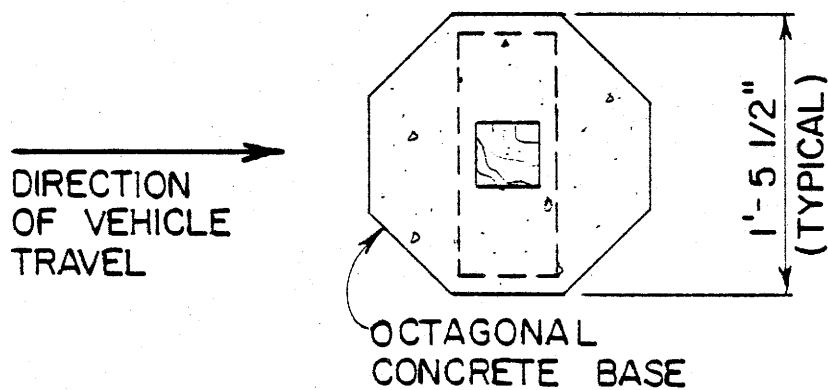
PLAN

FASTENERS

CAP TO POST	3 EACH	16d NAILS
BRACE TO CAP	4 EACH	8d NAILS
MAILBOX TO CAP	6 EACH	1 1/2" COMPOSITION ROOFING NAILS

Figure 5. Mailbox Support Configuration Type D.

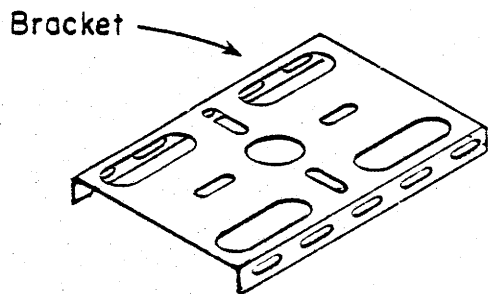
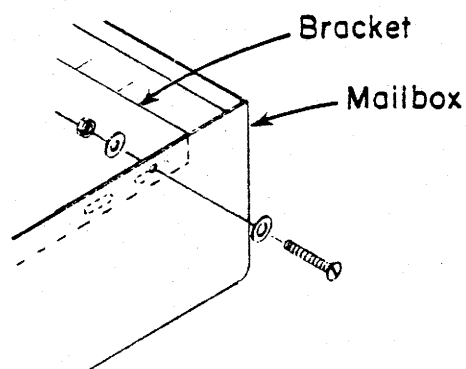
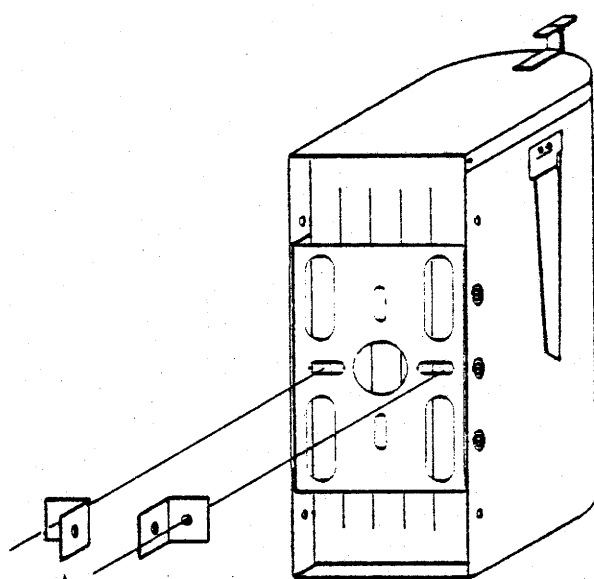
For bracket details
see Figure 6.

Bracket to mailbox fastener :
3/16" dia. x 3/4" screw ;
2 washers and 1 nut for each screw

For angle details
see Figure 11.

Angle to bracket fastener :
3/8" dia. x 5/8" bolt with
lock washer and nut

Angle to delineator fastener :
3/8" dia. x 2-1/2" bolt and nut

Figure 7. Mailbox Mount for Size No. 1 Mailbox.

Six full-scale vehicular crash tests were conducted to evaluate the impact behavior of various mailbox support designs, including four mailbox installations in a row and eight mailbox installations in a row. Table 1 summarizes the results of these tests. Table 2 lists the test articles, and Figure 1 gives a schematic of the test arrangement. Figures 2 through 5 show the typical mailbox support configurations referenced in Table 1. Figures 6 through 11 show mailbox mounting details.

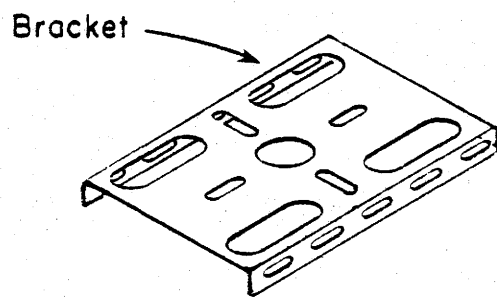
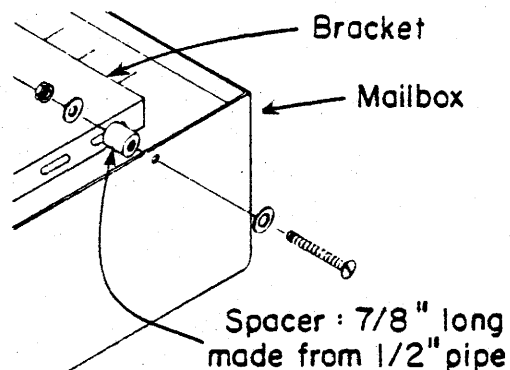
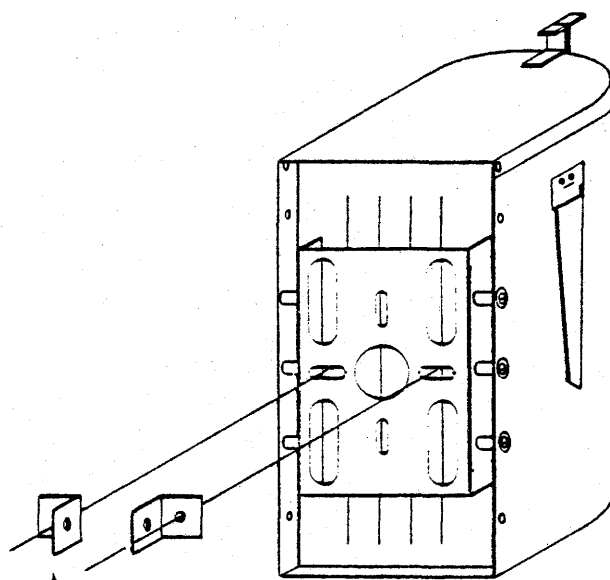
For bracket details
see Figure 6.

Spacer : 7/8" long
made from 1/2" pipe

Bracket to mailbox fastener :
1/4" dia. x 2" screw with
2 washers and 1 nut for each screw

Angle to bracket fastener :
3/8" dia. x 5/8" bolt with
lock washer and nut

Angle to delineator fastener :
3/8" dia. x 2-1/2" bolt and nut

For angle details
see Figure 11.

Figure 8. Mailbox Mount for Size No. 1½ Mailbox.

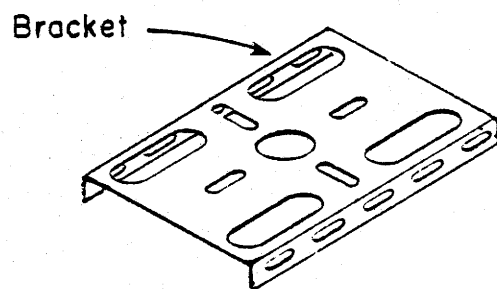
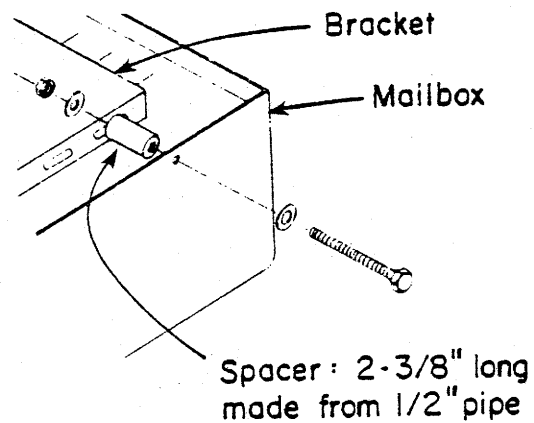
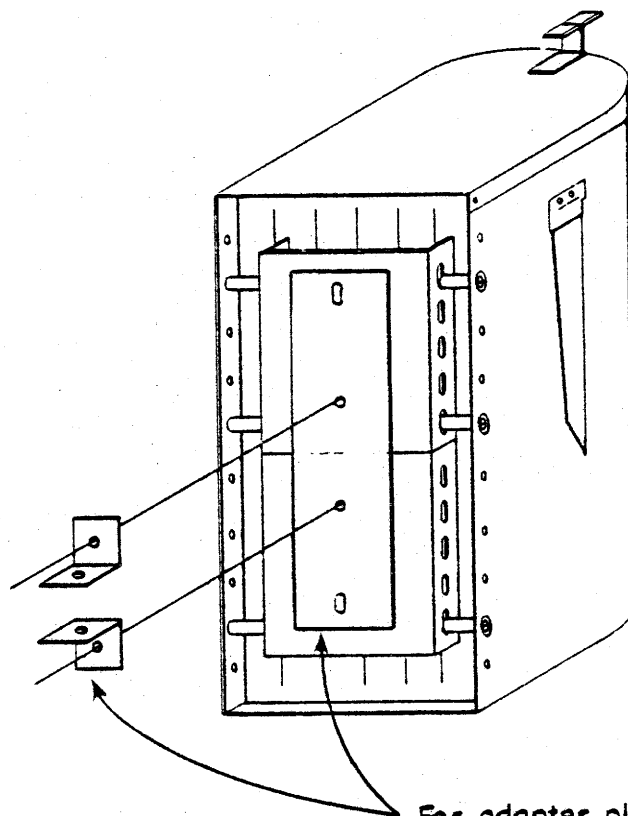
For bracket details
see Figure 6.
(Two required)

Spacer : 2-3/8" long
made from 1/2" pipe

Bracket to mailbox fastener :
1/4" dia. x 3" bolt with 2 washers
and 1 nut for each bolt

Adapter plate to bracket
fastener : 4 ea. 3/8" dia. x
5/8" bolt ; each bolt has a
lock washer and nut

For adapter plate details and angle details
see Figure 11.

Figure 9. Mailbox Mount for Size No. 2 Mailbox.

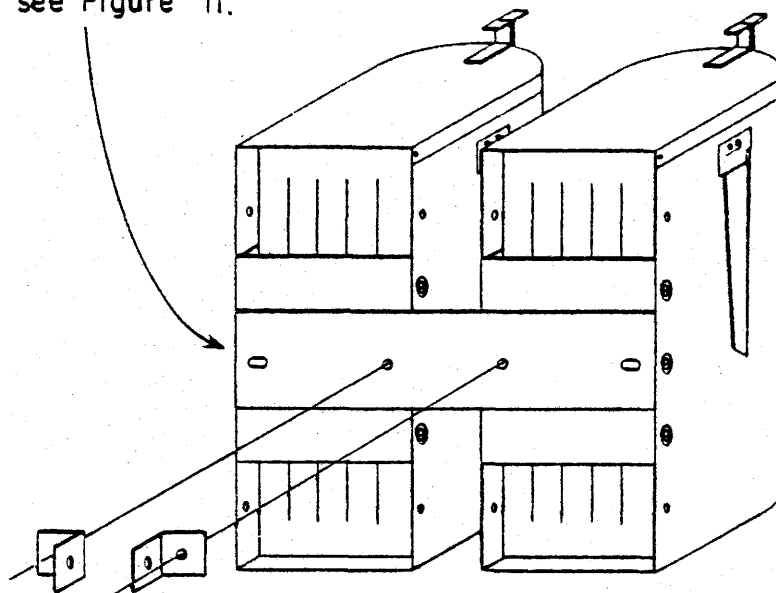
For bracket to mailbox details see Figure 6.

For adapter plate details
see Figure 11.

Adapter plate to
bracket fasteners:
4 ea. $\frac{3}{8}$ " dia. x $\frac{5}{8}$ "
bolt; each bolt has a
lock washer and nut

For angle details
see Figure 11.

Angle to delineator fastener:
 $\frac{3}{8}$ " dia. x $2\frac{1}{2}$ " bolt
and nut

FIGURE 10. Double Box Mount for Size No. 1 Mailbox.

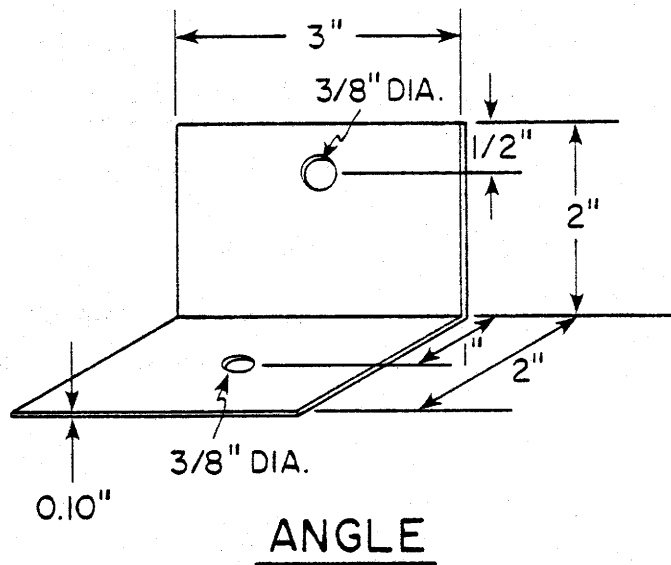
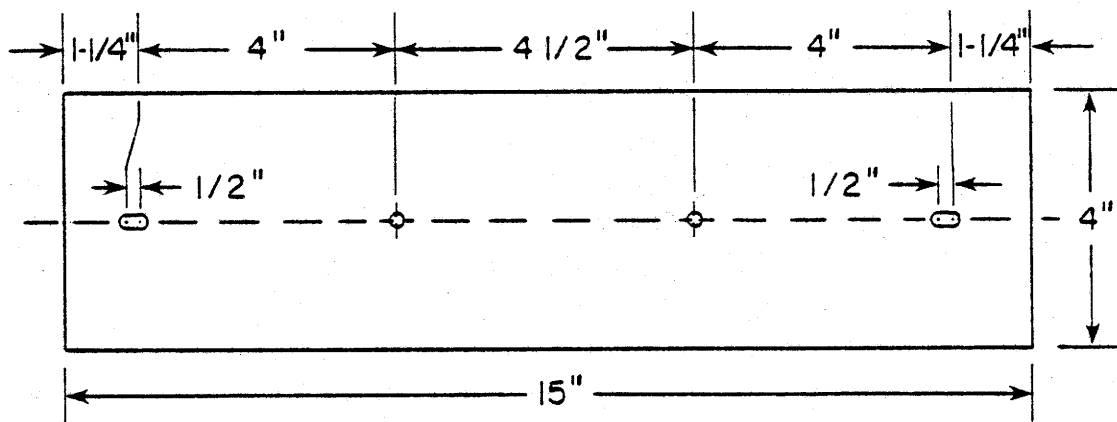
HOLES ARE 3/8" DIA.
0.10" THICK (CUT FROM USED SIGN BLANK)

ADAPTER PLATE

Figure 11. Adapter Plate and Angle Details.

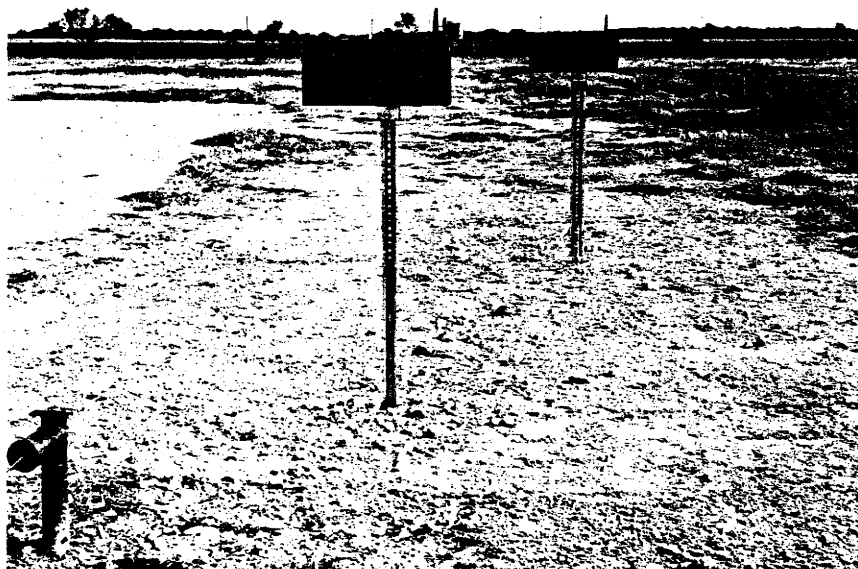
Figure 12. Test 1 Mailbox Installation Looking in the Direction of Vehicle Travel.

Test 1 - Photos of the test articles and vehicle for test 1 are shown in Figures 12 through 18. Sequential photos from high-speed film are shown in Figure 19, and Table 3 contains time-displacement-event data. Photos of the installations and vehicle after the test are shown in Figures 20 through 24. Accelerometer data are shown in Figures 25 and 26. Both systems easily met recommended safety performance standards for highway signs (1,2). As shown, the post in test 1A fractured about 18 inches (45.7 cm) above ground. In test 1B the adapter pipe was pulled out of the V-loc anchor. It is noted that the V-loc anchor system (3) used in test 1B rotated approximately 15 degrees in the direction of vehicle travel subsequent to impact. This indicated that the projected area of the stabilizer fins on the anchor system was insufficient to provide the needed soil bearing resistance. Larger fins were used in test 3B.

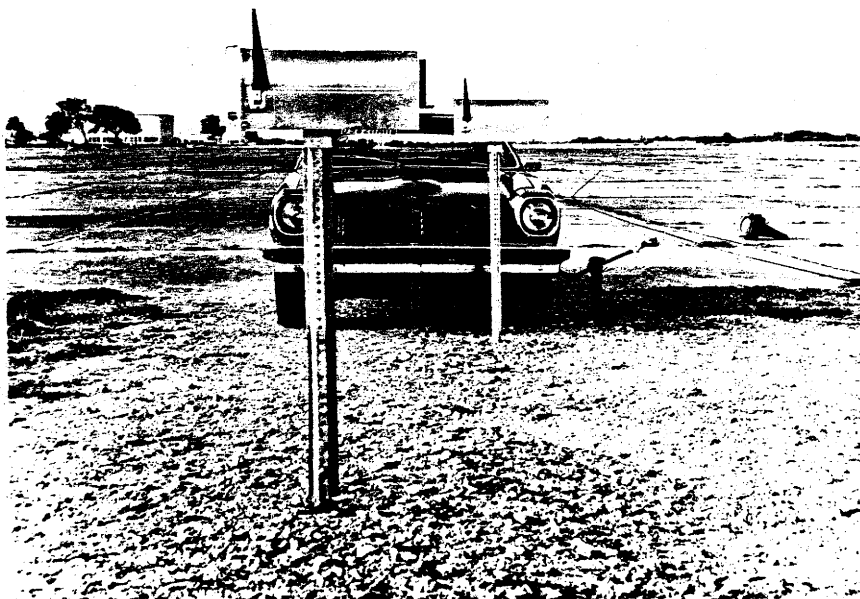
Figure 13. Test 1 Mailbox Installation Looking Opposite the Direction of Vehicle Travel.

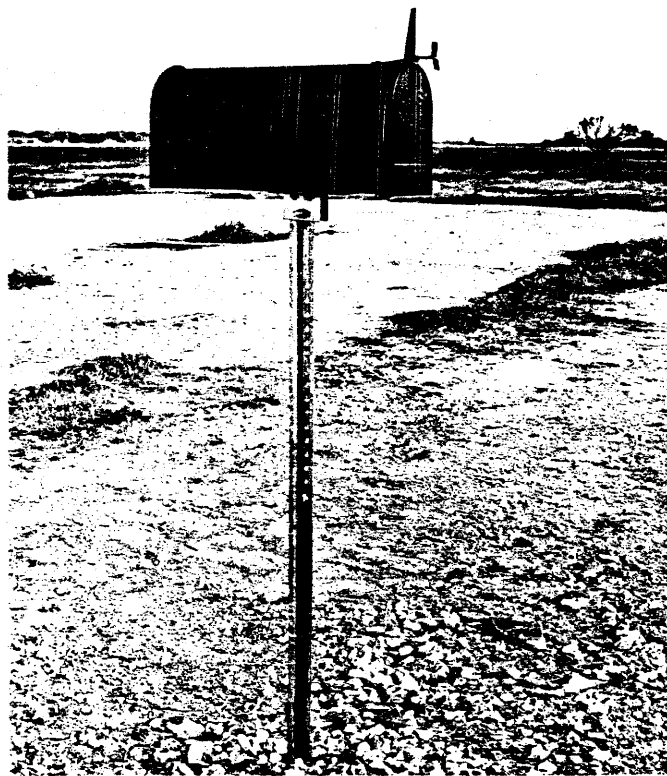
Figure 14. Test 1A Mailbox Installation.

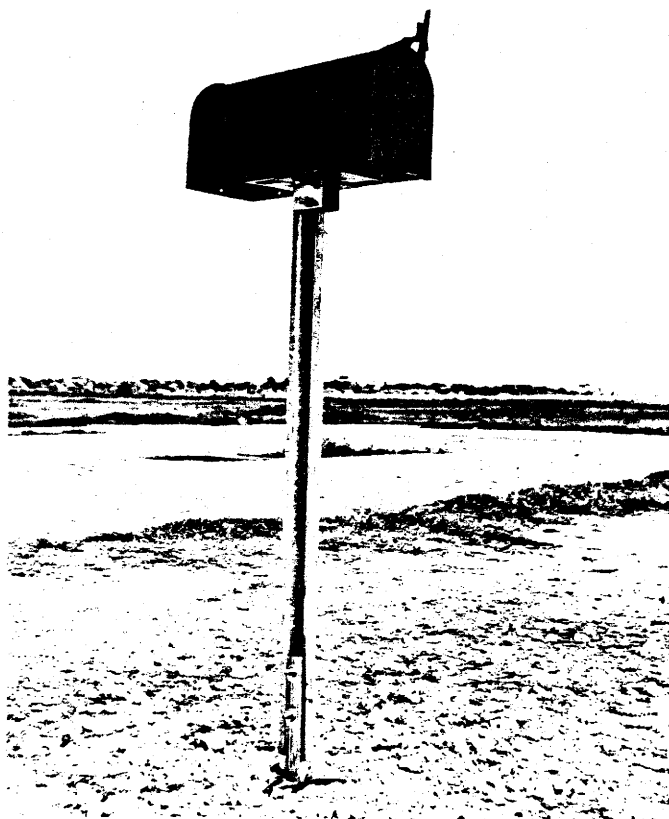
Figure 15. Test 1B Mailbox Installation.

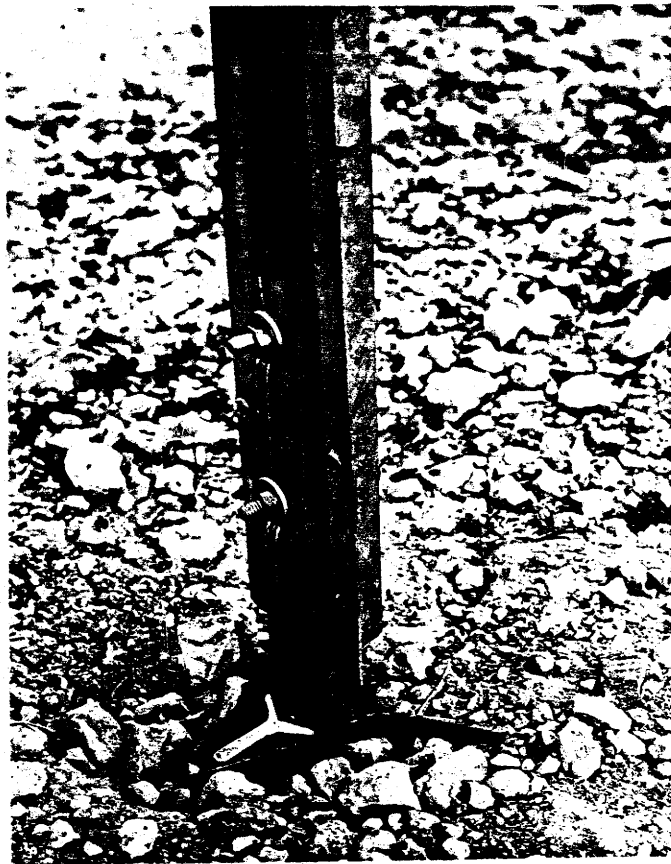
Figure 16. Test 1B Detail of V-Loc Socket Installation.

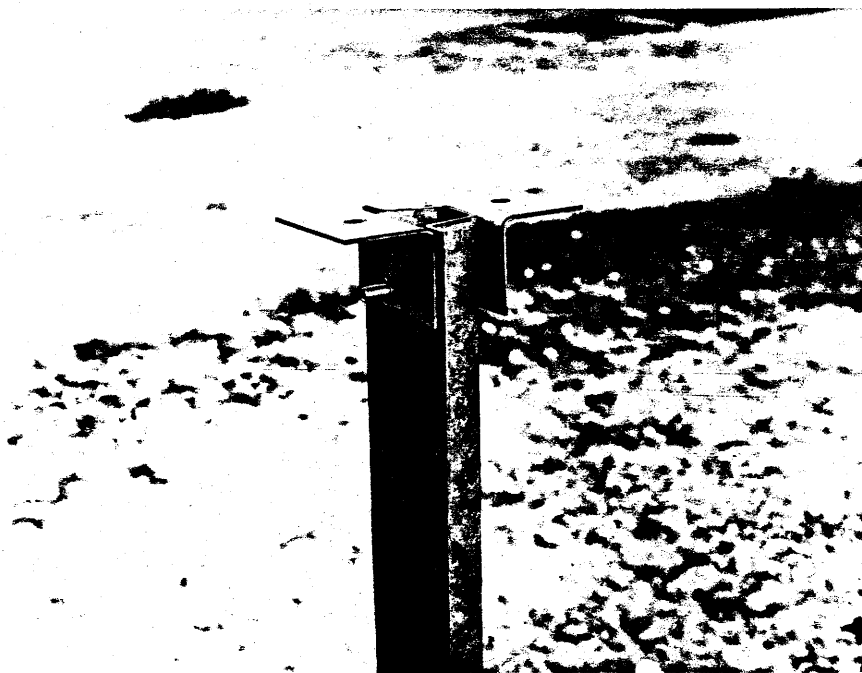
Figure 17. Typical Configuration of Angles-to-Support Connection.

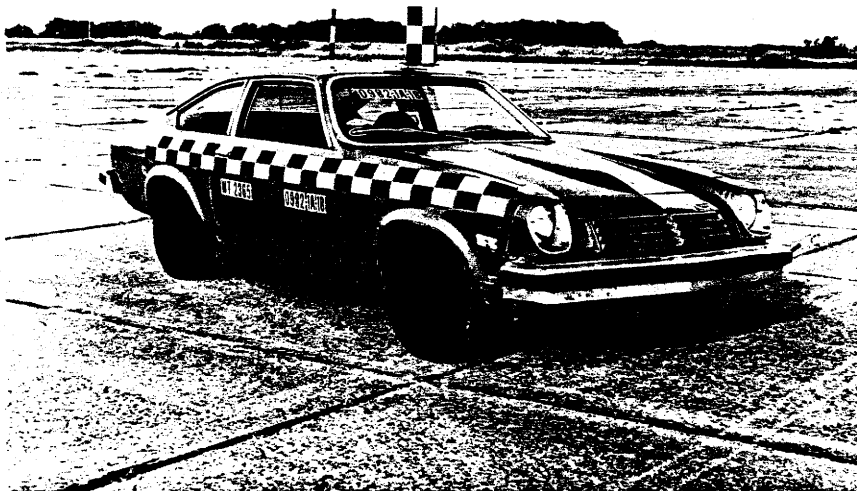
Figure 18. Test 1 Vehicle Before Impact.

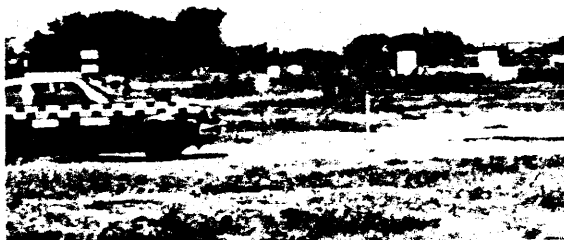
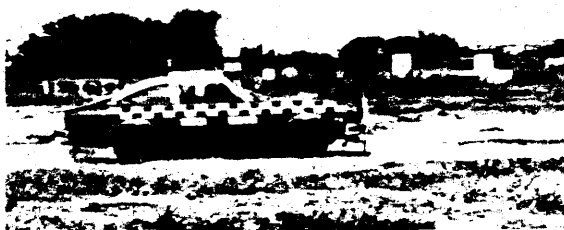
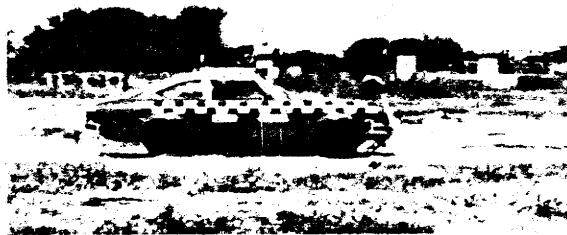
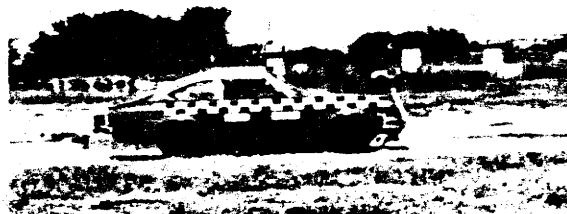
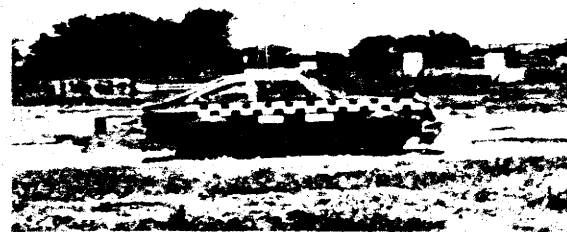
Figure 19. Sequential Photographs for Test 1.

Figure 19. Sequential Photographs for Test 1 (continued).

TIME (sec)	NOMINAL VEHICLE DISPLACEMENT (ft)	EVENT
0.000	0.00	Impact with 1A
0.010	0.88	Support for 1A breaks
0.035	3.05	1A box strikes hood
0.115	9.93	Impact with 1B
0.130	11.23	1A assembly thrown clear
0.133	11.45	1B assembly pulls out of socket
0.150	12.94	1B box strikes hood
0.178	15.30	1B assembly carried away by vehicle

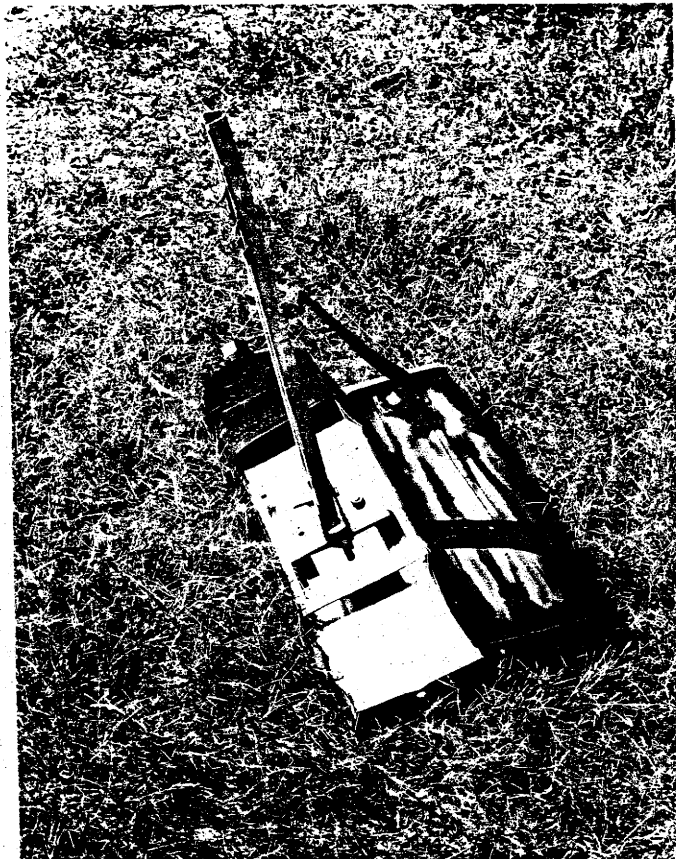
Figure 20. Test 1A Mailbox After Impact.

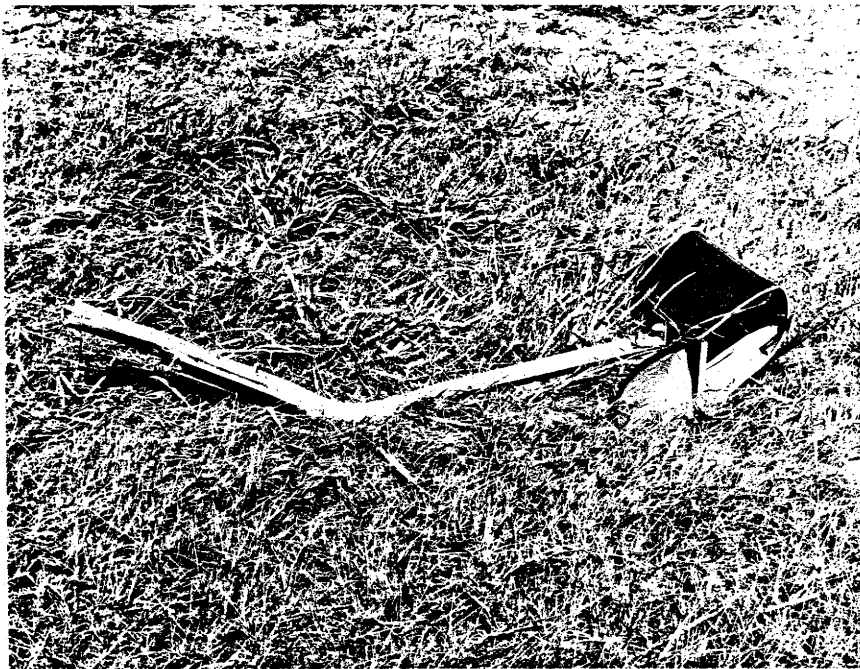
Figure 21. Test 18 Mailbox After Impact.

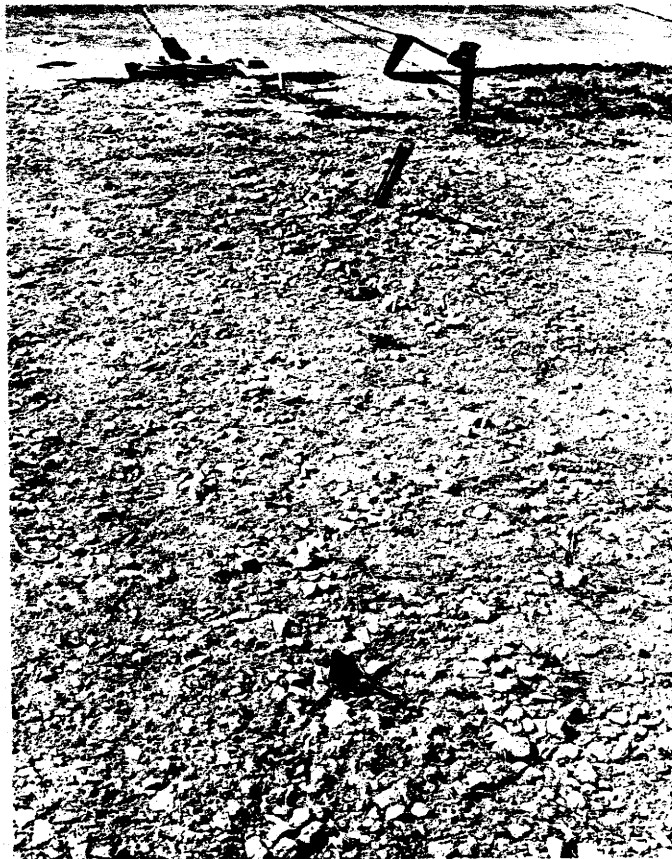
Figure 22. Test 1 Ground Connections After Impact
Looking Opposite the Direction of Vehicle Travel.

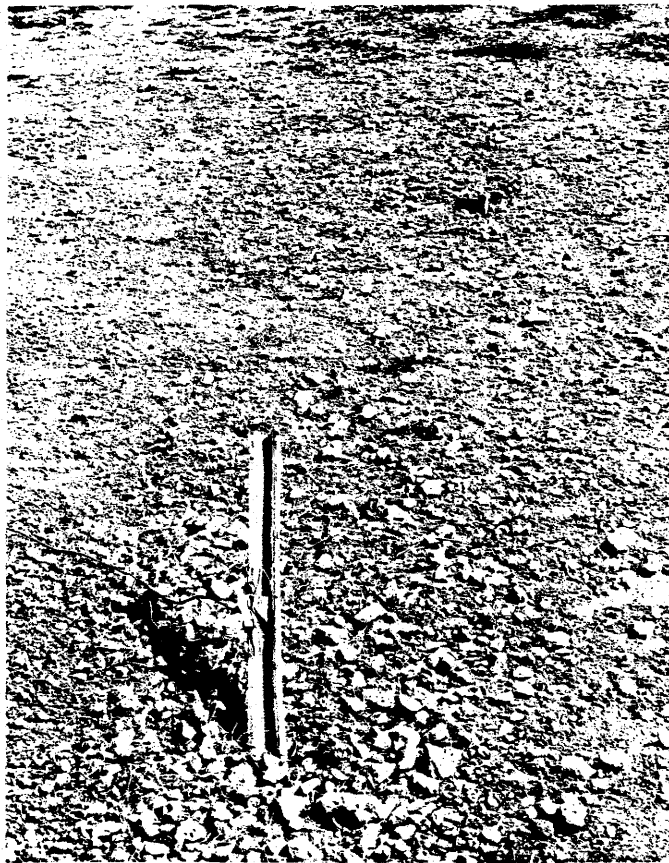
Figure 23. Test 1 Ground Connections After Impact Looking in the Direction of Vehicle Travel.

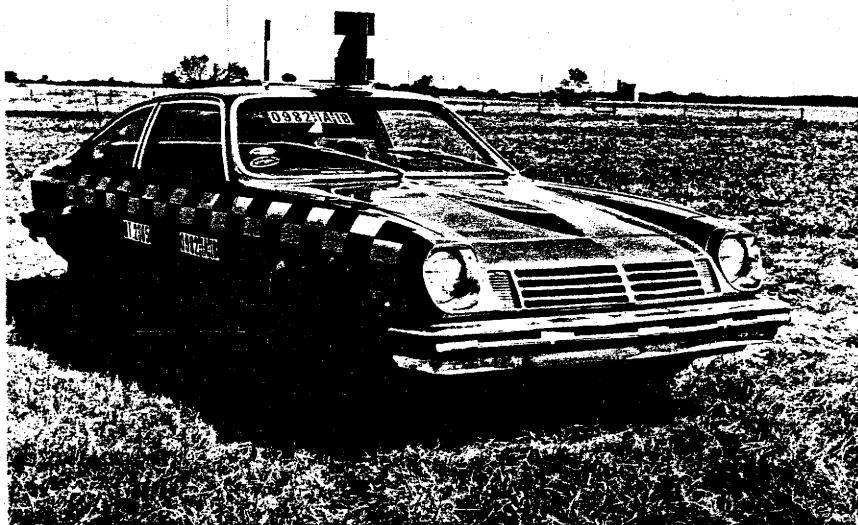
Figure 24. Test 1 Vehicle After Impact.

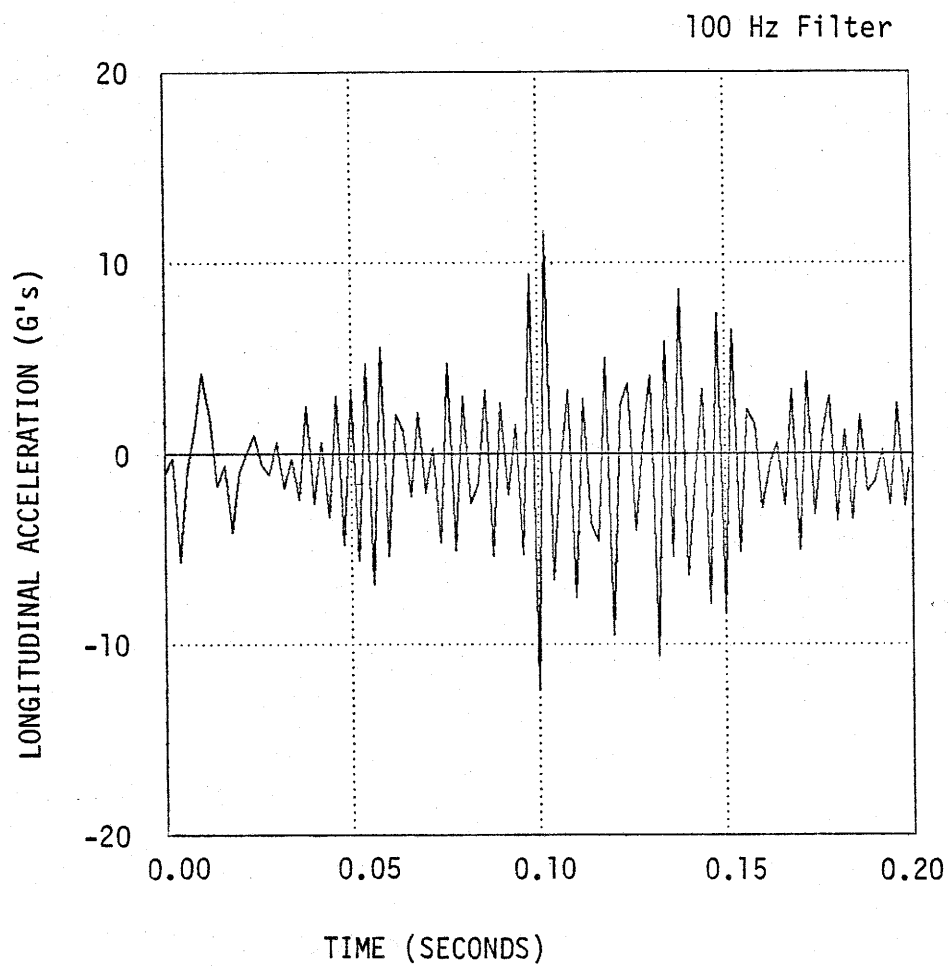
Figure 25. Longitudinal Acceleration From Vehicle's Left B-Pillar Accelerometer for Test 1.

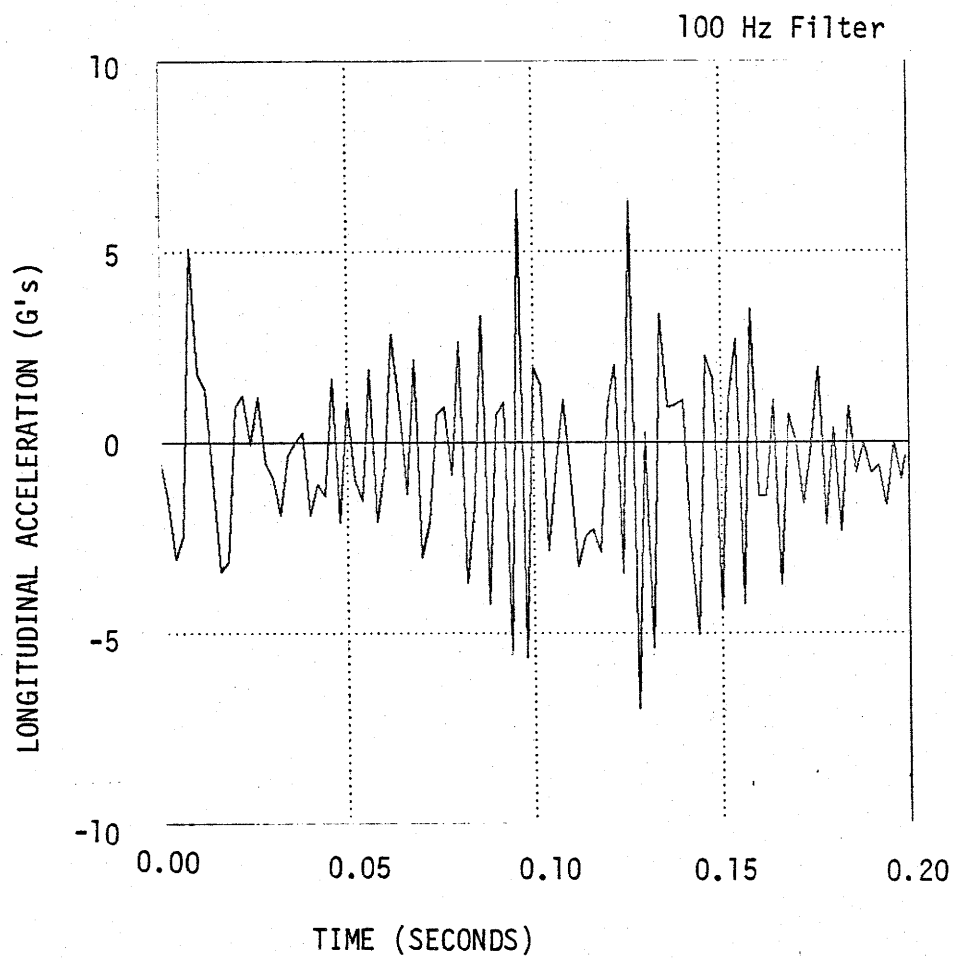
Figure 26. Longitudinal Acceleration From Vehicle's Right B-Pillar Accelerometer for Test 1.

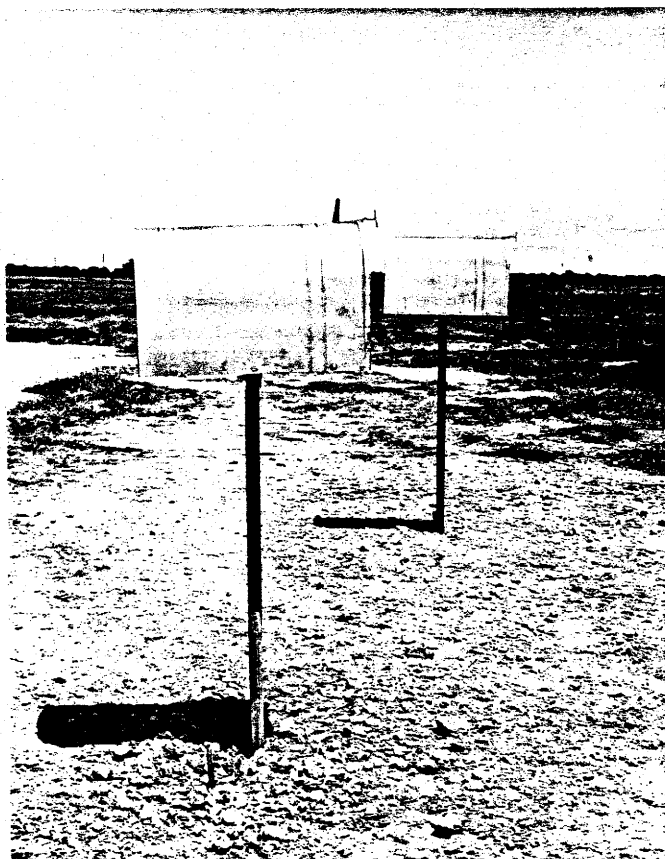
Figure 27. Test 2 Mailbox Installation Looking in the Direction of Vehicle Travel.

Test 2 - Photos of the test articles for test 2 are shown in Figures 27 through 30. Sequential photos from high-speed film are shown in Figure 31, and time-displacement-event data are shown in Table 4. Photos of the installations and vehicle after test 2 are shown in Figures 32 through 36. Accelerometer data are shown in Figures 37 and 38. Both systems easily met recommended safety performance standards for highway signs (1,2). In test 2A the support hooked onto the car and was pulled from the ground. In test 2B the bolts in the splice sheared off, as desired, and the post separated from the base. Note that the stub used in test 2B was bent and would probably not have been reusable.
