TEST AND EVALUATION OF RURAL MAILBOX INSTALLATIONS

Research Report 0982-1
on
SDHPT Contract No. TTI (1981) 7

THE TEXAS STATE DEPARTMENT OF HIGHWAYS
AND PUBLIC TRANSPORTATION

TEXAS TRANSPORTATION INSTITUTE
Texas A&M University
College Station, Texas

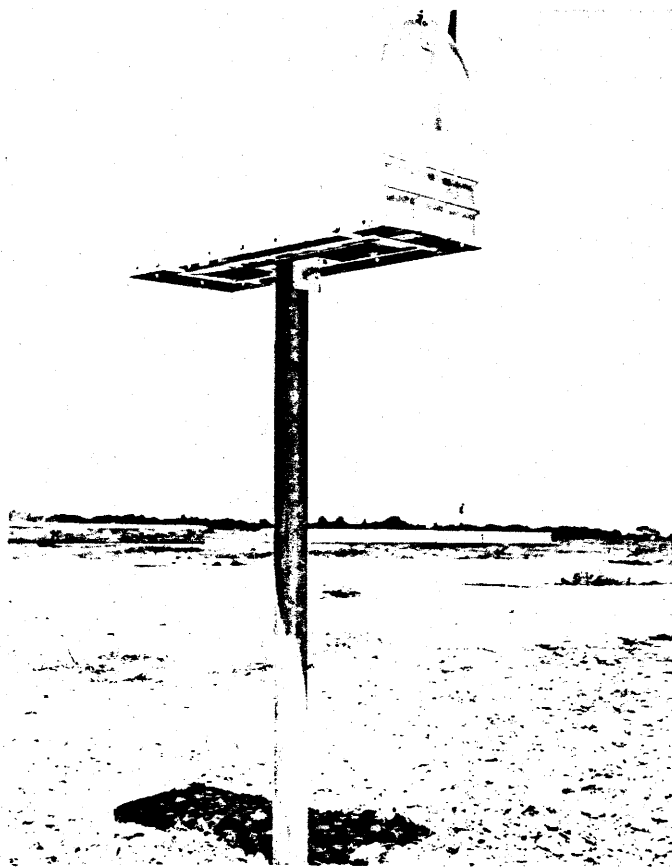
Figure 28. Test 2A Mailbox Installation.

Test 2 - Photos of the test articles for test 2 are shown in Figures 27 through 30. Sequential photos from high-speed film are shown in Figure 31, and time-displacement-event data are shown in Table 4. Photos of the installations and vehicle after test 2 are shown in Figures 32 through 36. Accelerometer data are shown in Figures 37 and 38. Both systems easily met recommended safety performance standards for highway signs (1,2). In test 2A the support hooked onto the car and was pulled from the ground. In test 2B the bolts in the splice sheared off, as desired, and the post separated from the base. Note that the stub used in test 2B was bent and would probably not have been reusable.

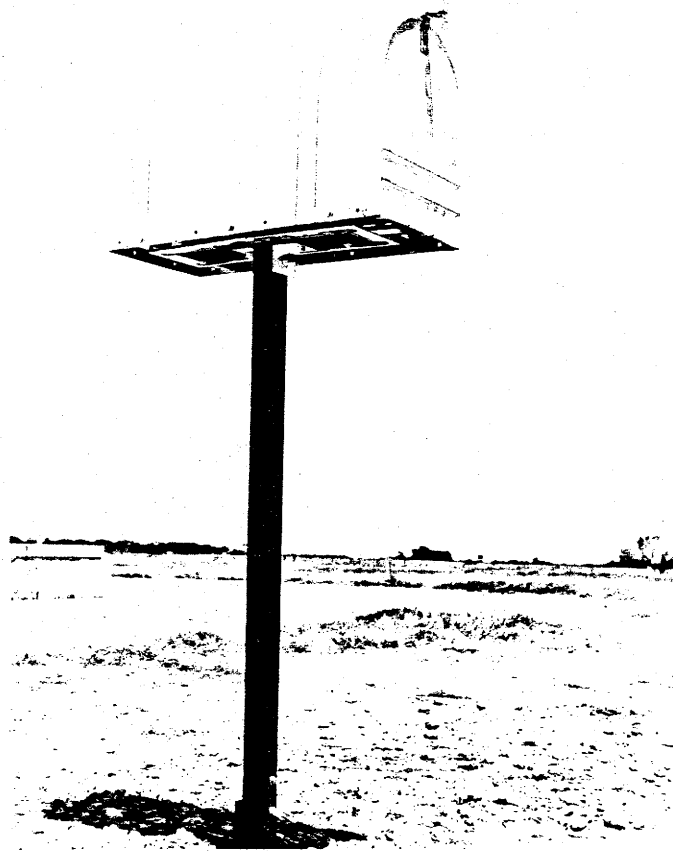
Figure 29. Test 2B Mailbox Installation.

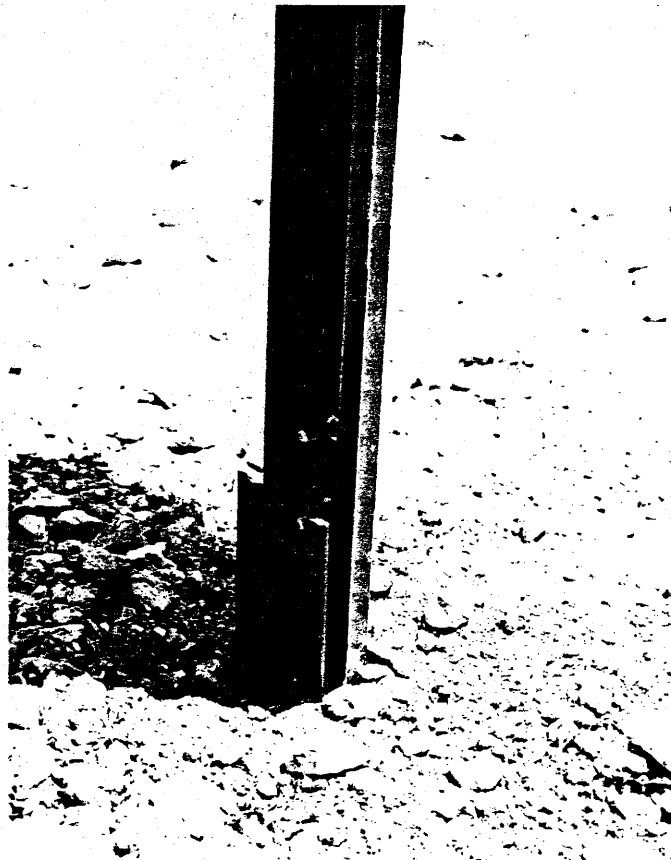
Figure 30. Test 2B Detail of Eze-Erect Installation.

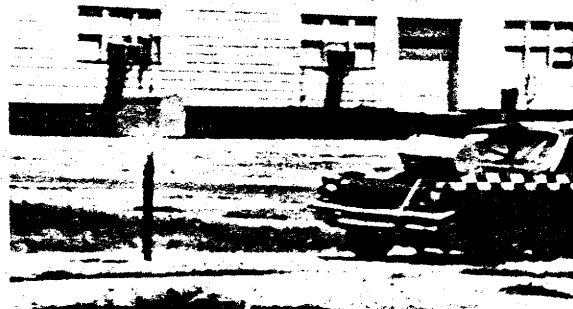
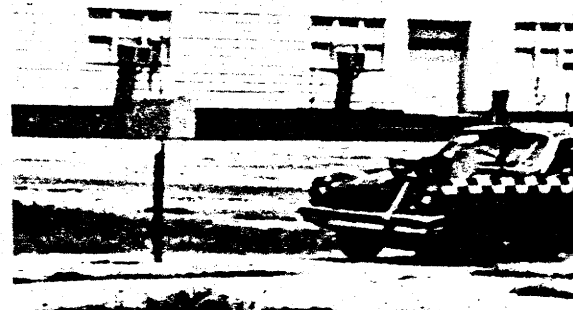
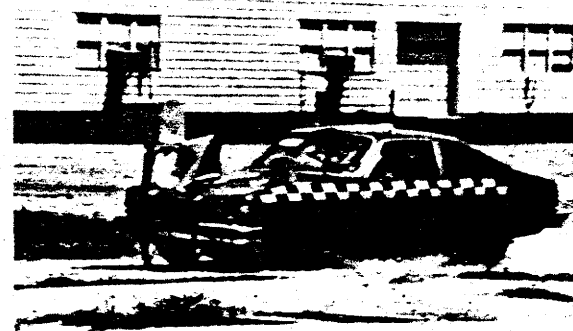
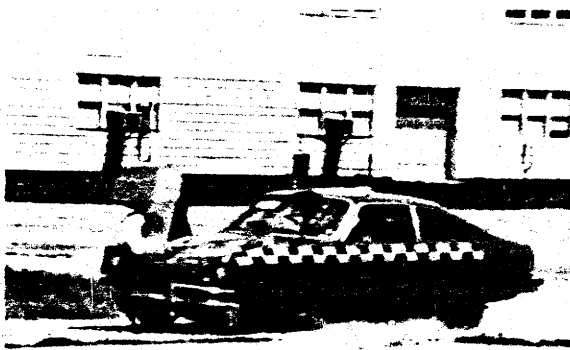
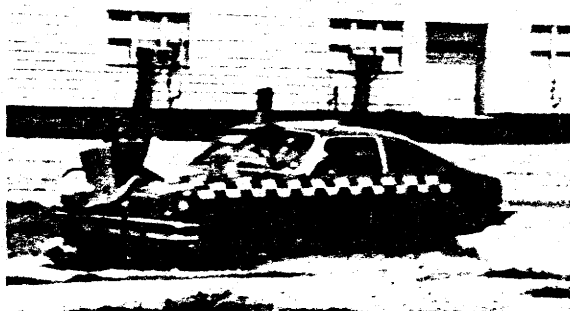
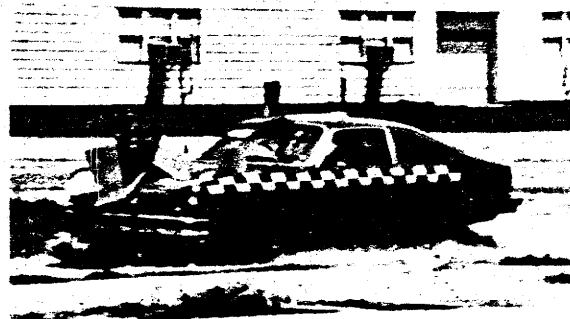
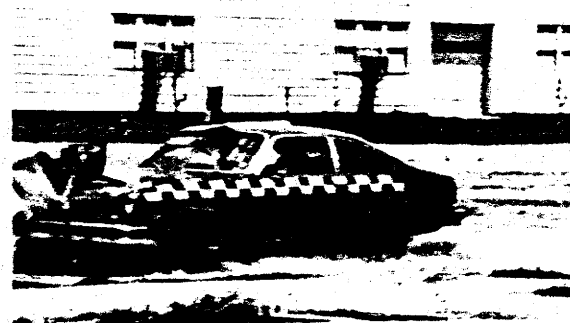
Figure 31. Sequential Photographs for Test 2.

Figure 31. Sequential Photographs for Test (continued).

TIME (sec)	NOMINAL VEHICLE DISPLACEMENT (ft)	EVENT
0.000	0.00	Impact with 2A
0.028	2.37	2A box strikes hood
0.038	3.20	2A support pulls out of ground
0.124	10.68	Impact with 2B
0.134	11.57	2B support post separates from stub-post
0.167	14.55	2B box strikes hood
0.169	14.79	2B support post leaves ground
0.195	17.16	2A & 2B assemblies carried away by vehicle

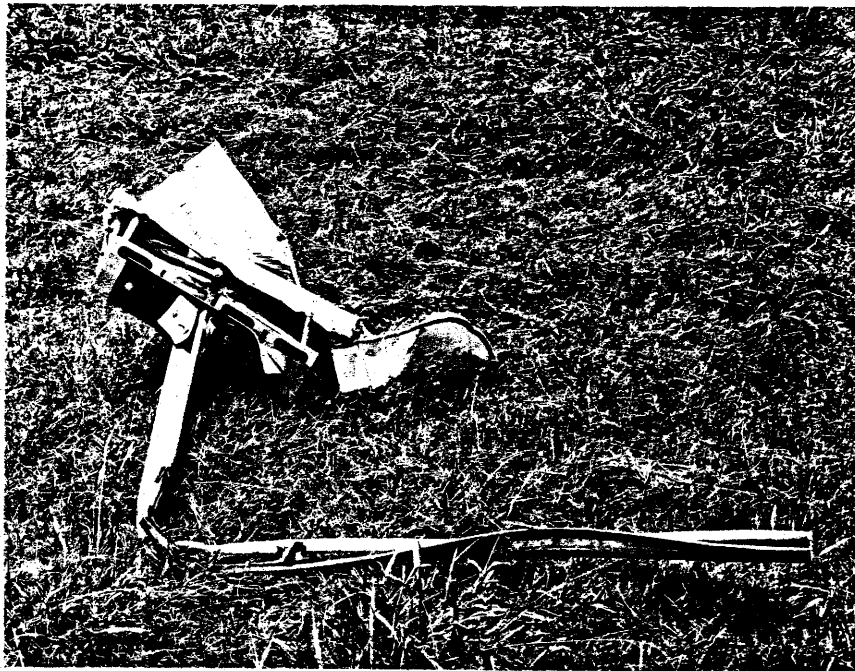
Figure 32. Test 2A Mailbox After Impact.

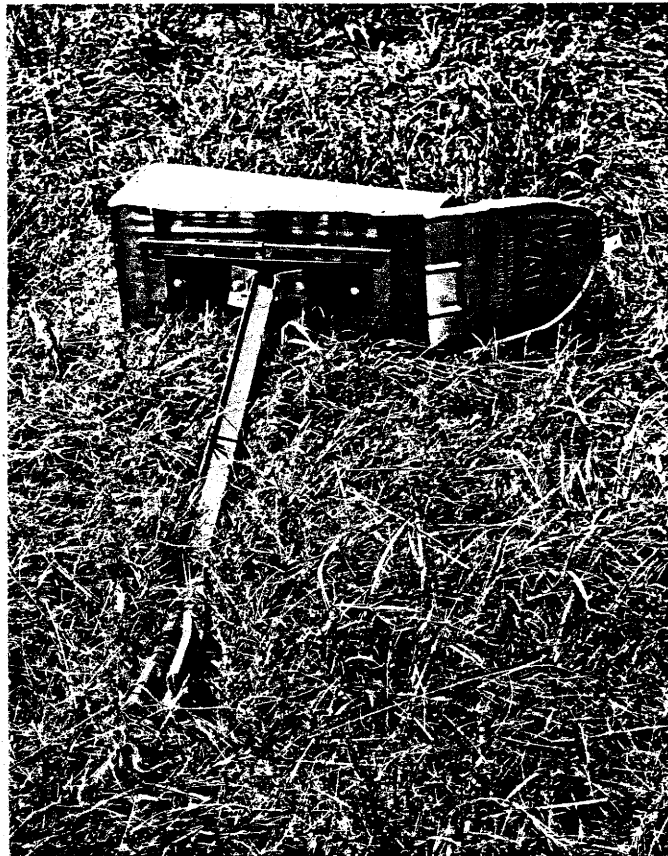
Figure 33. Test 2B Mailbox After Impact.

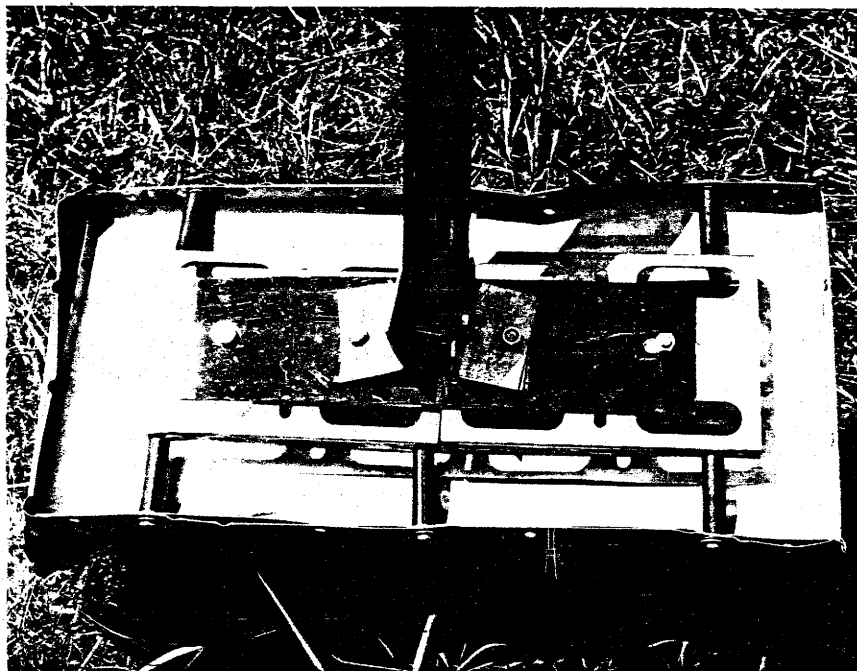
Figure 34. Test 2B Mailbox Mount Close-Up After Impact.

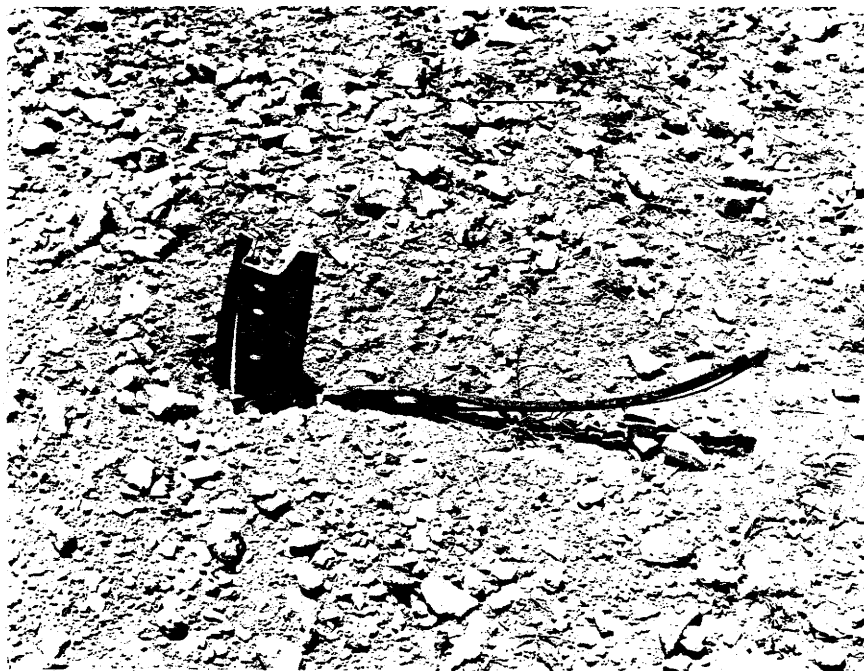
Figure 35. Test 2B Eze-Erect Ground Connection After Impact.

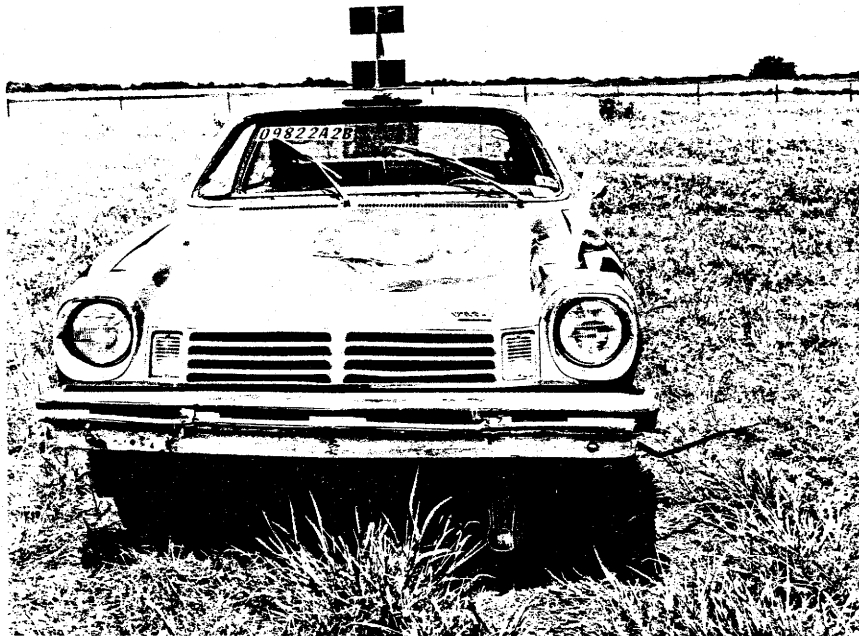
Figure 36. Test 2 Vehicle After Impact.

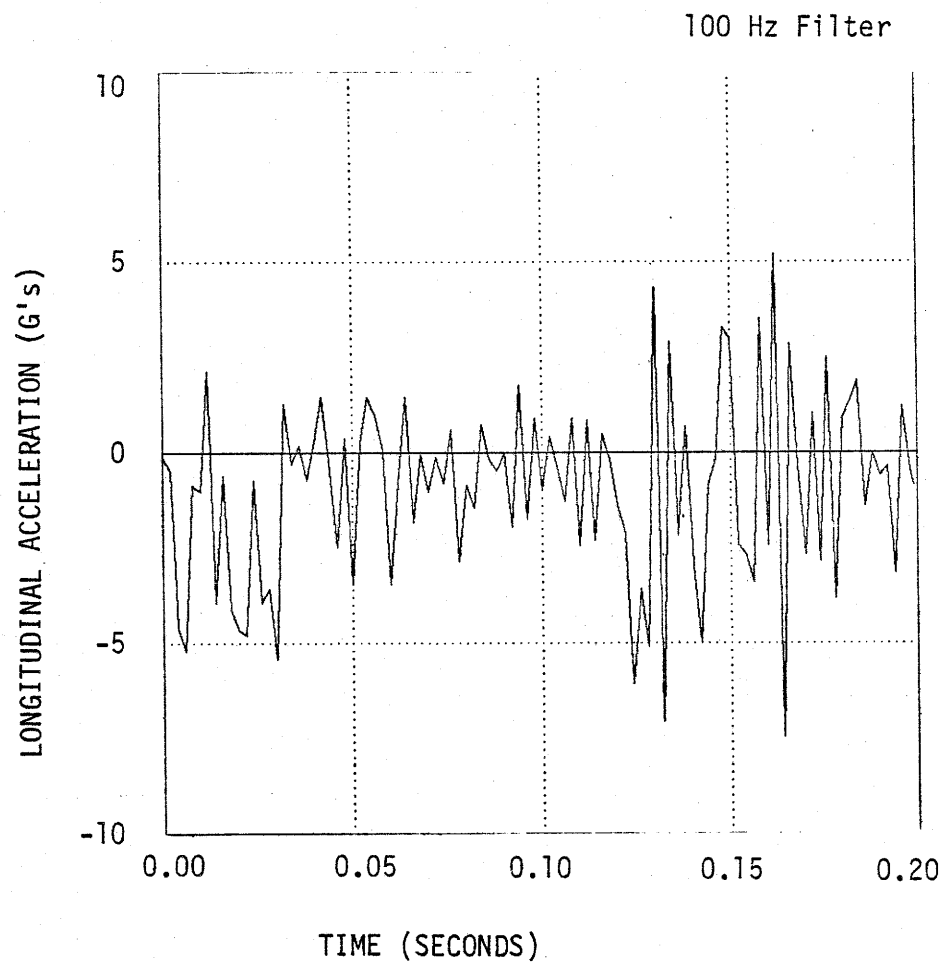
Figure 37. Longitudinal Acceleration From Vehicle's Left B-Pillar Accelerometer for Test 2.

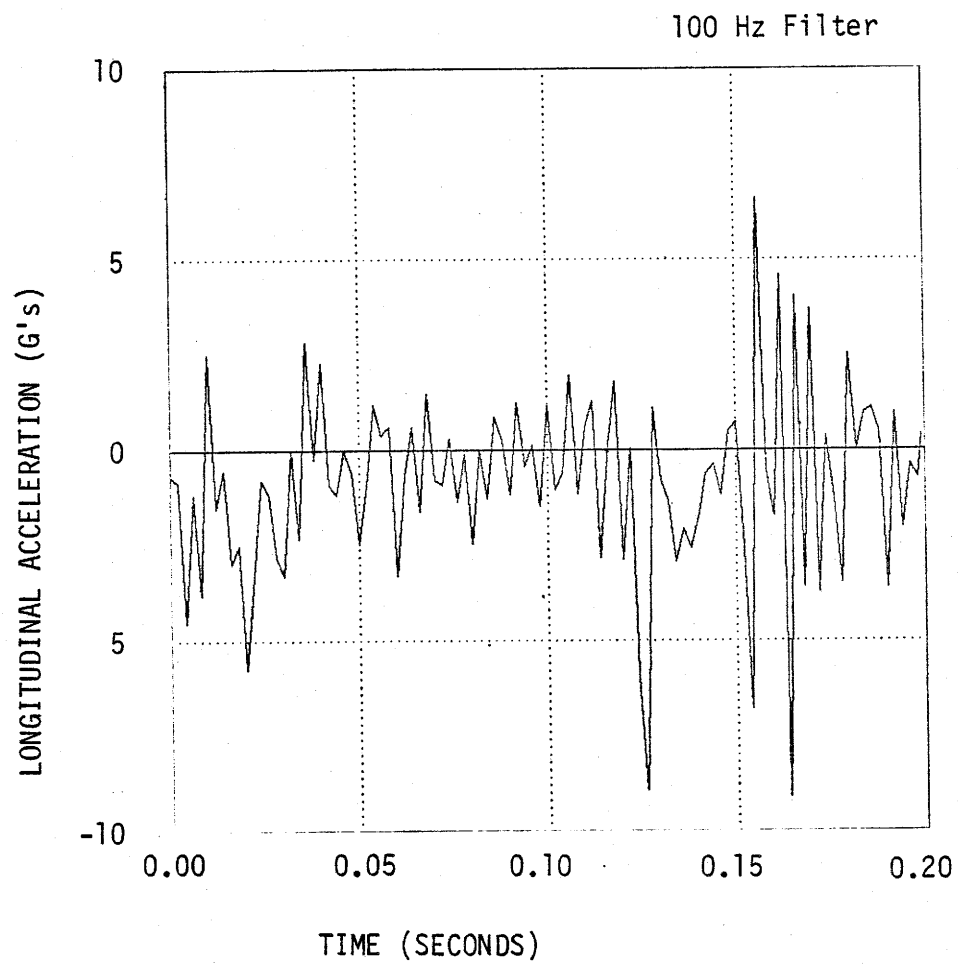
Figure 38. Longitudinal Acceleration From Vehicle's Right B-Pillar Accelerometer for Test 2.

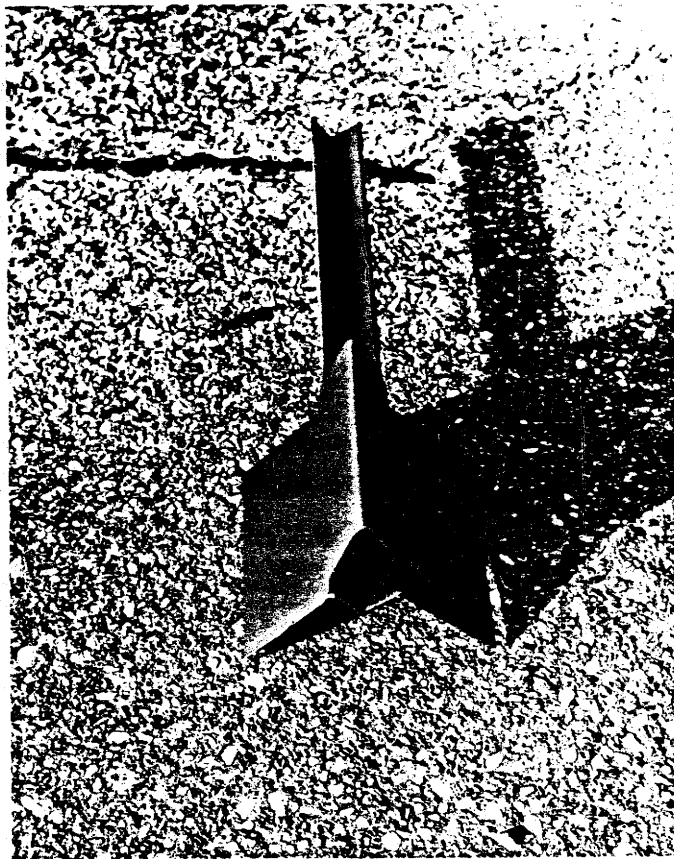
Figure 39. Modified V-Loc Socket for Test 3B.

Test 3 - Photos of the test articles and vehicle for test 3 are shown in Figures 39 through 46. Sequential photos from high-speed film are shown in Figure 47, and time-displacement-event data are given in Table 5. Photos of the installations and vehicle after test 3 are shown in Figures 48 through 50. Accelerometer data are given in Figures 51 and 52. Both systems easily met recommended safety performance standards for highway signs (1,2). In test 3A the support hooked onto the car and was pulled from the ground. In test 3B the adapter pipe was pulled out of the V-loc anchor. Note the difference in the size of the stabilizer fins for test 3 versus test 1 (see Figures 3 and 39). The increased size of the fins in test 3 prevented any significant rotation and movement of the V-loc anchor.

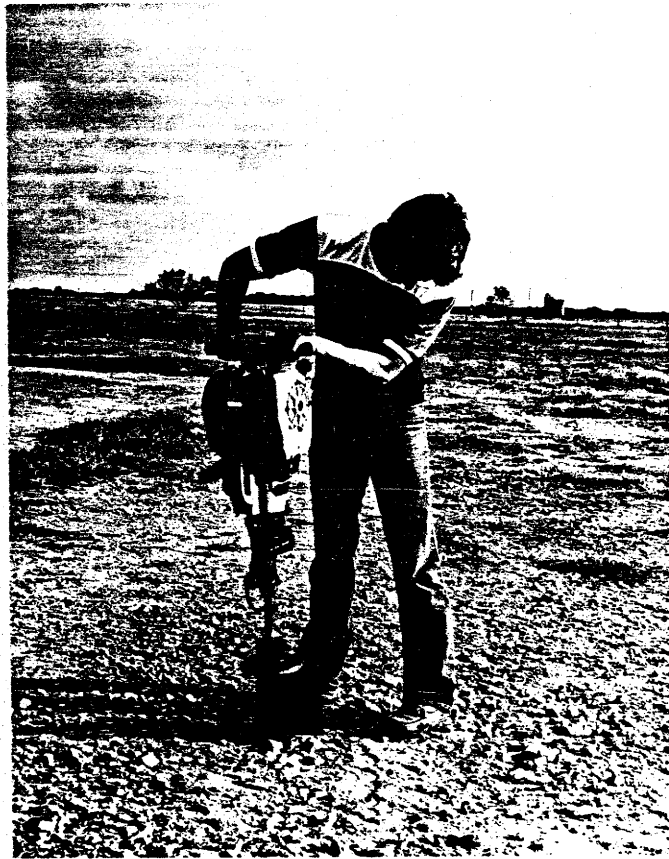
Figure 40. Socket Installation with Pionjar Hammer for Test 3B.

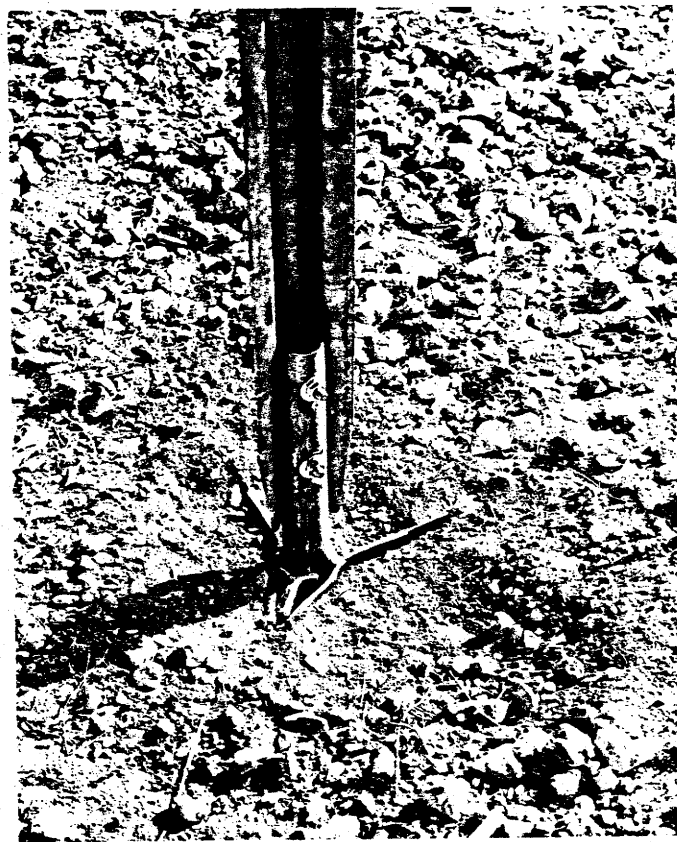
Figure 41. Support-to-Socket Connection for Test 3B.

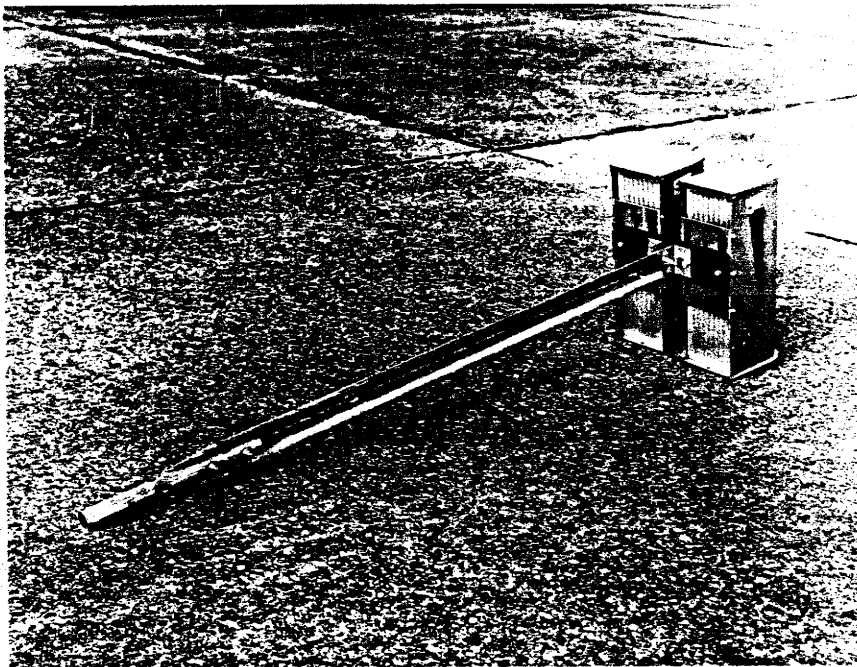
Figure 42. Test 3B Mailbox and Support Assembly Before Installation.

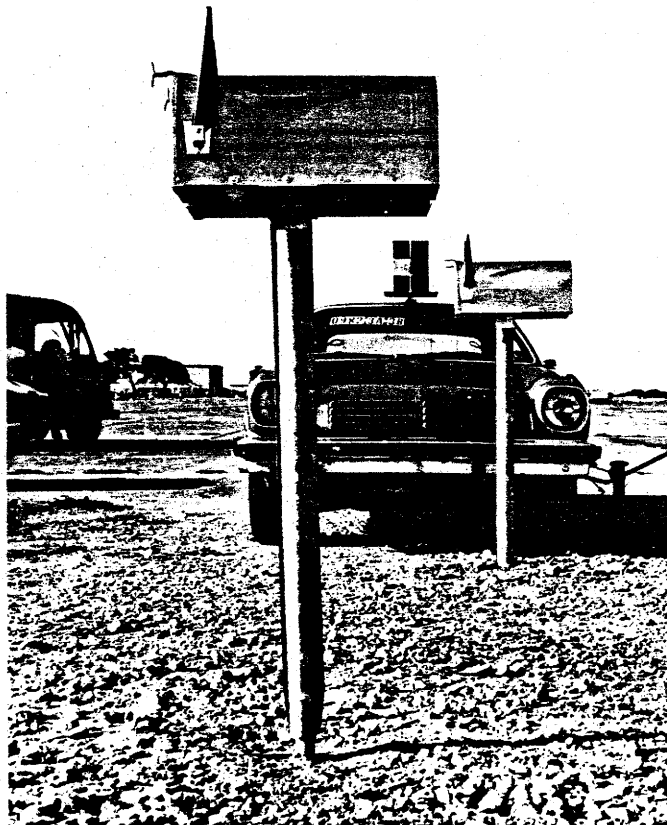
Figure 43. Test 3 Mailbox Installation Looking Opposite the Direction of Vehicle Travel.

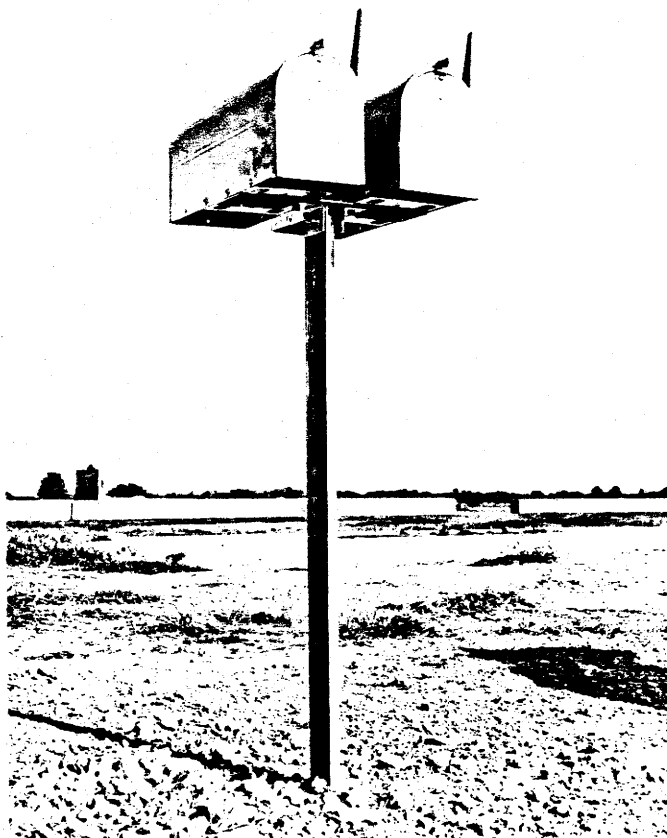
Figure 44. Test 3A Mailbox Installation.

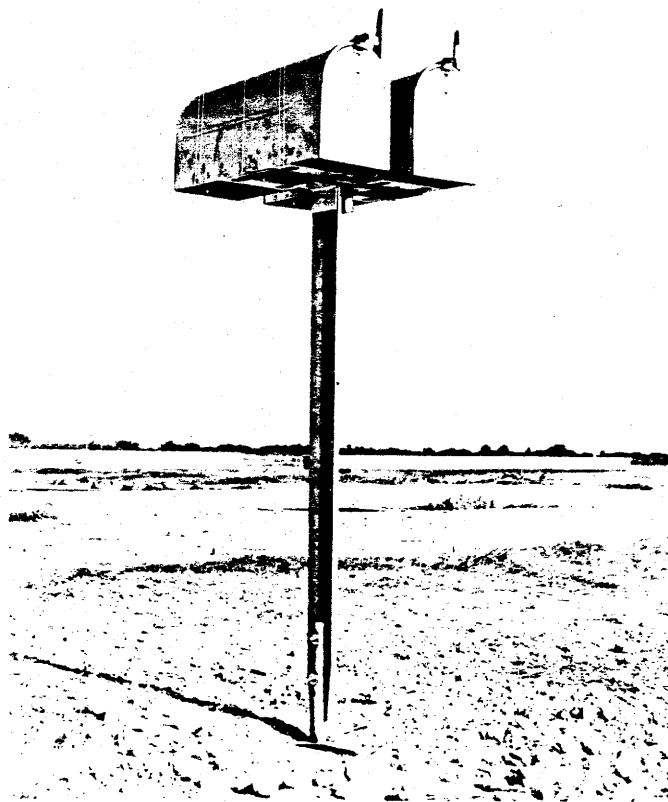
Figure 45. Test 3B Mailbox Installation.

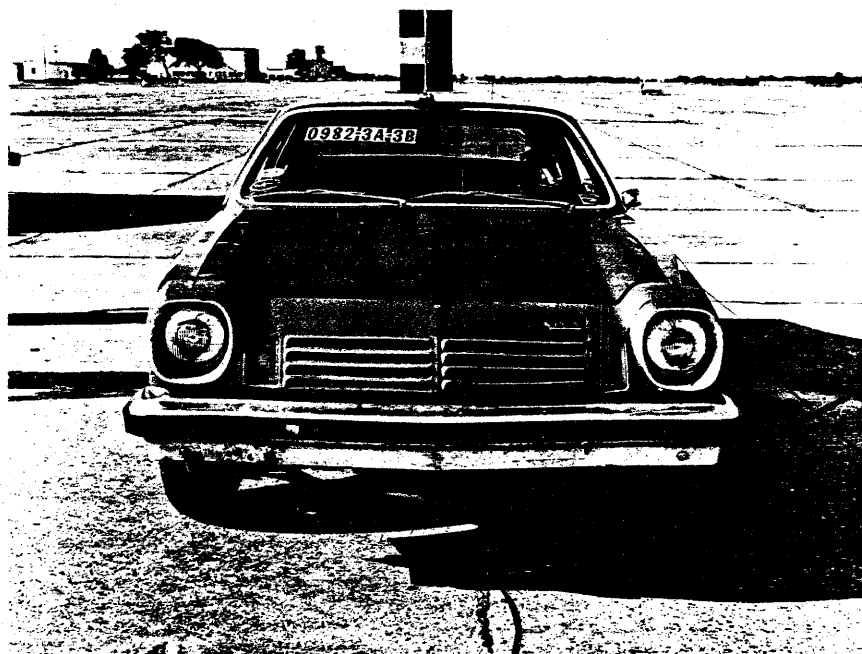
Figure 46. Test 3 Vehicle Before Impact.

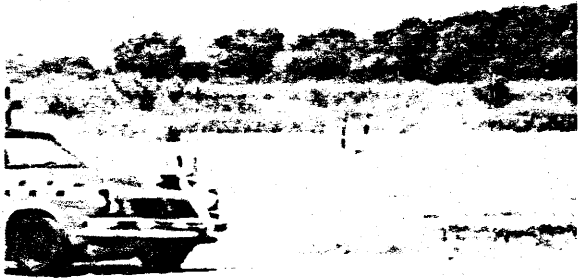
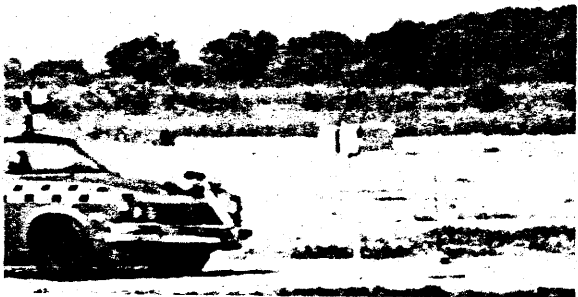
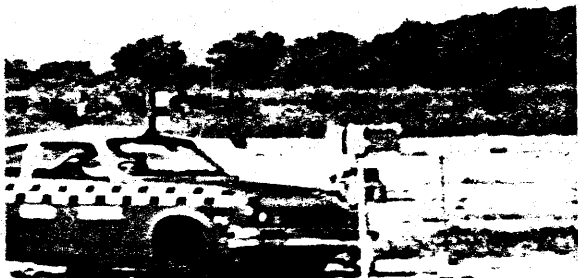
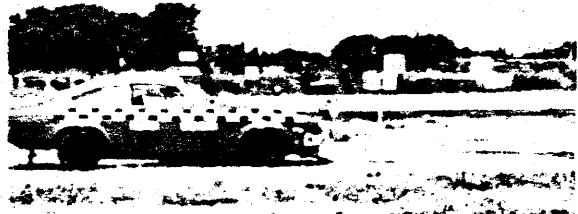
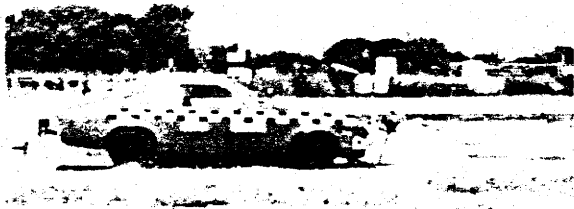
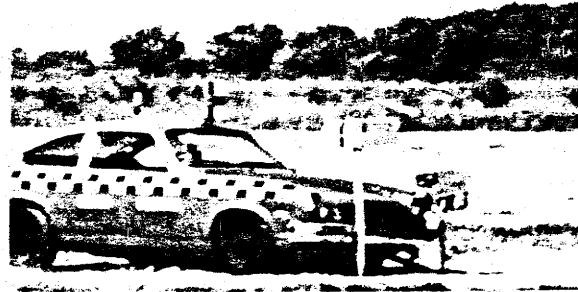
Figure 47. Sequential Photographs for Test 3.

Figure 47. Sequential Photographs for Test 3 (continued).

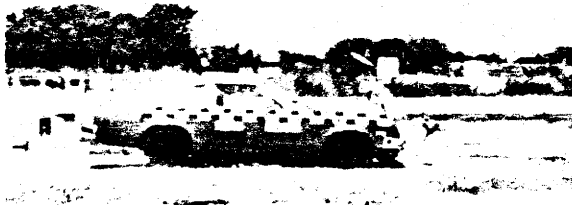
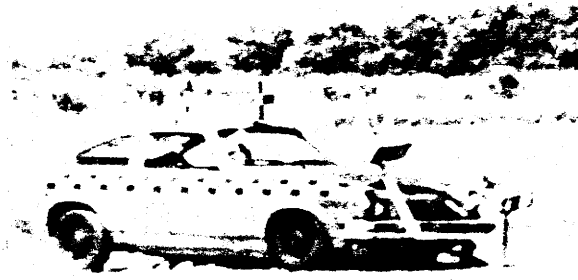
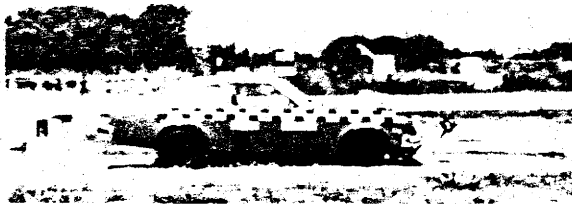
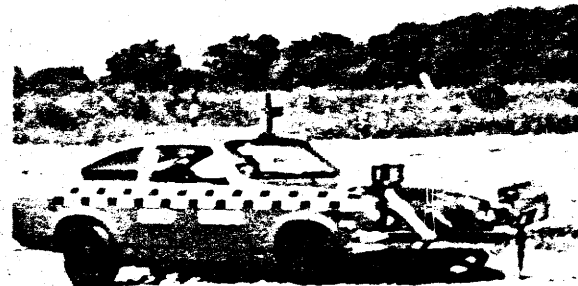
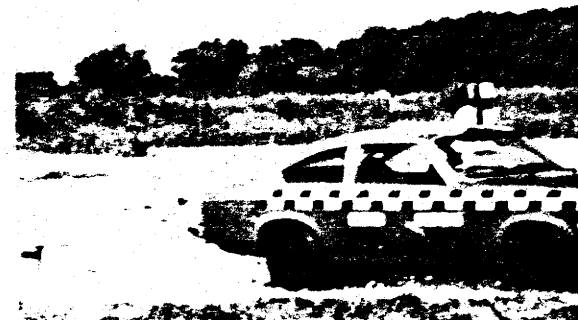
TIME (sec)	NOMINAL VEHICLE DISPLACEMENT (ft)	EVENT
0.000	0.00	Impact with 3A
0.025	2.09	3A boxes strikes hood
0.038	3.15	3A support pulls out of ground
0.088	7.27	3A support strikes ground
0.118	9.73	Impact with 3B
0.135	11.15	3B support pulls out of socket
0.145	11.95	3B boxes strike hood
0.250	20.50	3B thrown free of car; 3A carried away by vehicle

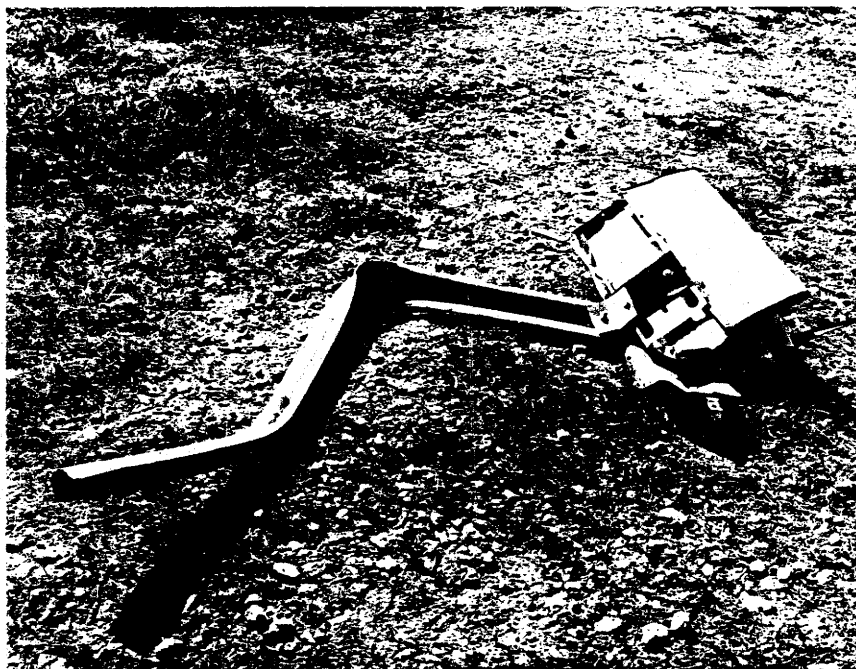
Figure 48. Test 3A Mailbox After Impact.

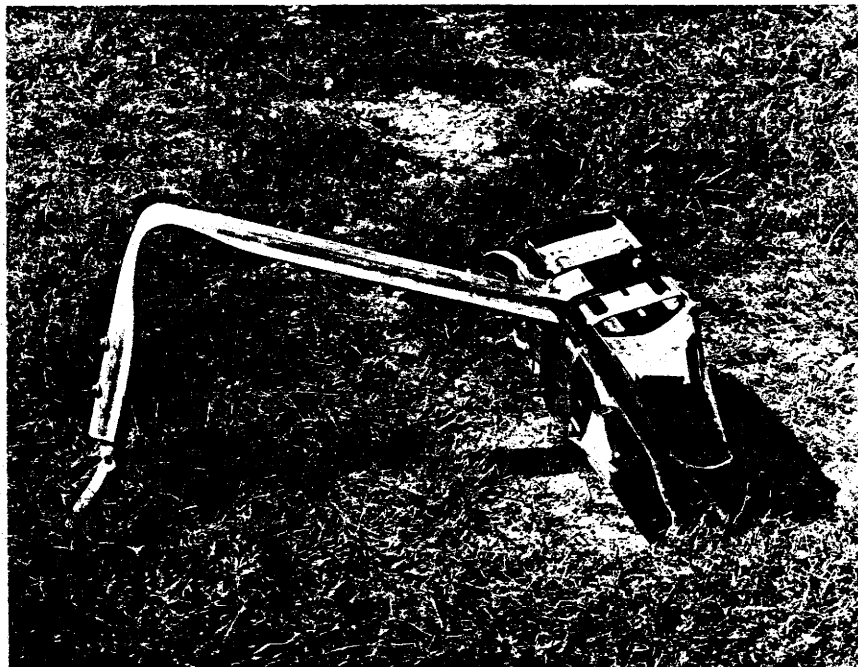
Figure 49. Test 3B Mailbox After Impact.

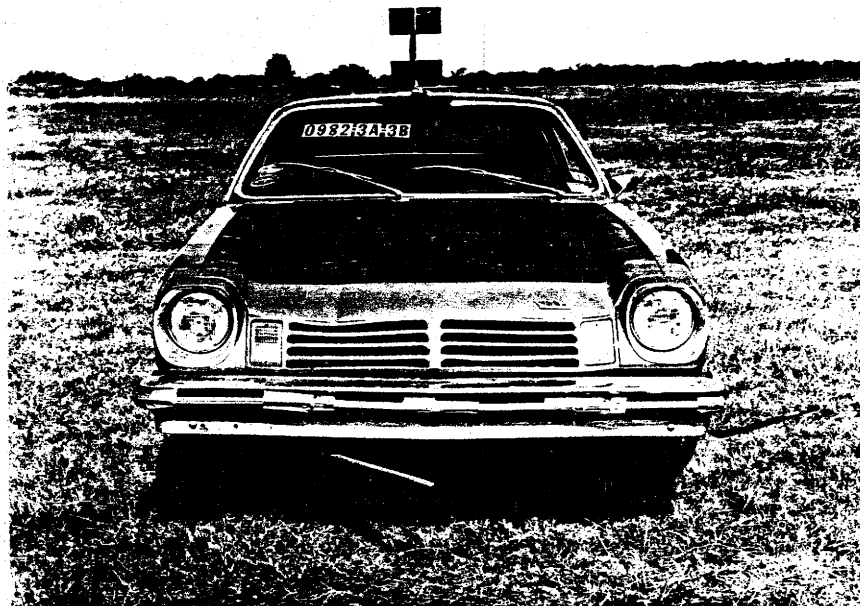
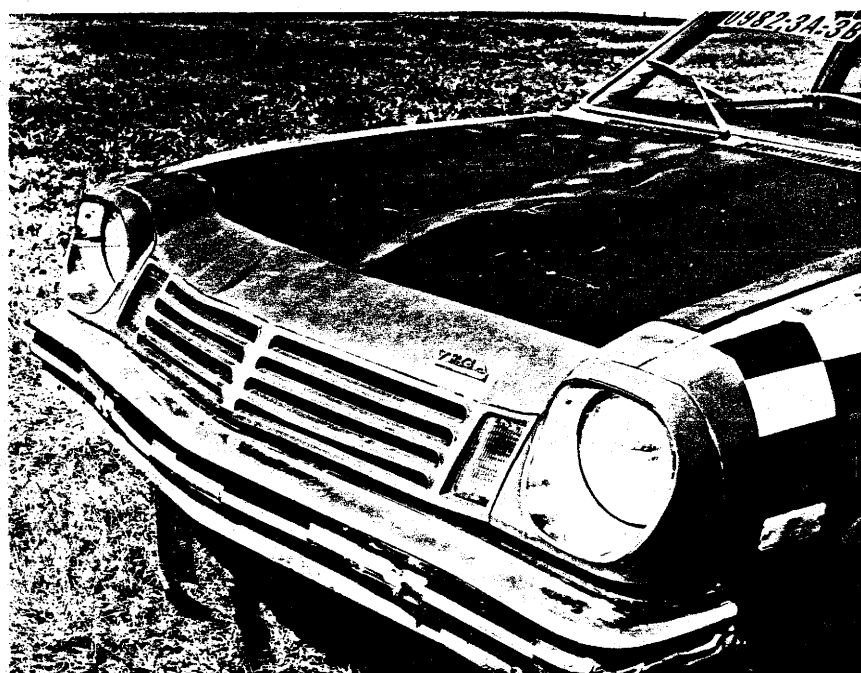
Figure 50. Test 3 Vehicle After Impact.

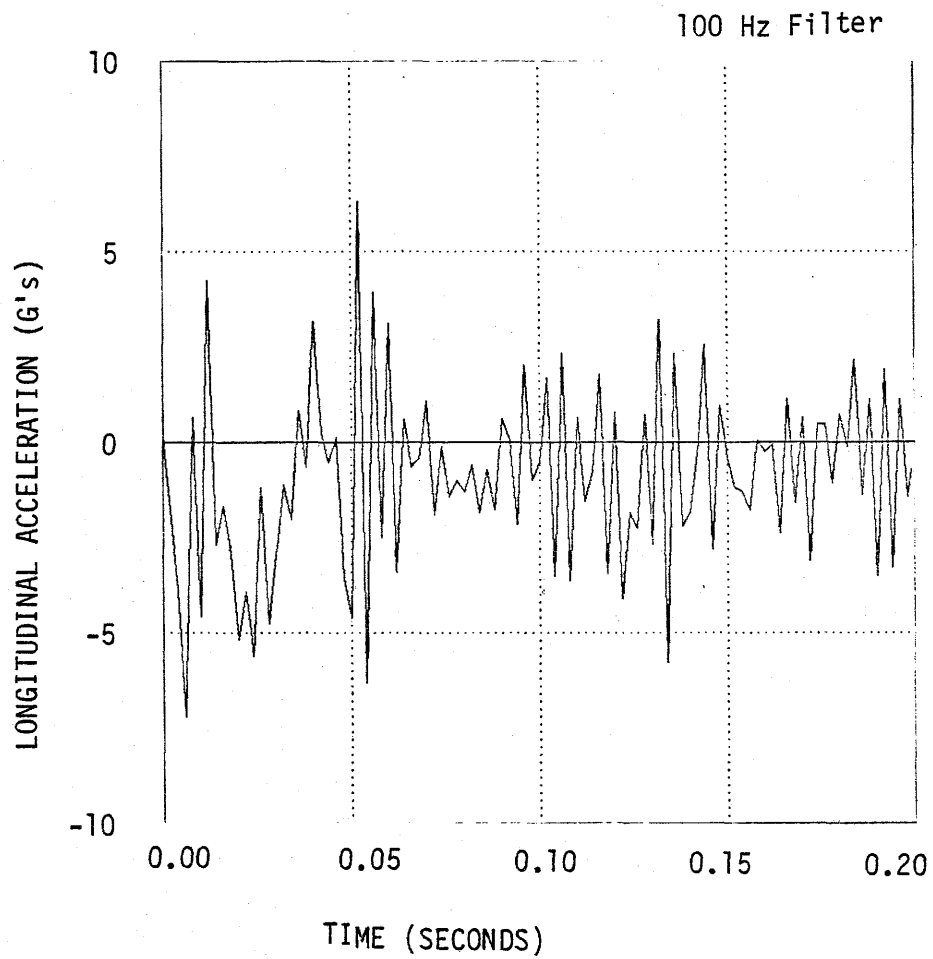
Figure 51. Longitudinal Acceleration from Vehicle's Left B-Pillar Accelerometer for Test 3.

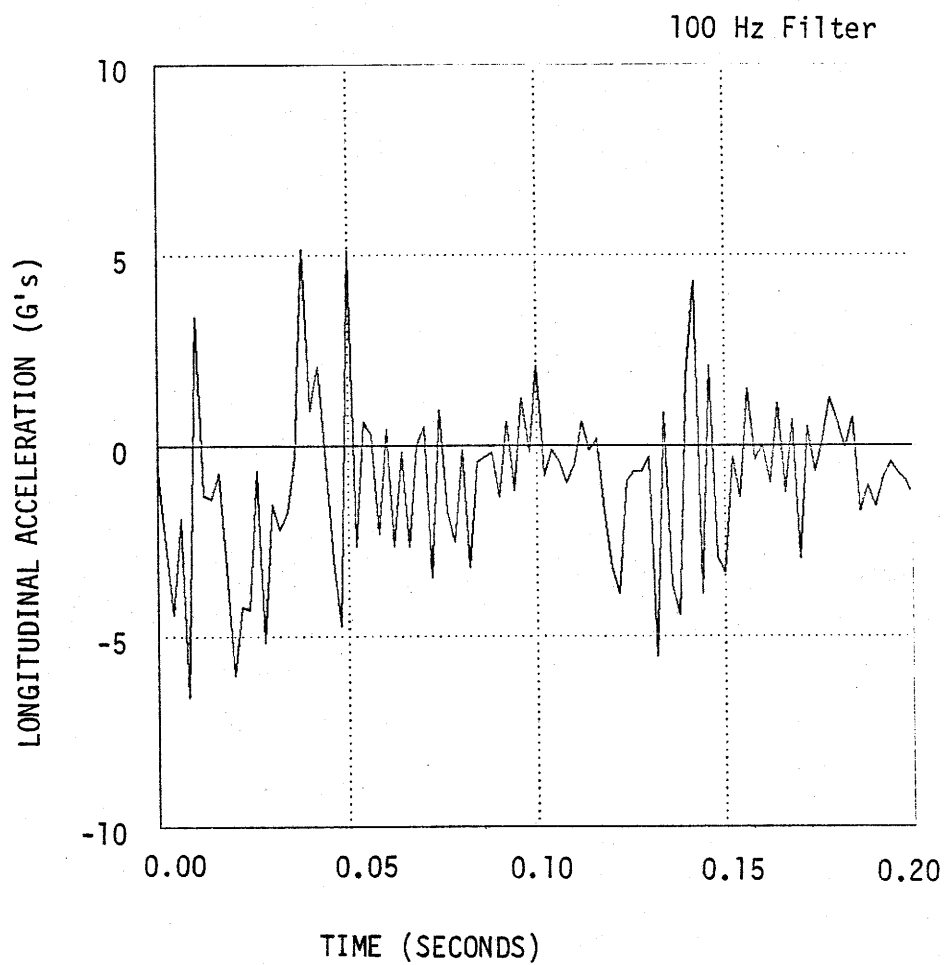
Figure 52. Longitudinal Acceleration from Vehicle's Right B-Pillar Accelerometer for Test 3.

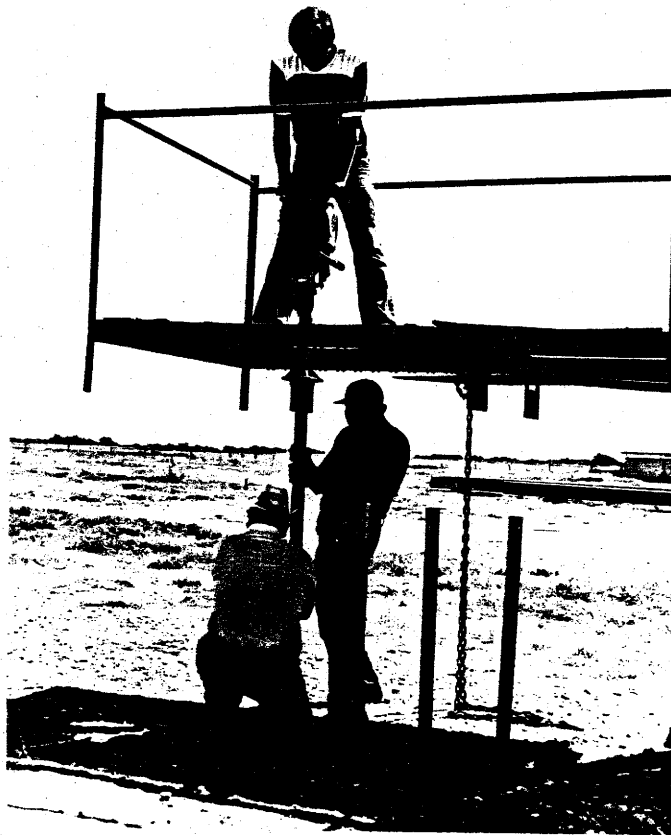
Figure 53. Driving Delineator with
Pionjar Hammer for Test 4.

Test 4 - Photos of the test articles for test 4 are shown in Figures 53 through 56. Sequential photos from high-speed film are shown in Figure 57, and time-displacement-event data are shown in Table 6. Photos of the installation and vehicle after the test are shown in Figures 58 and 59. Accelerometer data are given in Figures 60 and 61. Upon impact the first two posts hooked onto the car and were pulled from the ground. The other two posts were bent over as the boxes were stripped from the posts. The eccentric impact load caused the vehicle to spin about 180 degrees before it came to rest. Results of test 4 indicate that an installation of four 2 lb/ft (3.0 kg/m) U-posts is only marginally acceptable in terms of recognized performance limits (1,2).

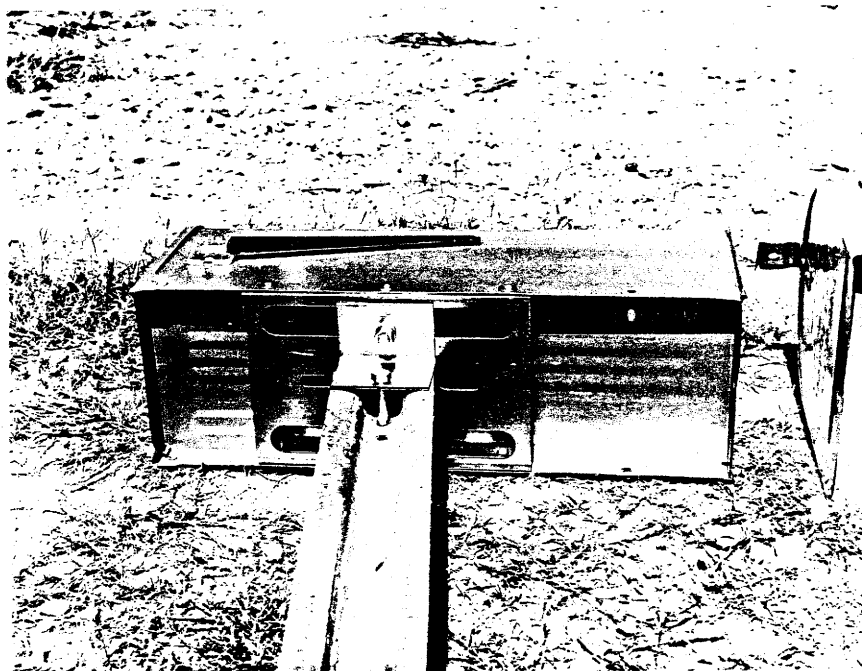
Figure 54. Typical Size #1 Mailbox Mount.

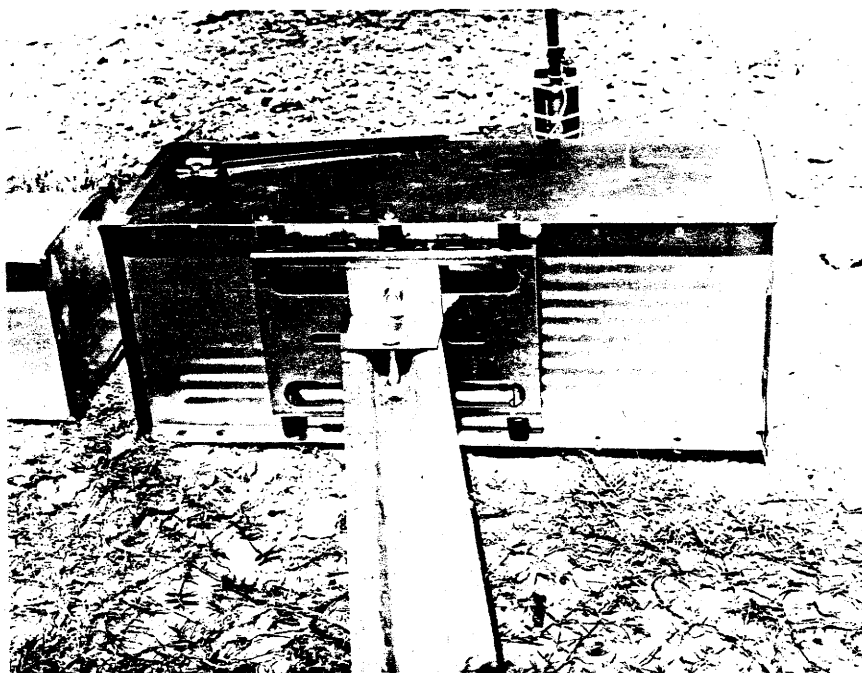
Figure 55. Typical Size #1-1/2 Mailbox Mount.

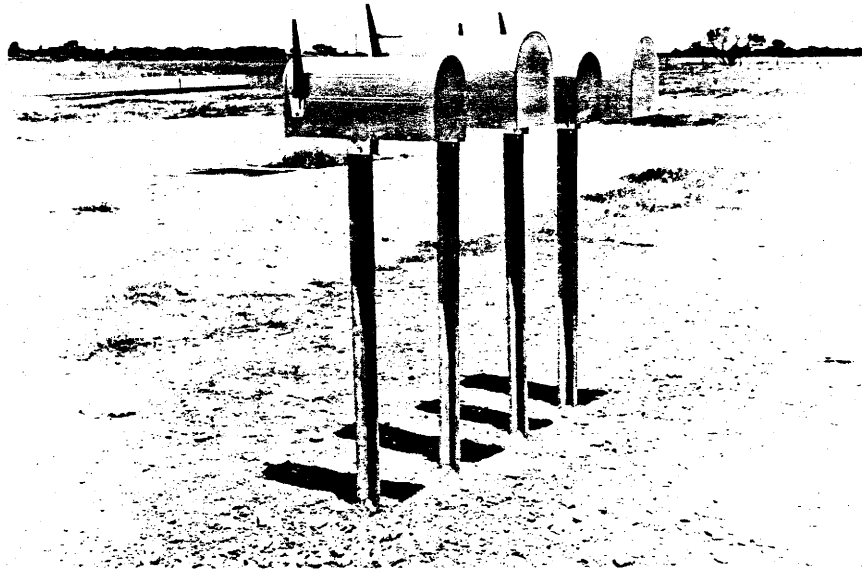
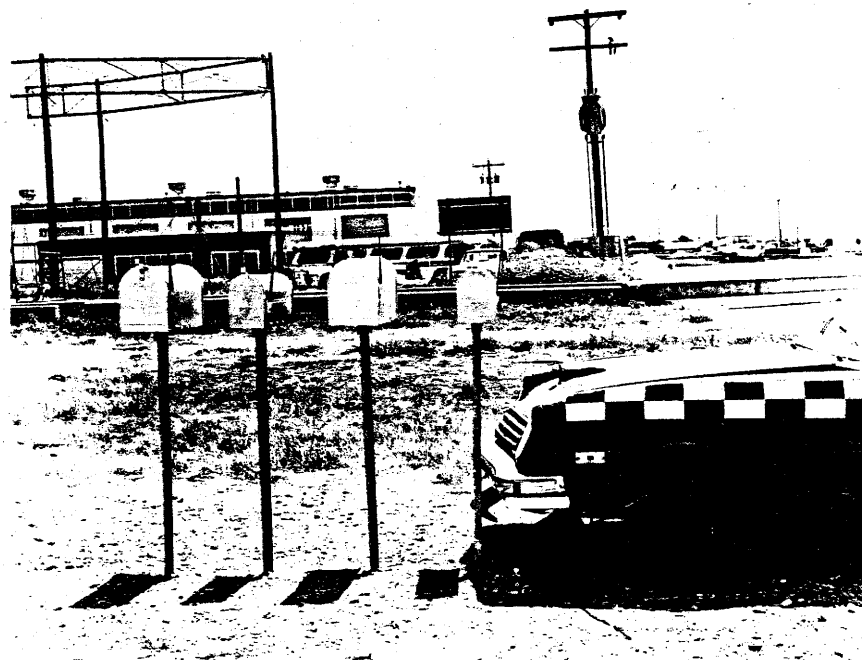
Figure 56. Test 4 Mailbox Installation.

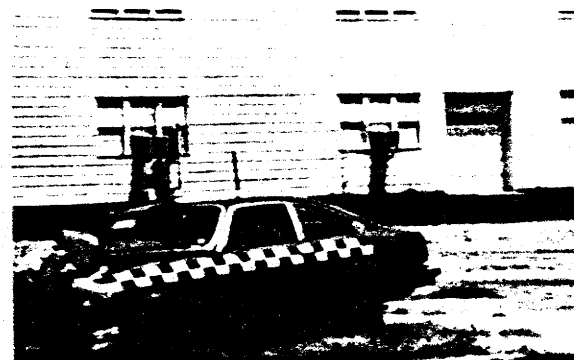
Figure 57. Sequential Photographs for Test 4 (continued).

TIME (sec)	NOMINAL VEHICLE DISPLACEMENT (ft)	EVENT
0.000	0.00	Impact with box #1
0.018	1.52	Impact with box #2
0.038	3.24	Impact with box #3
0.053	4.49	Impact with box #4
0.060	5.07	Left underside of car strikes ground
0.179	13.93	Left underside of car leaves ground
0.186	14.49	Left rear tire leaves ground
0.197	15.27	Vehicle carries away four boxes and two posts

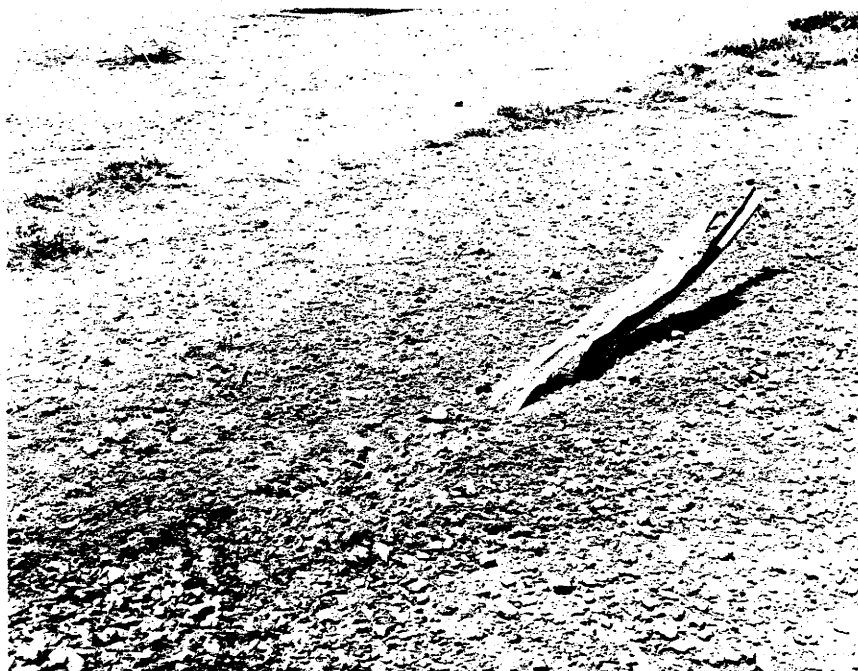
Figure 58. Test 4 Ground Connections After Impact.
