TEST AND EVALUATION OF RURAL MAILBOX INSTALLATIONS

Research Report 0982-1
on
SDHPT Contract No. TTI (1981) 7

THE TEXAS STATE DEPARTMENT OF HIGHWAYS
AND PUBLIC TRANSPORTATION

TEXAS TRANSPORTATION INSTITUTE
Texas A&M University
College Station, Texas

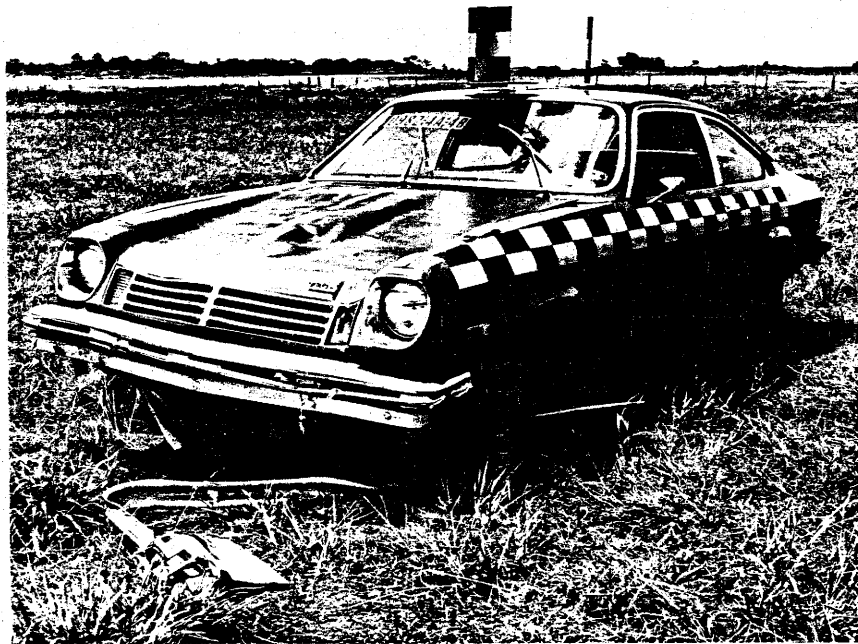
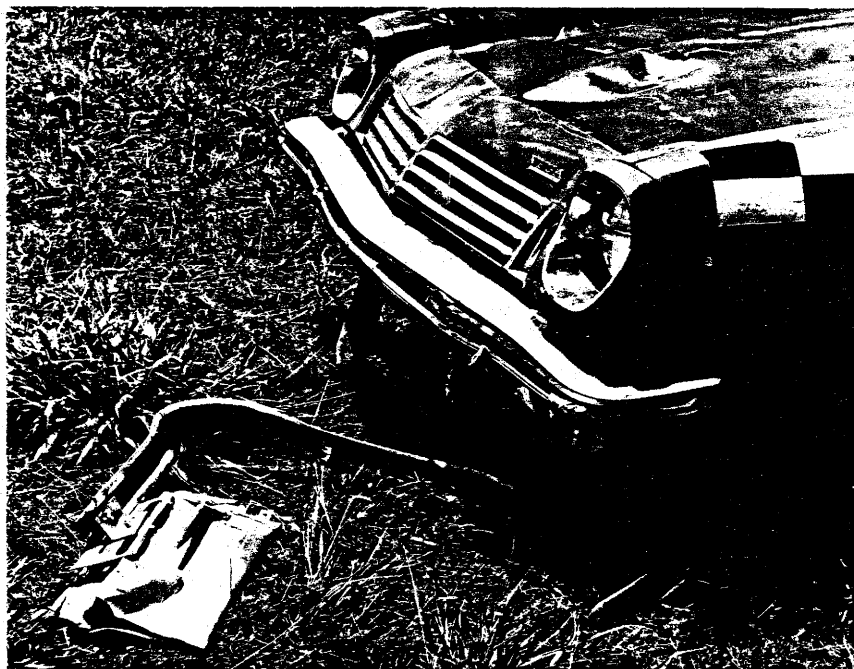
Figure 59. Vehicle After Test 4.

Test 4 - Photos of the test articles for test 4 are shown in Figures 53 through 56. Sequential photos from high-speed film are shown in Figure 57, and time-displacement-event data are shown in Table 6. Photos of the installation and vehicle after the test are shown in Figures 58 and 59. Accelerometer data are given in Figures 60 and 61. Upon impact the first two posts hooked onto the car and were pulled from the ground. The other two posts were bent over as the boxes were stripped from the posts. The eccentric impact load caused the vehicle to spin about 180 degrees before it came to rest. Results of test 4 indicate that an installation of four 2 lb/ft (3.0 kg/m) U-posts is only marginally acceptable in terms of recognized performance limits (1,2).

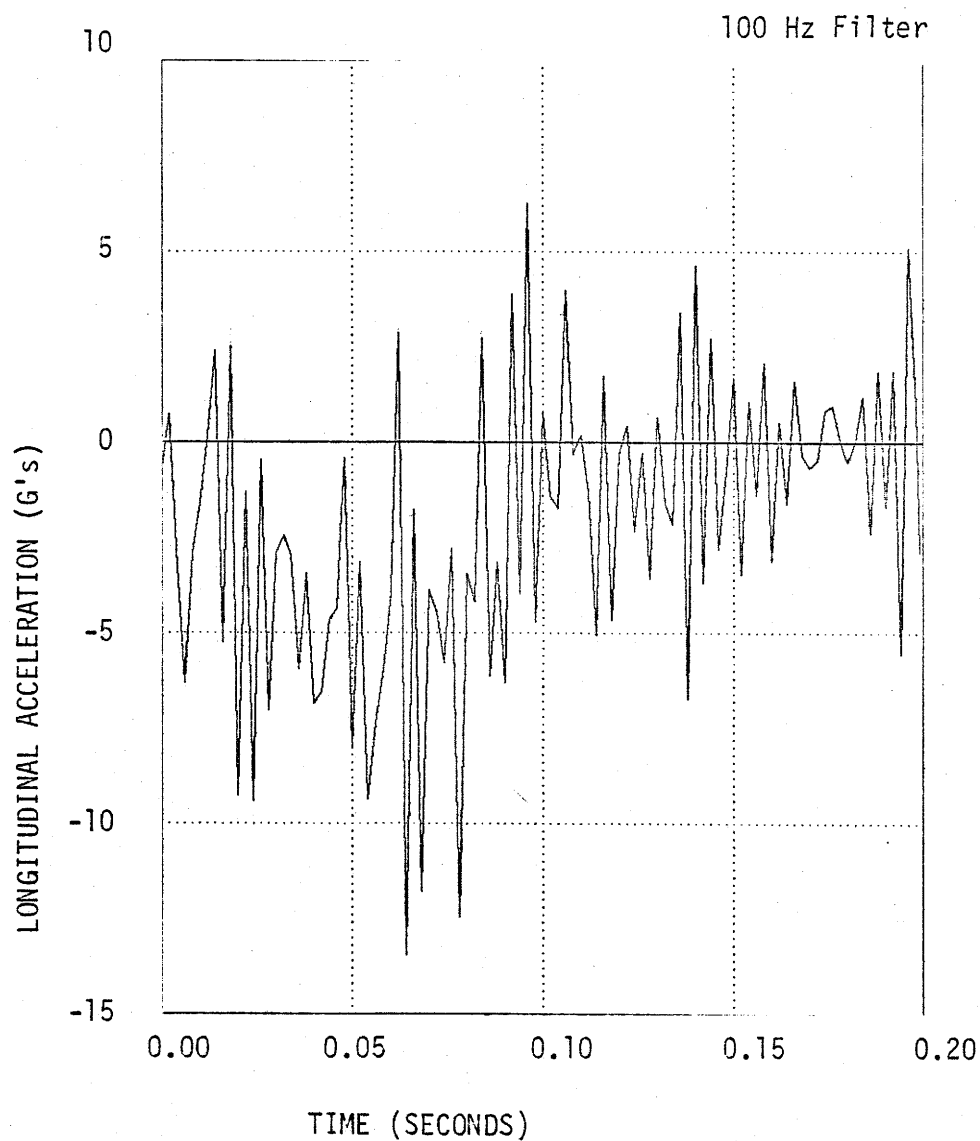
Figure 60. Longitudinal Acceleration from Vehicle's Left B-Pillar Accelerometer for Test 4.

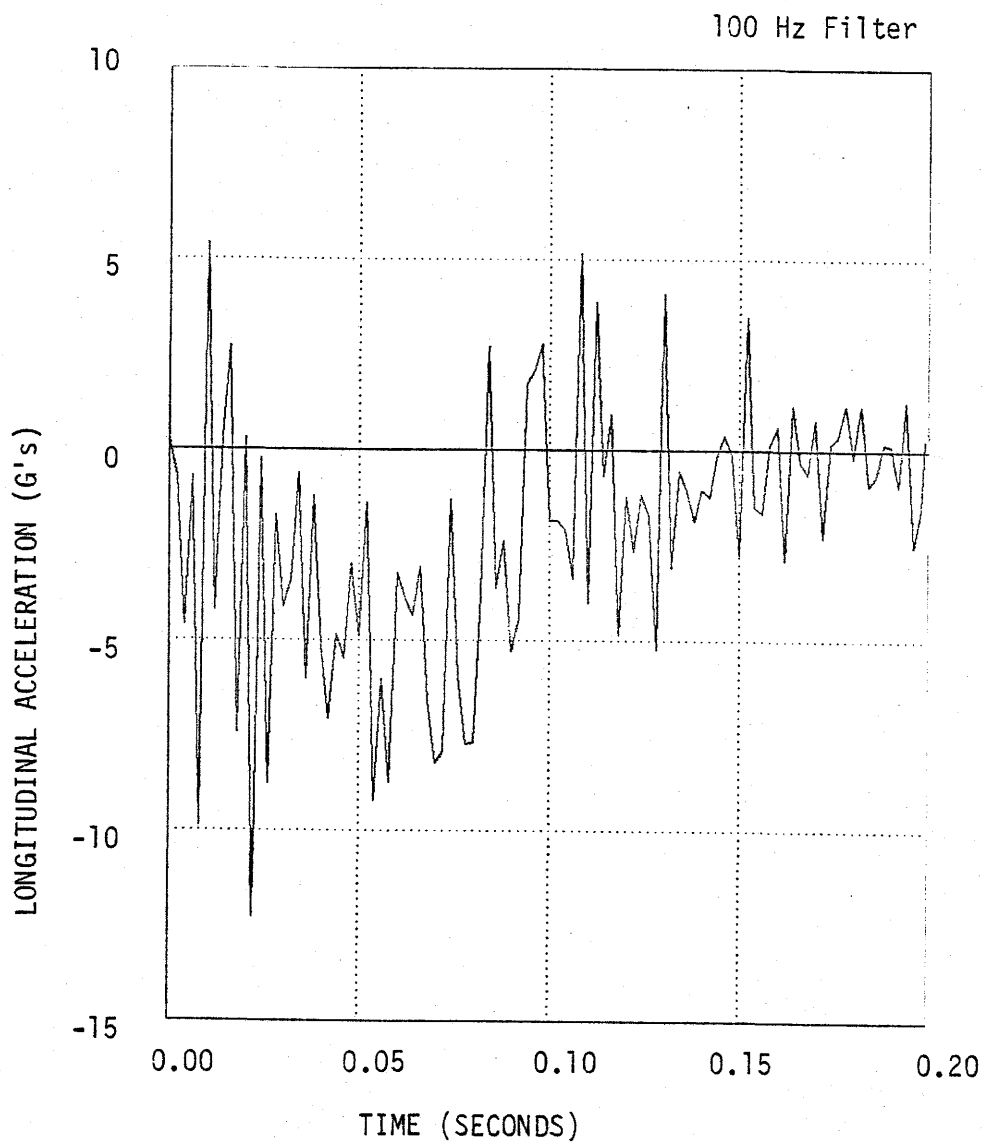
Figure 61. Longitudinal Acceleration from Vehicle's Right B-Pillar Accelerometer for Test 4.

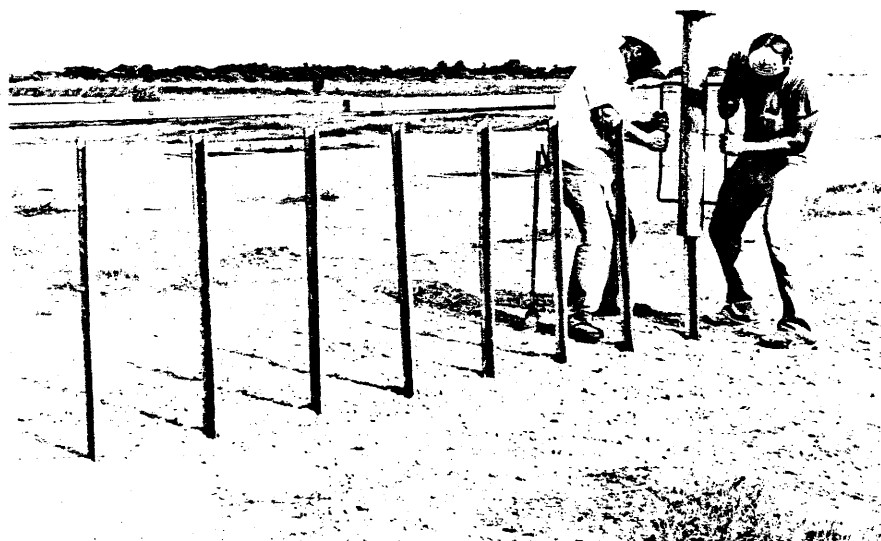
Figure 62. Driving Delineator with Special Tool for Test 5.

Test 5 - Photos of the test articles and vehicle for test 5 are shown in Figures 62 through 65. Sequential photos from the high-speed film are shown in Figures 66, and time-displacement-event data are shown in Table 7. Photos of the installation and vehicle after the test are shown in Figures 67 through 69. Accelerometer data are shown in Figures 70 and 71.

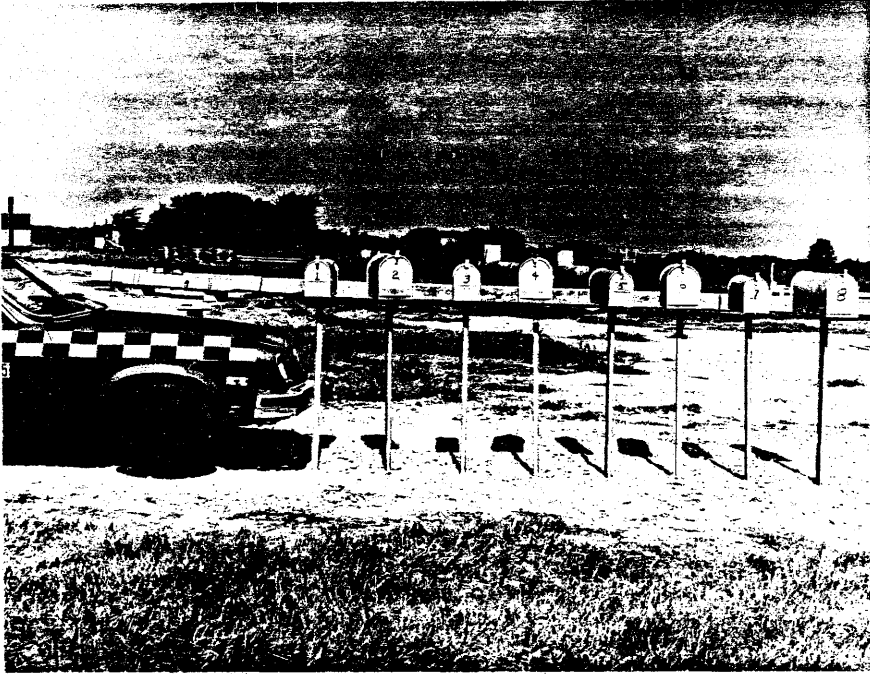
Figure 64. Test 5 Mailbox Installation.

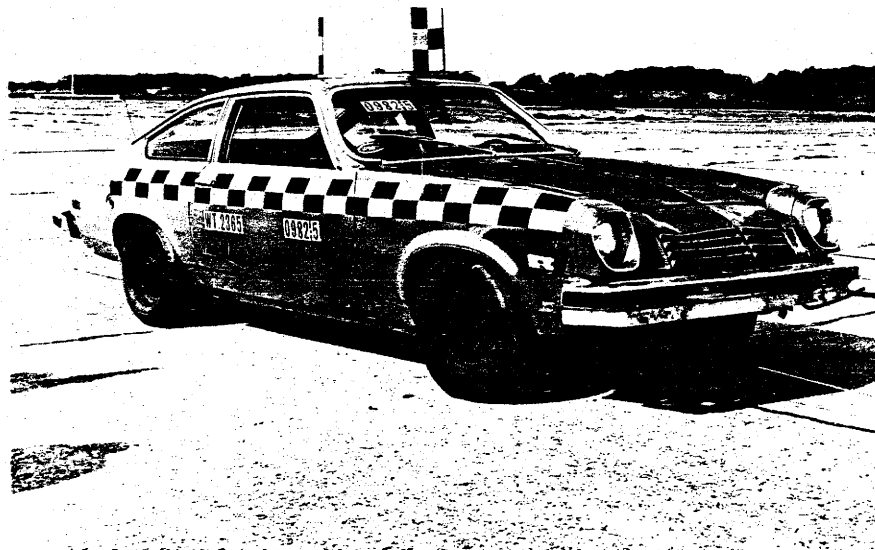
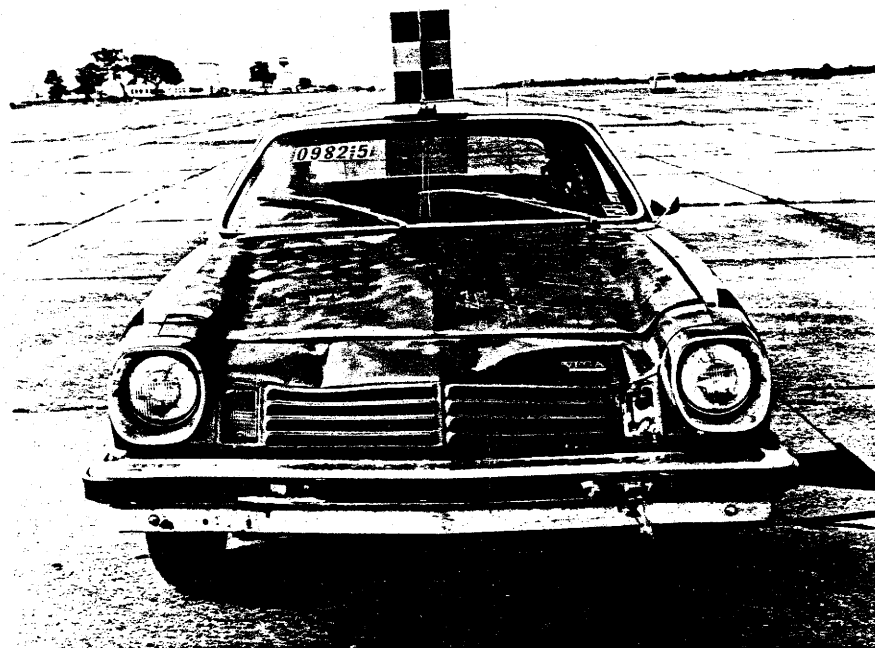
Figure 65. Test 5 Vehicle Before Impact.

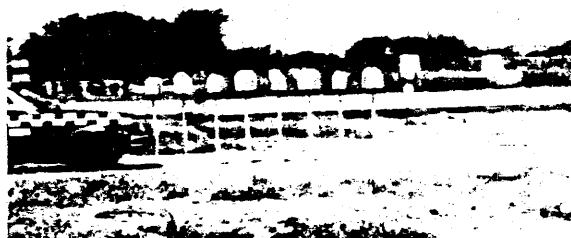
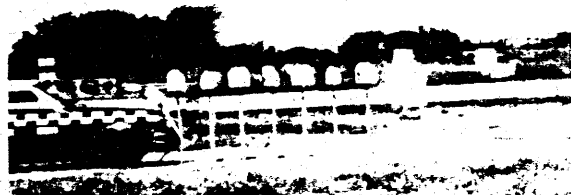
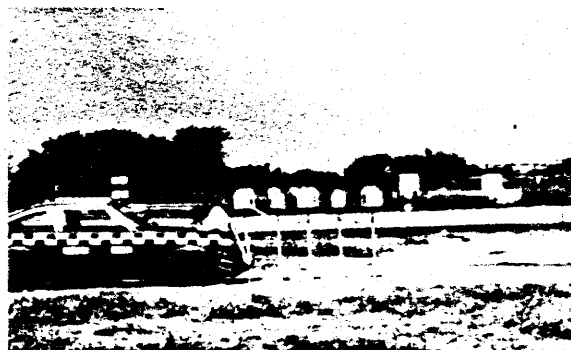
Figure 66. Sequential Photographs for Test 5.

TIME (sec)	NOMINAL VEHICLE DISPLACEMENT (ft)	EVENT
0.000	0.00	Impact with box #1
0.018	1.53	Impact with box #2
0.038	3.24	Impact with box #3
0.055	4.64	Impact with box #4
0.065	5.46	Right underside of car strikes ground
0.075	6.22	Impact with box #5
0.095	7.68	Impact with box #6
0.103	8.20	Clump of boxes hits ground in front of car
0.118	9.17	Impact with box #7
0.140	10.60	Impact with box #8
0.143	10.76	Right underside of car leaves ground
0.163	11.92	Right rear tire leaves ground
0.341	21.29	Vehicle ascending

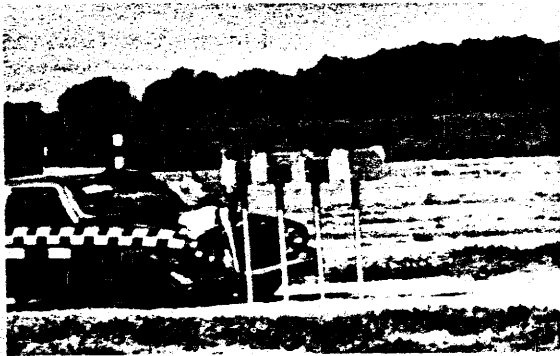
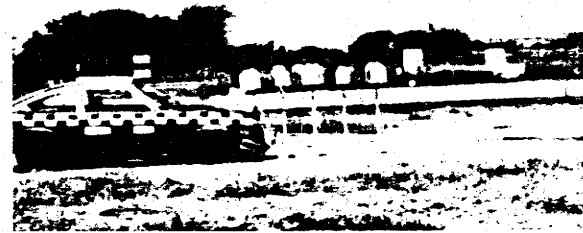
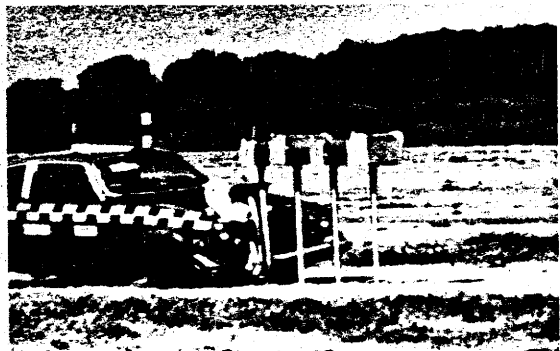
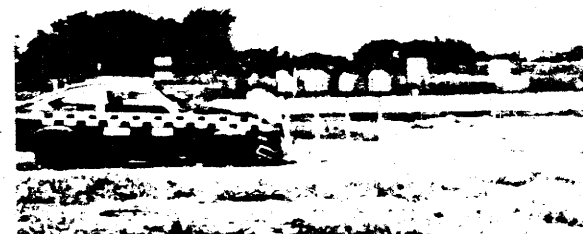
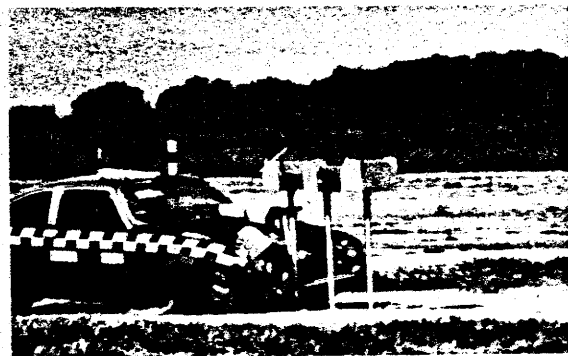
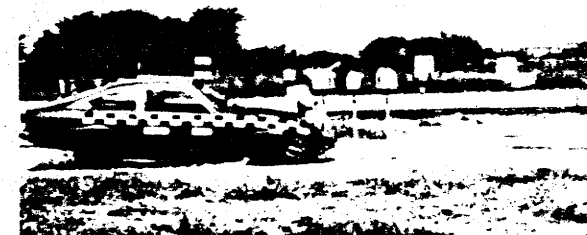
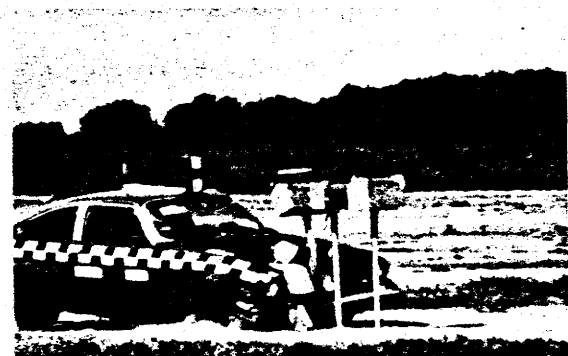
Figure 66. Sequential Photographs for Test 5 (continued).

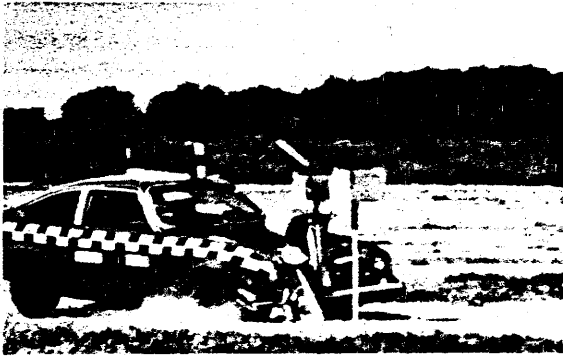
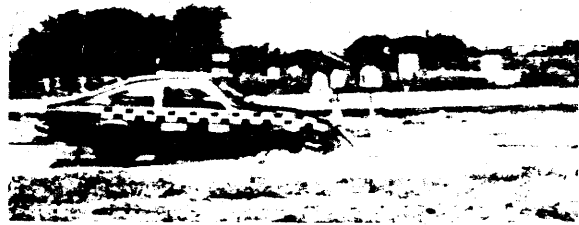
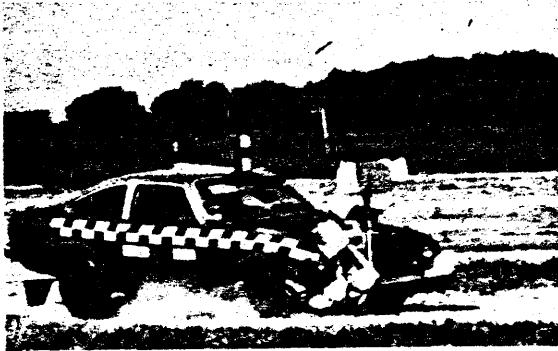
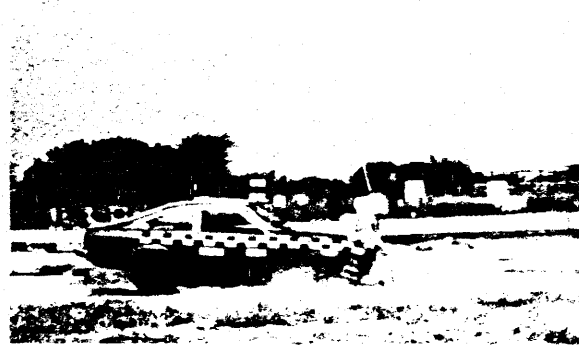
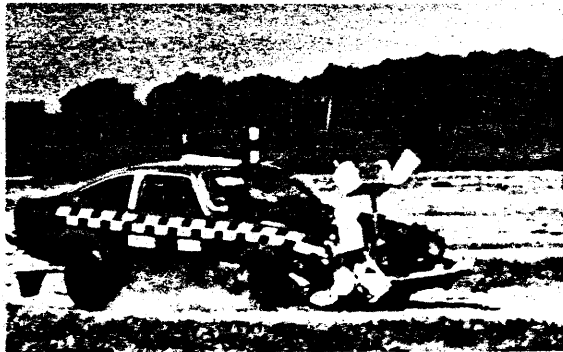
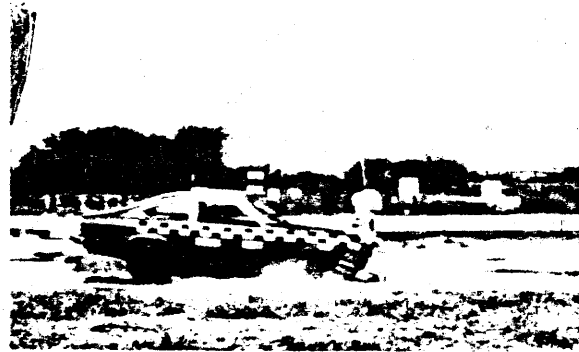
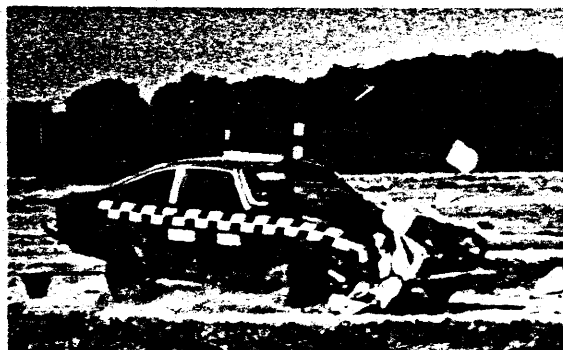
Figure 66. Sequential Photographs for Test 5 (continued).

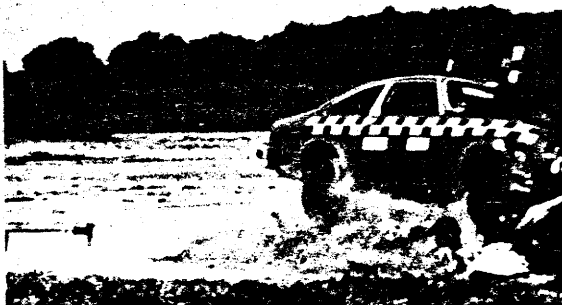
Figure 66. Sequential Photographs for Test 5 (continued).

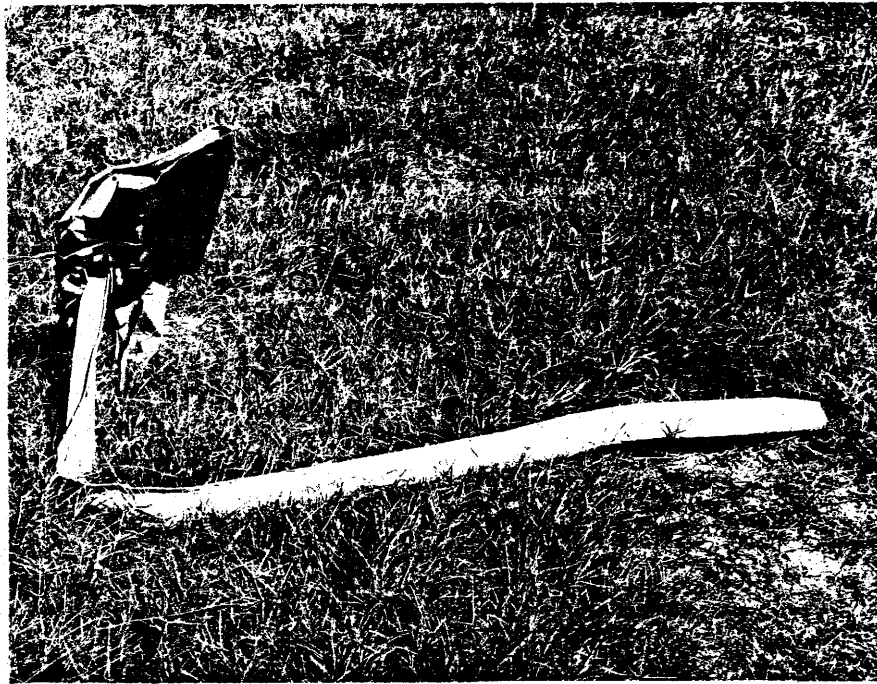
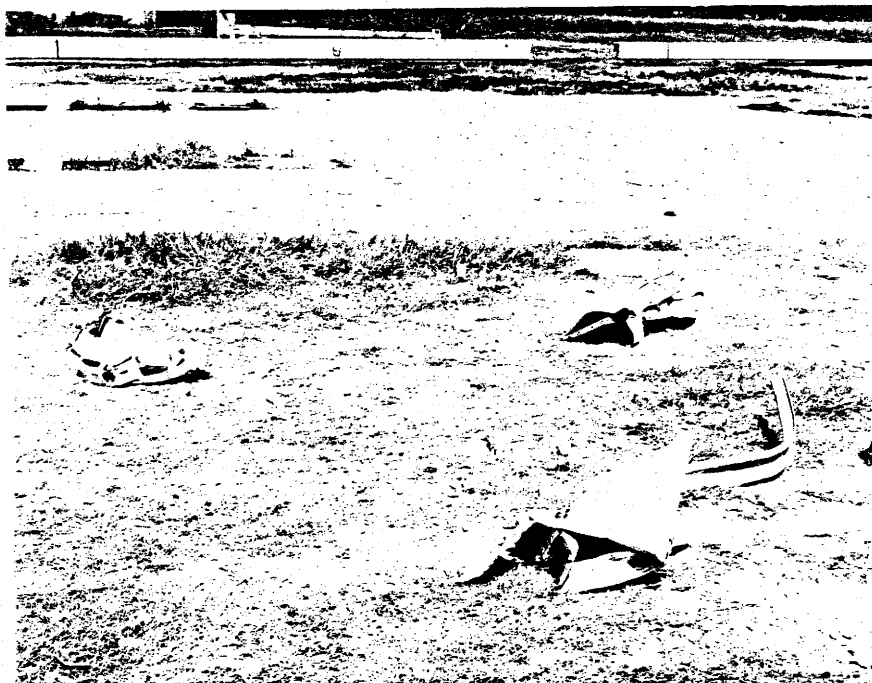
Figure 67. Mailboxes after Test 5.

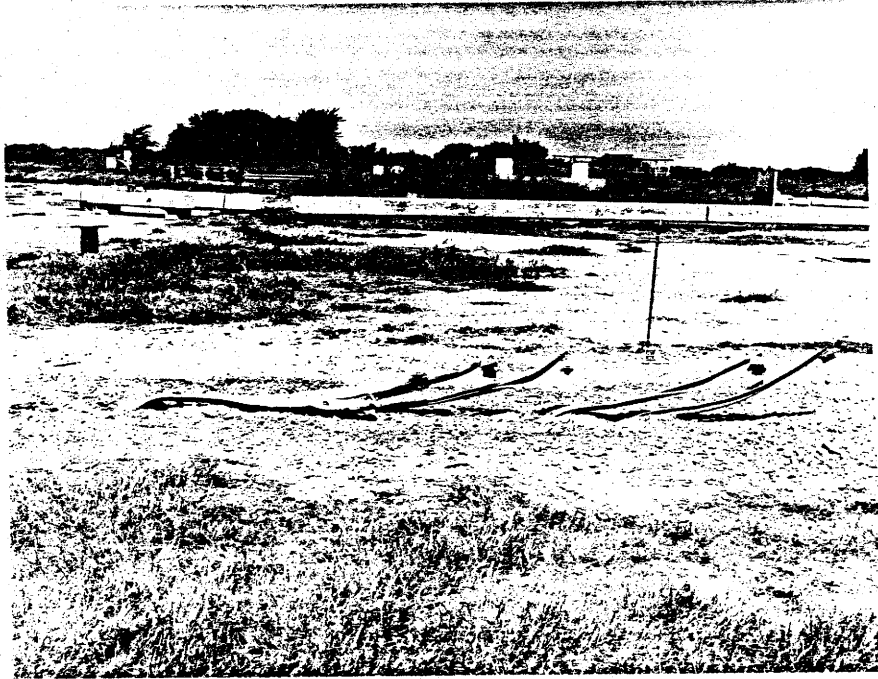
Figure 68. Test 5 Ground Connections After Impact.

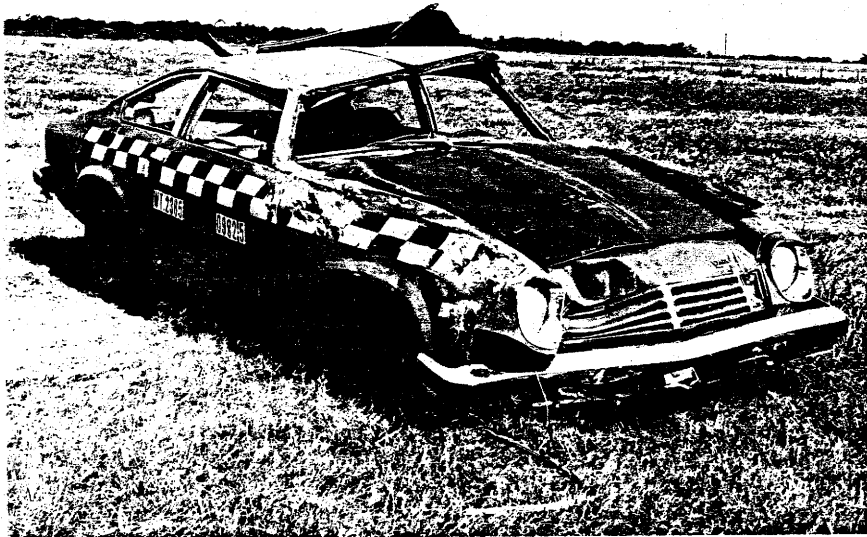
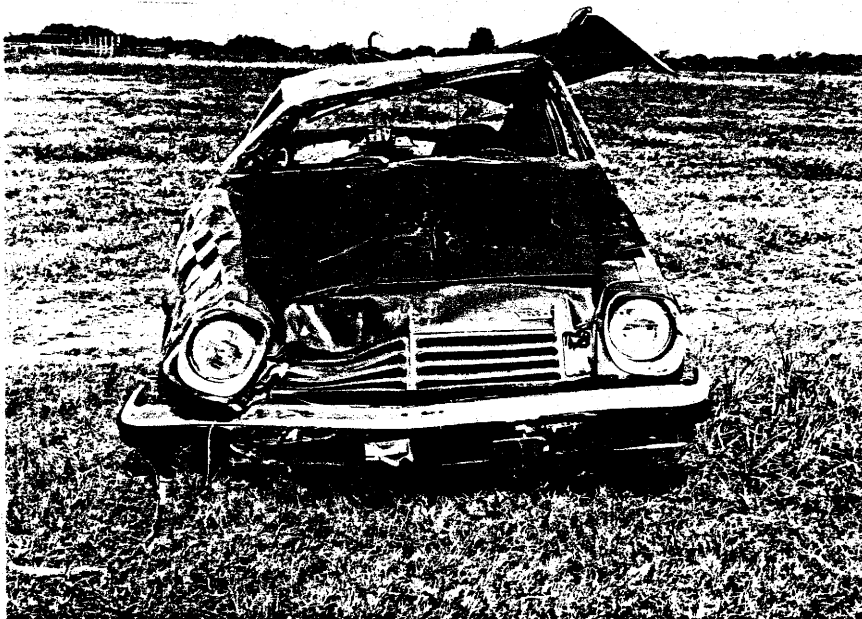
Figure 69. Test 5 Vehicle After Impact.

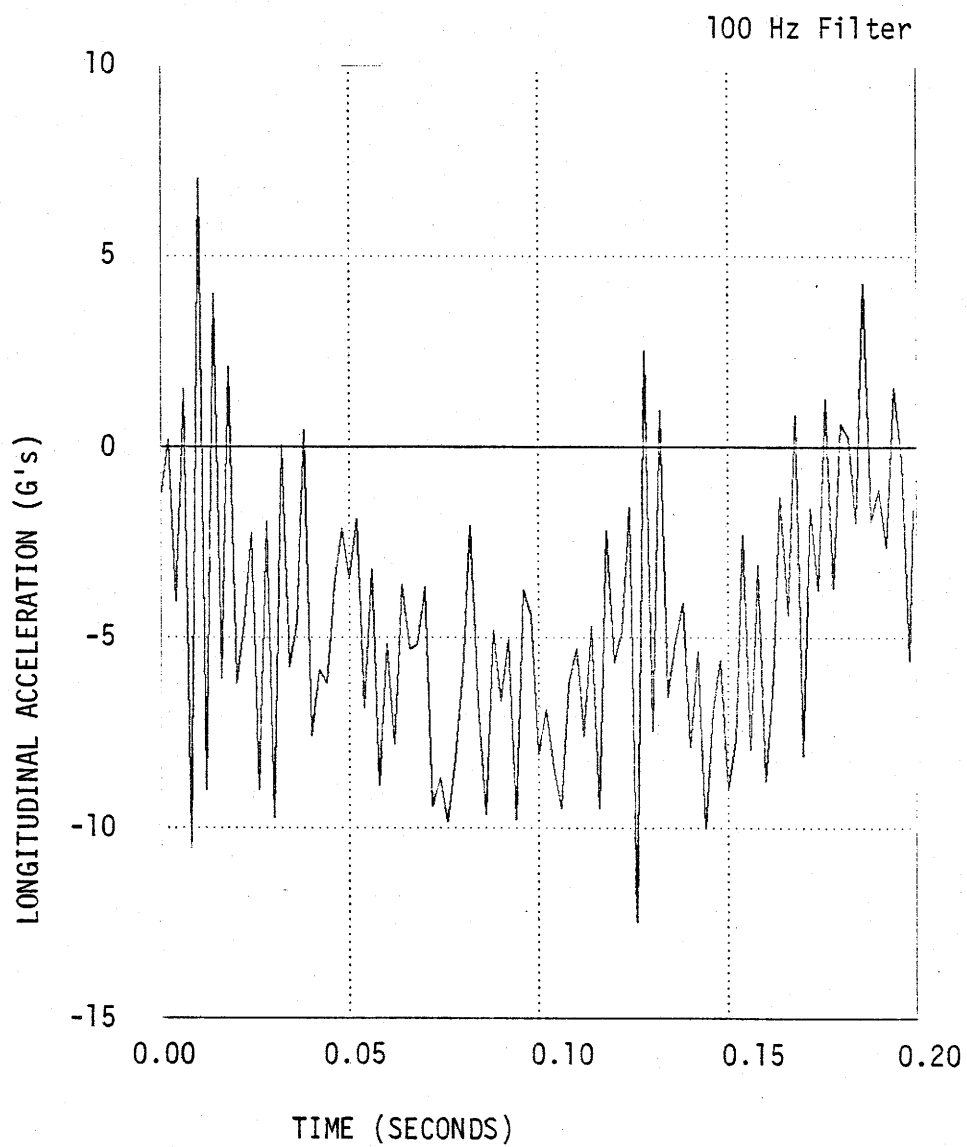
Figure 70. Longitudinal Acceleration from Vehicle's Left B-Pillar Accelerometer for Test 5.

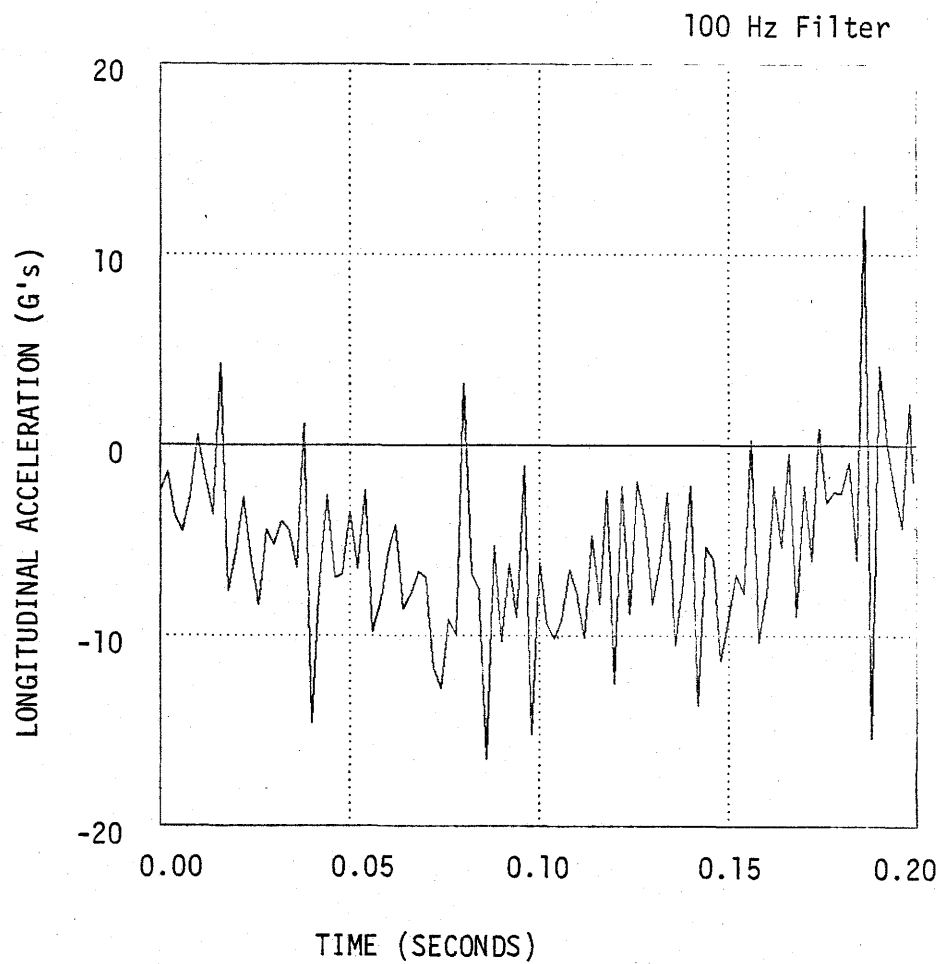
Figure 71. Longitudinal Acceleration from Vehicle's Right B-Pillar Accelerometer for Test 5.

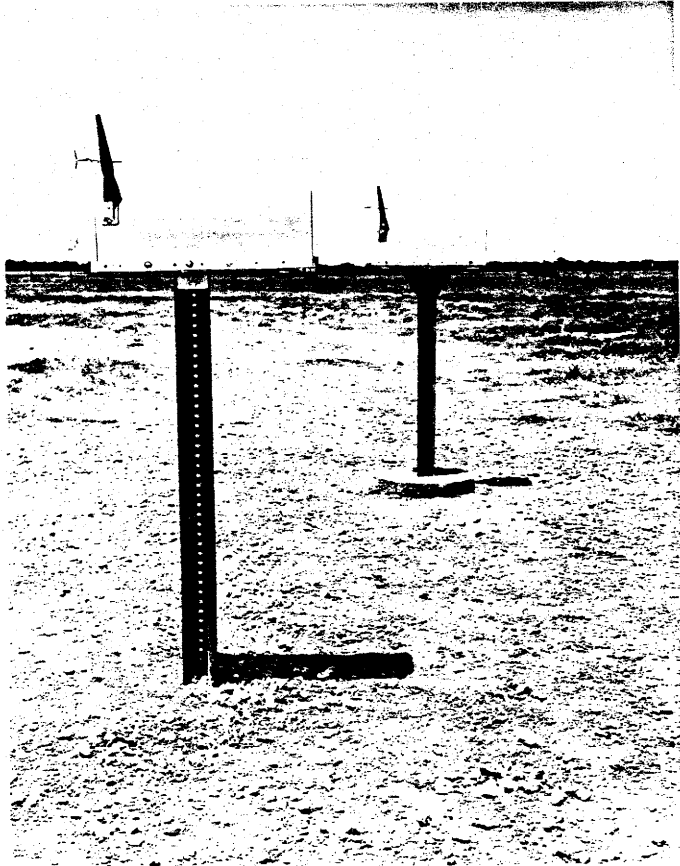
Figure 72. Test 6 Mailbox Installation Looking in the Direction of Vehicle Travel.

Test 6 - Photos of the test articles and vehicle for test 6 are shown in Figures 72 through 76. Sequential photos from the high-speed film are shown in Figure 77, and time-displacement-event data are shown in Table 8. Photos of the installations and the vehicle after test 6 are shown in Figures 78 through 81. Accelerometer data are shown in Figures 82 and 83.

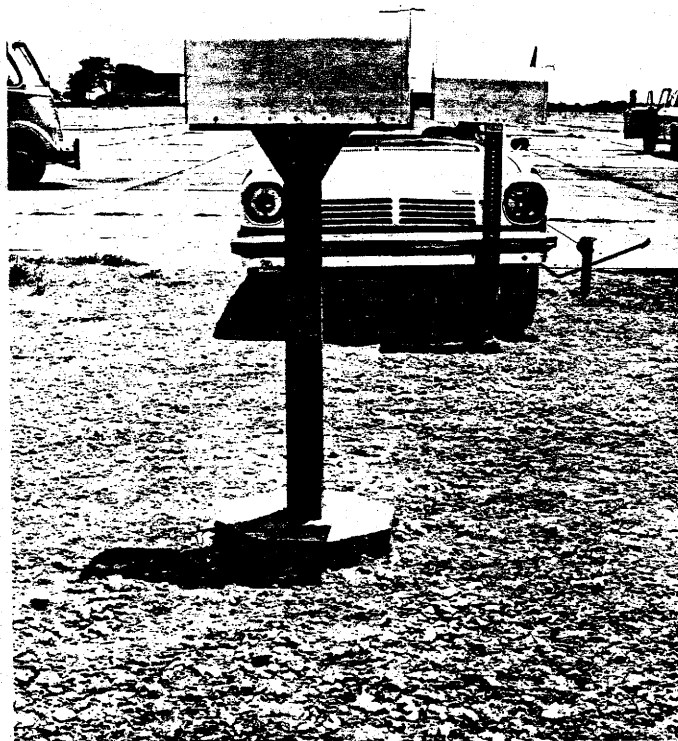
Figure 73. Test 6 Mailbox Installation Looking Opposite the Direction of Vehicle Travel.

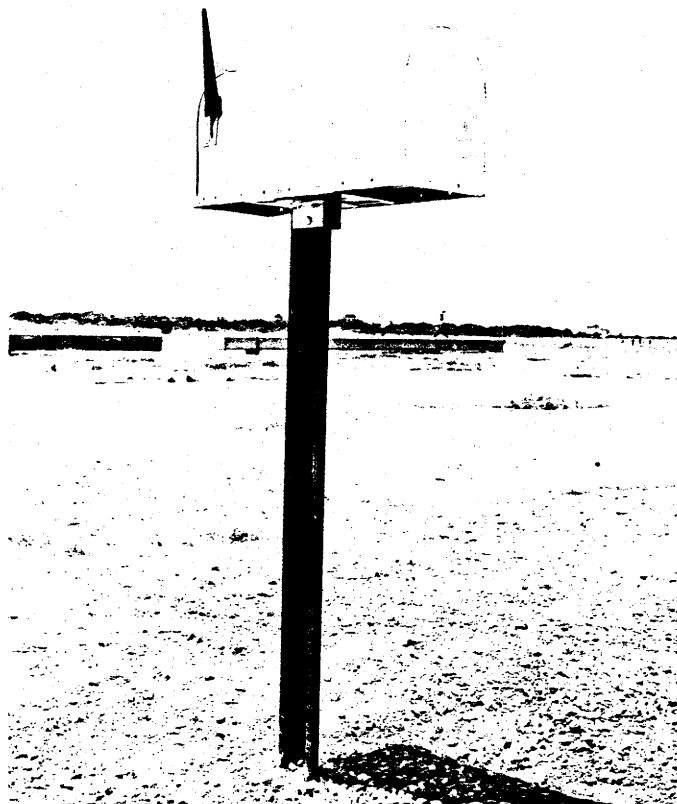
Figure 74. Test 6A Mailbox Installation.

In test 6A the 4 lb/ft (6.0 kg/m) U-post was pushed over by the impacting car. After impact the box separated from the post. However, it attained a velocity approximately equal to that of the car at separation and therefore did not impact the windshield. Changes in vehicle velocity and momentum were well below the recommended limits (1,2).

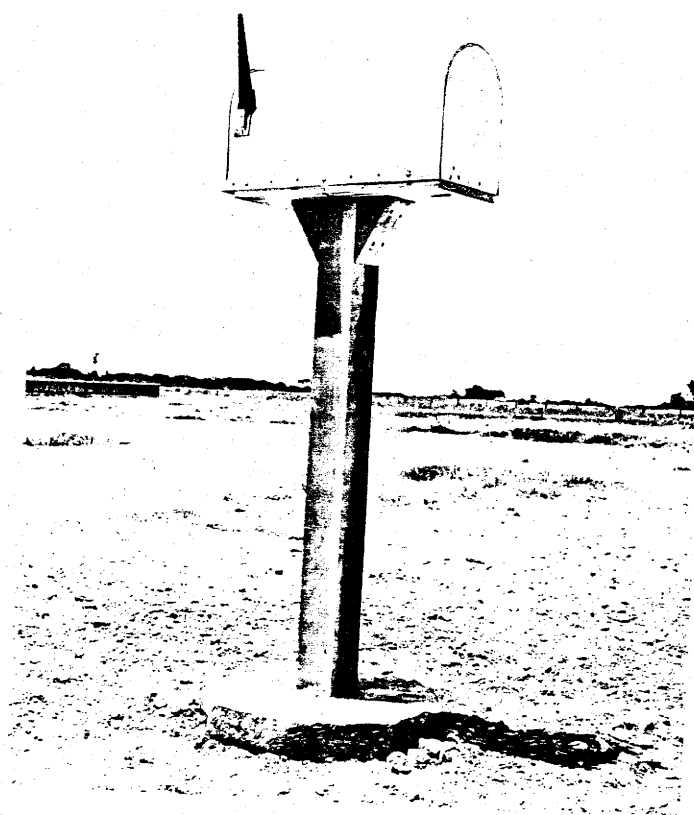
Figure 75. Test 6B Mailbox Installation.

In test 6B, the wooden post fractured upon impact and the mailbox separated from the post. The windshield of the vehicle then impacted the almost stationary mailbox. The box shattered and almost penetrated the windshield. The concrete pedestal at the base of the post rolled under the car at impact and fractured into several chunks, damaging the vehicle's control arms and a tie rod. Changes in vehicle velocity and momentum were well below the recommended limits (1,2).

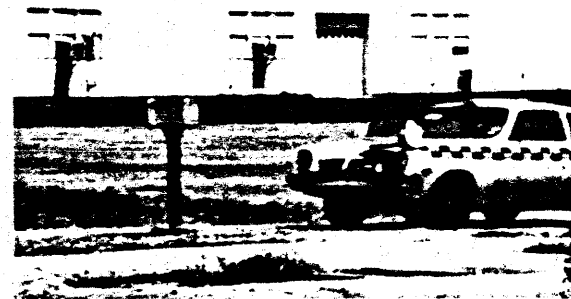
Figure 77. Sequential Photographs for Test 6.

TIME (sec)	NOMINAL VEHICLE DISPLACEMENT (ft)	EVENT
0.000	0.00	Impact with 6A
0.015	1.30	6A box breaks off of support post
0.035	2.96	6A box impacts hood
0.114	9.43	Impact with 6B
0.129	10.64	6B box separates from support post
0.152	12.47	6B concrete base begins to break up
0.182	14.95	6B box impacts windshield
0.223	18.21	6B box leaves windshield

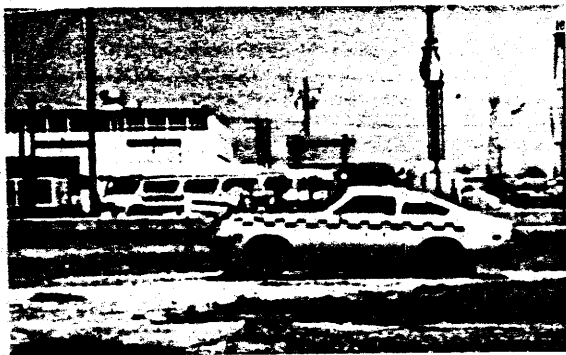
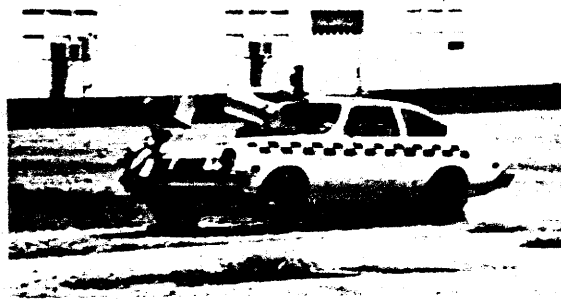
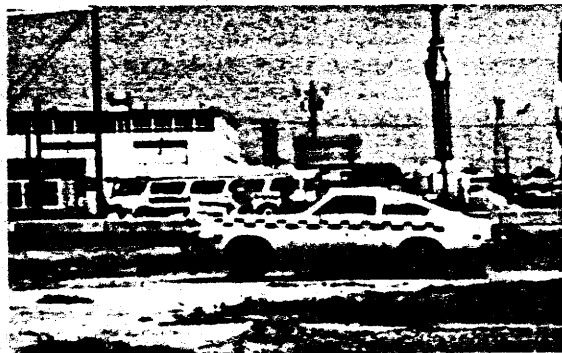
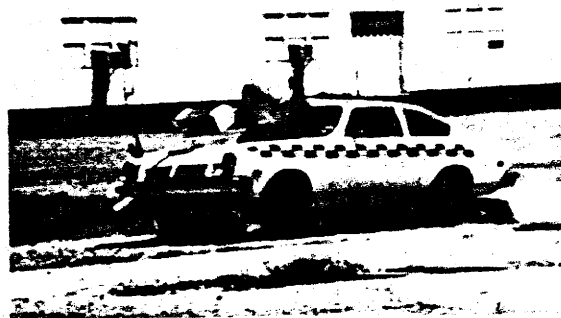
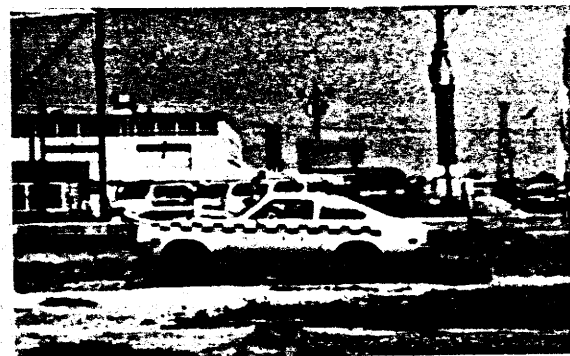
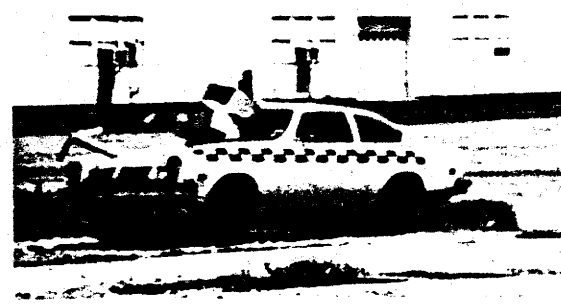
Figure 77. Sequential Photographs for Test 6 (continued).

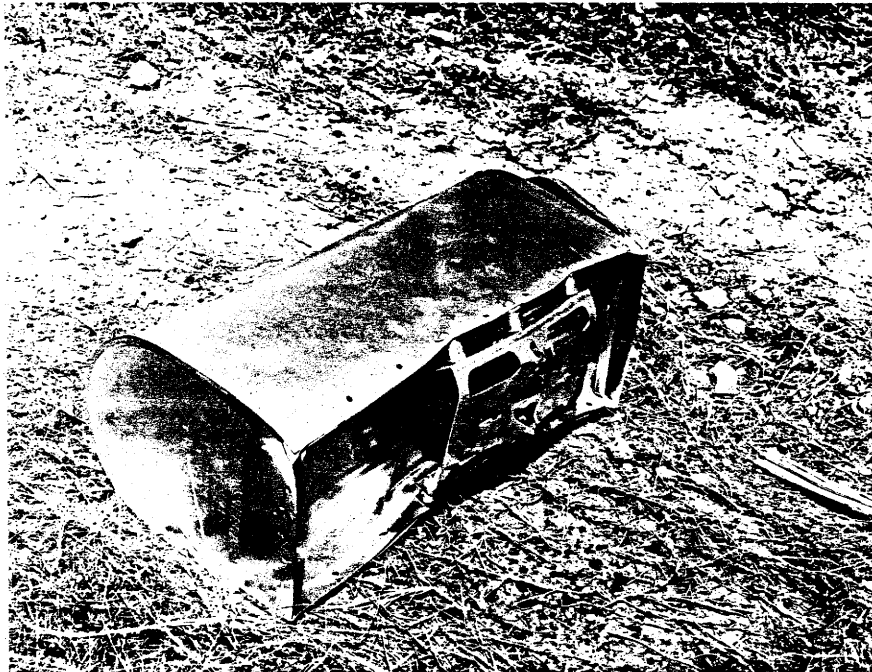
Figure 78. Test 6A Mailbox After Impact.

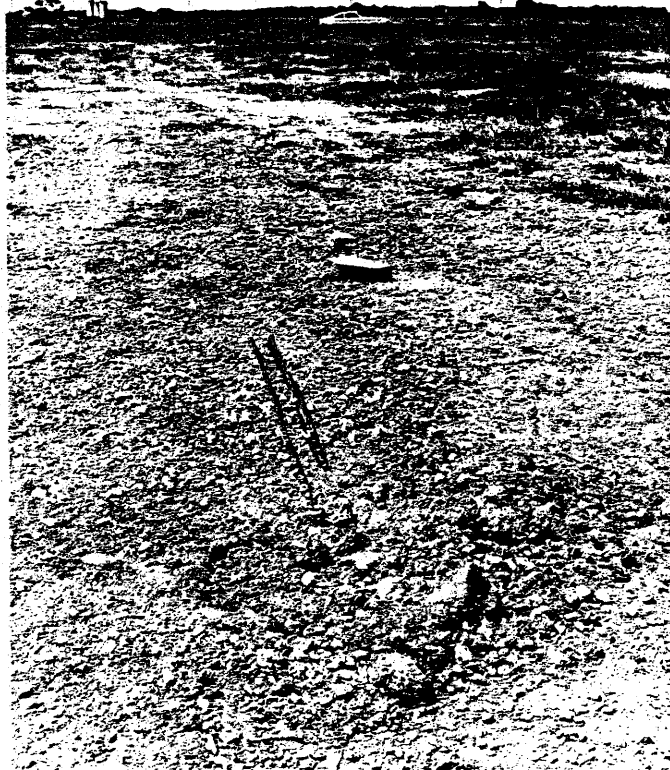
Figure 79. Test 6 Ground Connections After Impact Looking in the Direction of Vehicle Travel.

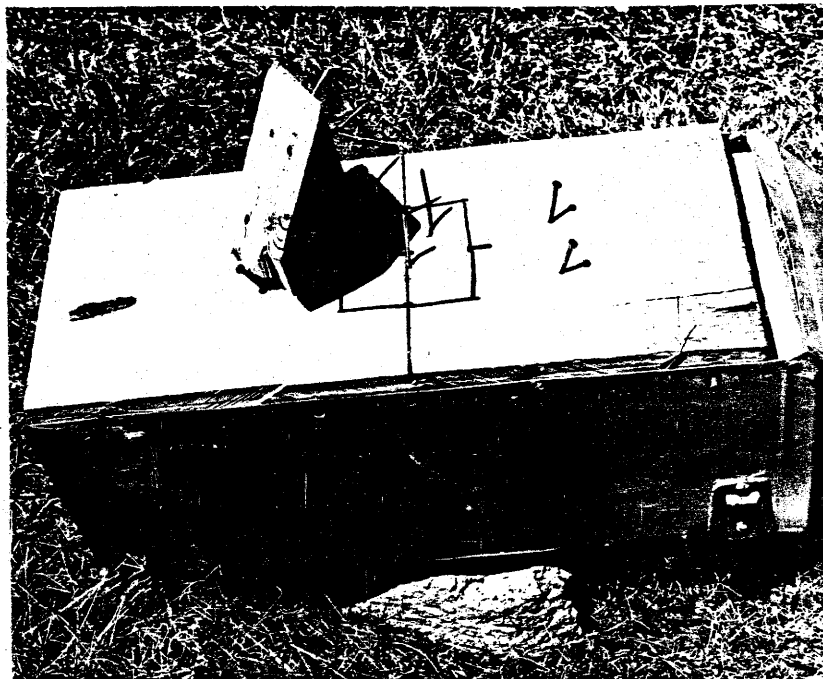
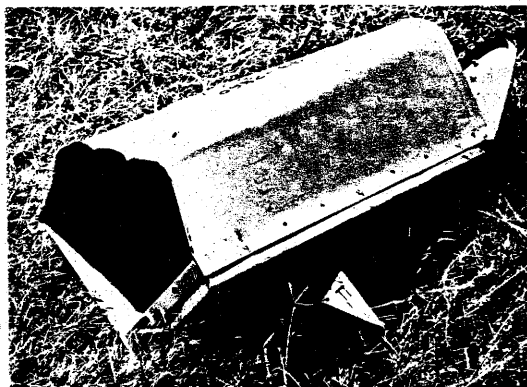
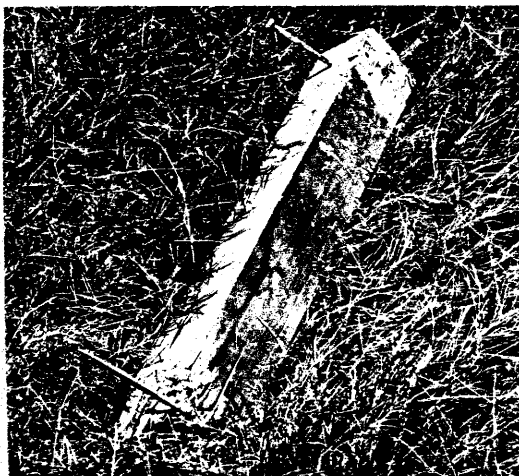
Figure 80. Test 6B Mailbox After Impact.

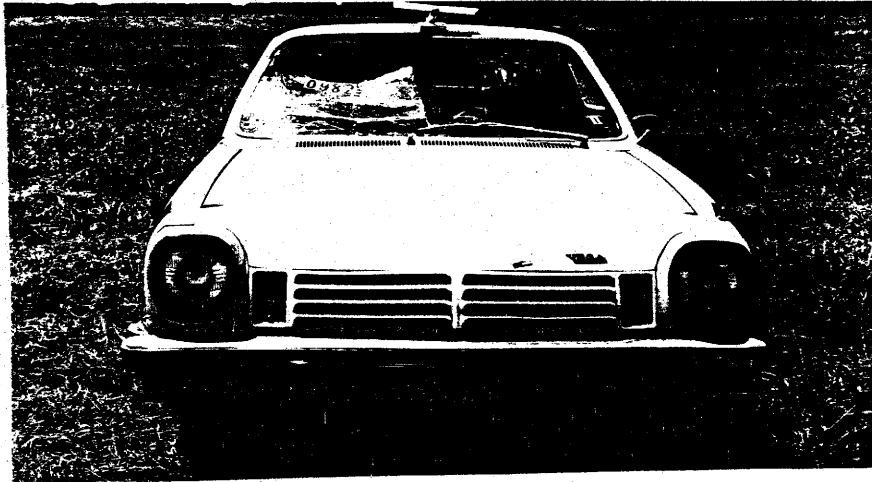
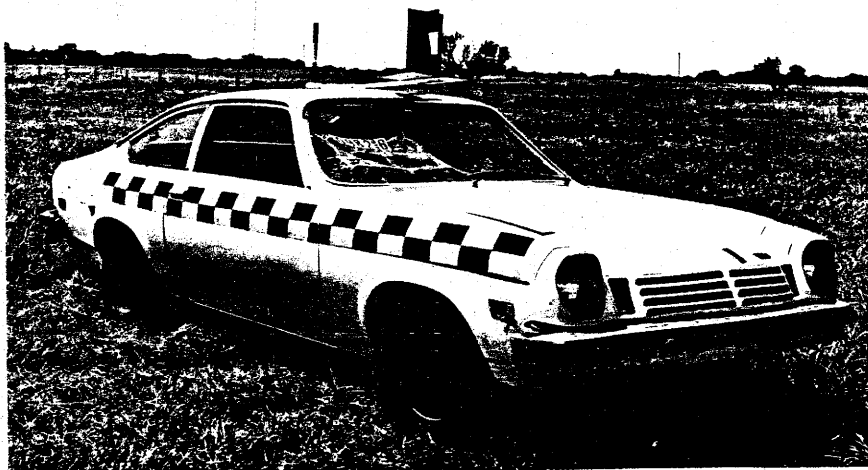
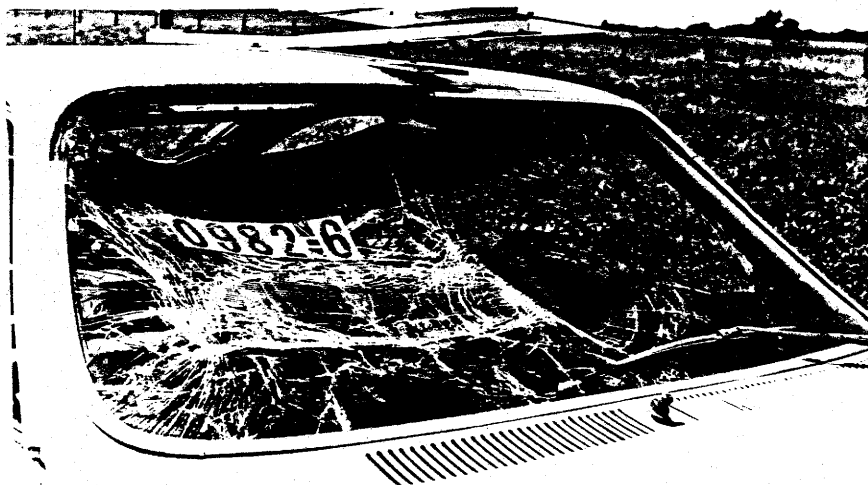
Figure 81. Test 6 Vehicle After Impact.

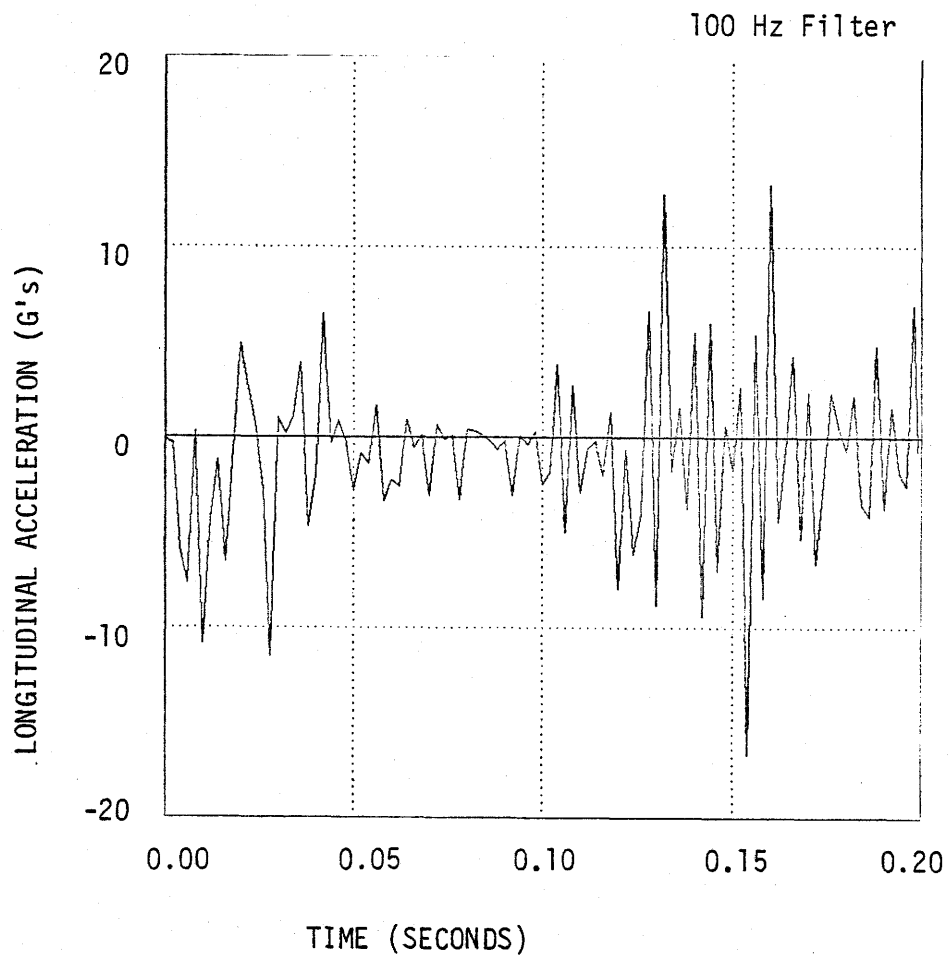
Figure 82. Longitudinal Acceleration from Vehicle's Left B-Pillar Accelerometer for Test 6.
