TEST AND EVALUATION OF RURAL MAILBOX INSTALLATIONS

Research Report 0982-1
on
SDHPT Contract No. TTI (1981) 7

THE TEXAS STATE DEPARTMENT OF HIGHWAYS
AND PUBLIC TRANSPORTATION

TEXAS TRANSPORTATION INSTITUTE
Texas A&M University
College Station, Texas

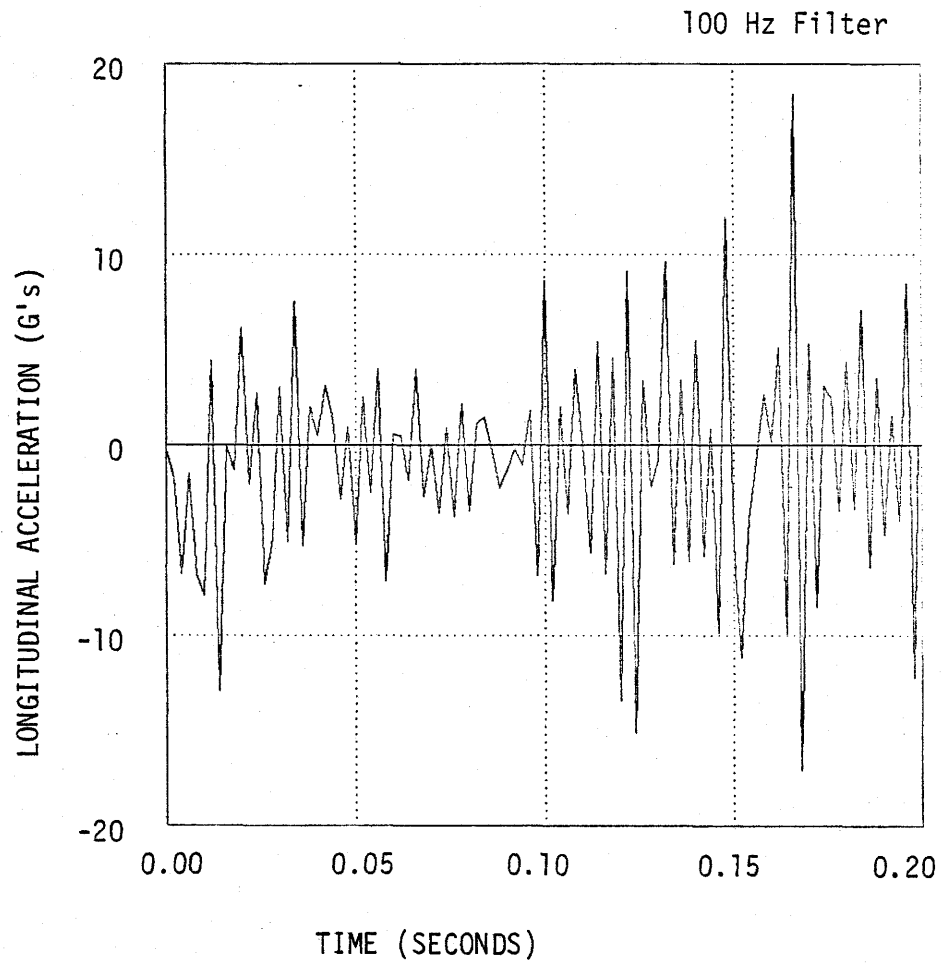
Figure 83. Longitudinal Acceleration from Vehicle's Right B-Pillar Accelerometer for Test 6.

Test 6 - Photos of the test articles and vehicle for test 6 are shown in Figures 72 through 76. Sequential photos from the high-speed film are shown in Figure 77, and time-displacement-event data are shown in Table 8. Photos of the installations and the vehicle after test 6 are shown in Figures 78 through 81. Accelerometer data are shown in Figures 82 and 83.
