Rail Crew Resource Management Pilot Course

Participant's Manual

Railroad Crew Resource Management (CRM) Training Course

Engineering Track

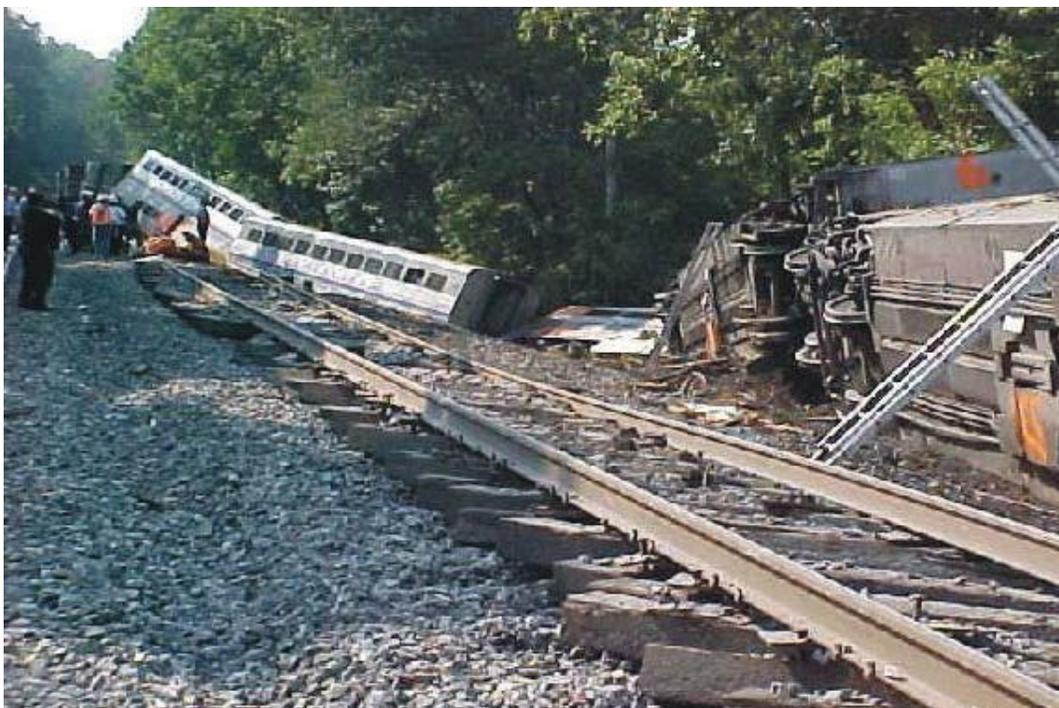
View of Wreckage Looking South
Source: NTSB Railroad Accident Brief RAB-04/05

service brake application before placing the brake handle in emergency. The event recorder data indicated that a separation in the train line (due to the derailment) had initiated an emergency brake application just before the engineer placed the brake handle in emergency. The train's locomotives came to a stop about 400 feet beyond the point of the emergency brake application.
