Project Summary Report 0-4395-S

Project 0-4395: Optimum Spot Base/Subgrade Repair Techniques  
for Moderate to High Traffic Highways over Highly Expansive  
Subgrade Soils

## Development of Guidelines for Maintenance Base Repairs on Expansive Soils

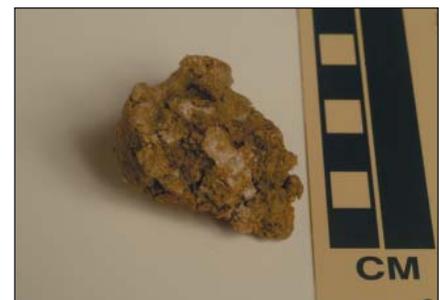
treated, chemical lime reacts better with plastic soils than cement. An application rate of 6 percent is a good general value for lime-treated soils. If considering subgrade treatment, maintenance forces must be aware of organics and sulfates. Soils high in organics will typically be dark in color and have a distinct odor; organic contents in excess of 1 percent can significantly decrease the effectiveness of lime treatment. Likewise sulfates, typically observed in the form of gypsum crystals in the soil as shown in Figure 4, react with lime or cement and cause heaving in the road. Sulfates in excess of 0.3 percent can result in pavement damage. The district pavement engineer can assist with determining the level of organics or sulfates in a soil if excess levels are suspected.

Figure 4. Gypsum Crystals in Soil.
