What Is Microcracking?

Product 0-4502-P4

TxDOT Project 0-4502:

Microcracking Stabilized Bases during
Construction to Minimize Shrinkage

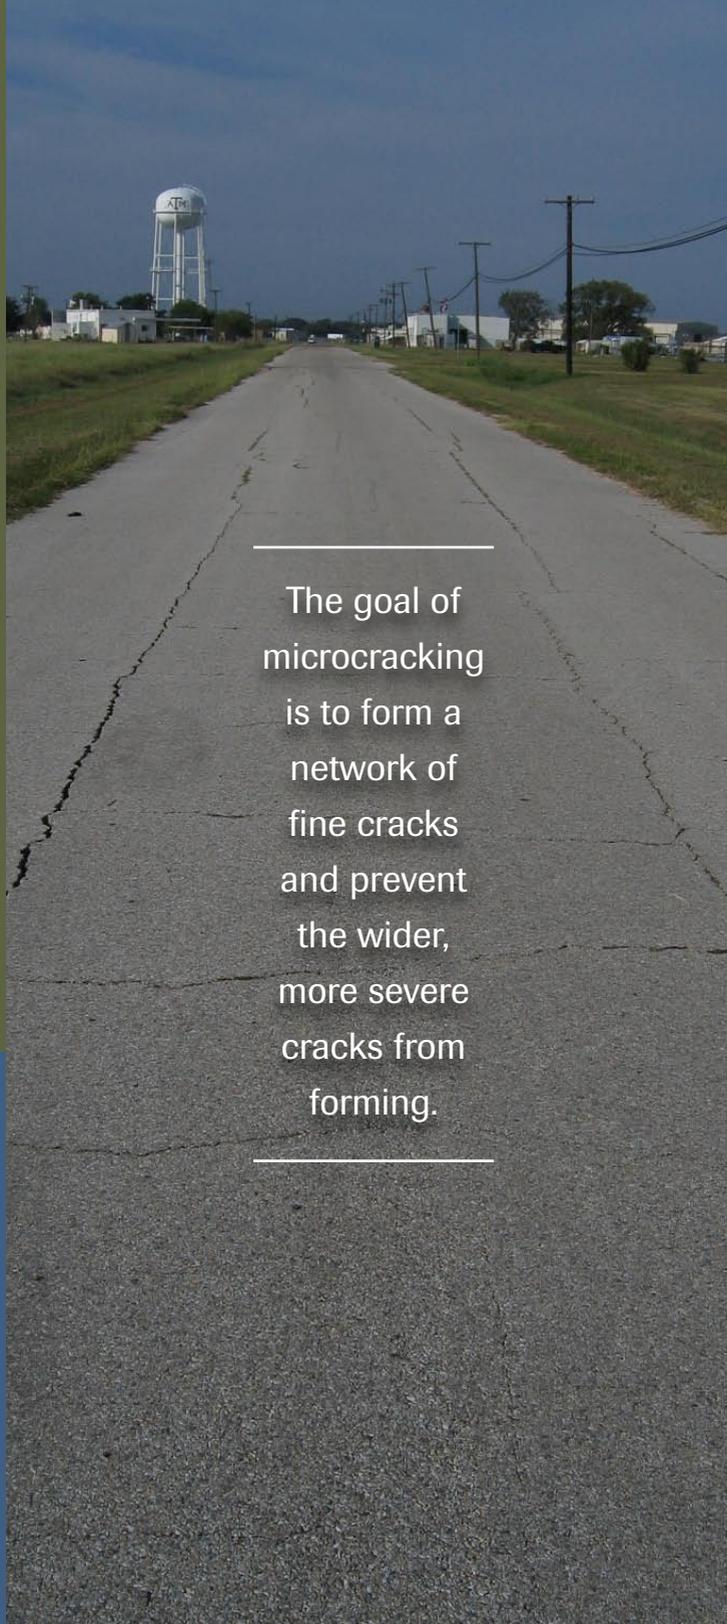
Block cracking typical of CTB.

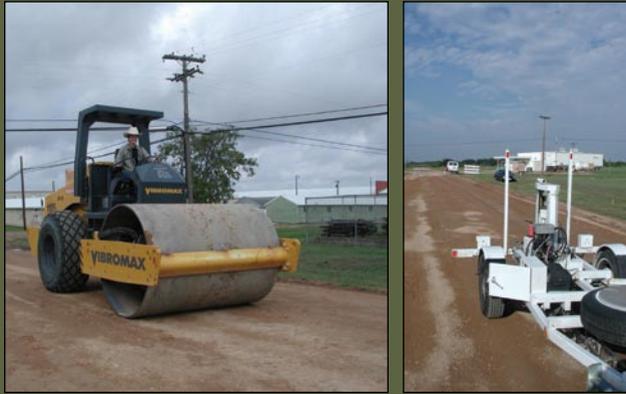
Microcracking in progress with the vibratory roller. TxDOT's FWD can serve as the control mechanism to determine when to stop rolling by measuring the reduction in average base modulus.

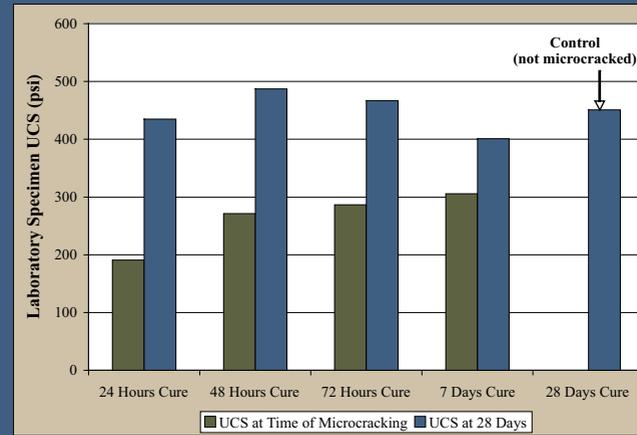
The 28-day unconfined compressive strength (UCS) of CTB is not harmed by microcracking at an early age.

Performance of microcracked field projects in Texas indicates no detrimental structural effects from microcracking. Even after failure at an early curing stage, the strength of the material recovers by continued cement hydration. At the end of the hydration stage, the strength of the previously failed material does not differ significantly from material simply cured to an age of 28 days. Additionally, the base modulus recovers after microcracking since the procedure takes place at an early curing stage. Microcracking imparts a temporary reduction in the base modulus. With additional curing time the base modulus rapidly recovers. Given the observed benefits and the lack of negative effects, microcracking can be considered for any properly designed CTB.

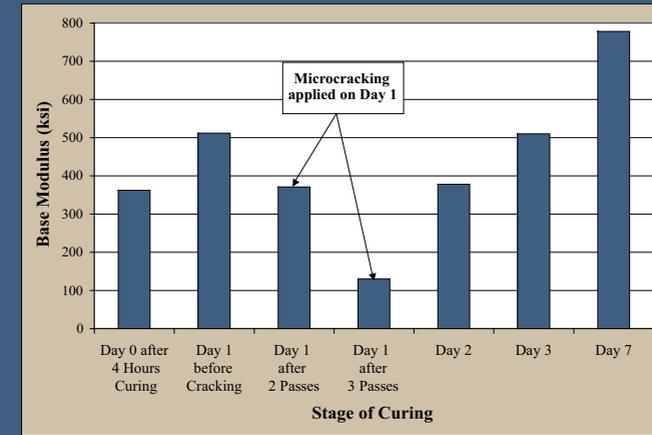
Microcracking creates a temporary dip in the increase in modulus as curing progresses. (Modulus backcalculated from FWD with Modulus 6.0)

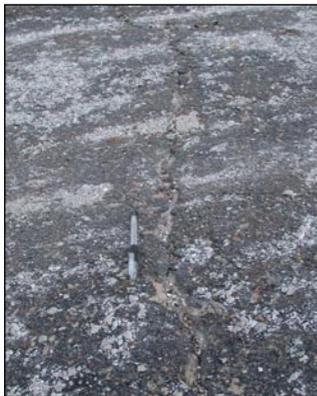
Crack in moist-cured section.

Microcracking reduces the severity of shrinkage cracking problems in CTB. Compared to moist curing alone, microcracking improves the performance of CTB by reducing the crack width, reducing the total crack length, or both. Through these mechanisms, microcracking reduces the risk of reflective cracking through the surface layer.

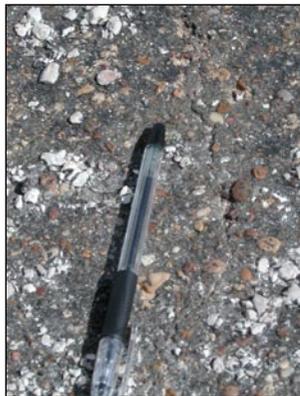
Crack in section microcracked.

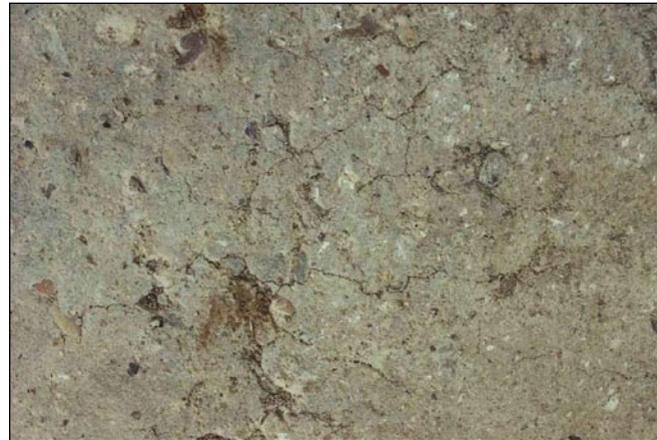
Visible cracks in CTB after microcracking are rarely observed.

Upon introduction to the microcracking concept, most pavements personnel fear microcracking will rubblize or powder the base. Contrary to this fear, a properly microcracked CTB looks no different than an ordinary CTB. Typically, no visual changes are detectable in the base immediately after microcracking. On rare occasions, some visible hairline cracks may appear. However, use of some type of stiffness testing device, such as the falling weight deflectometer (FWD), is typically the only method to definitively detect a change in the base after microcracking.

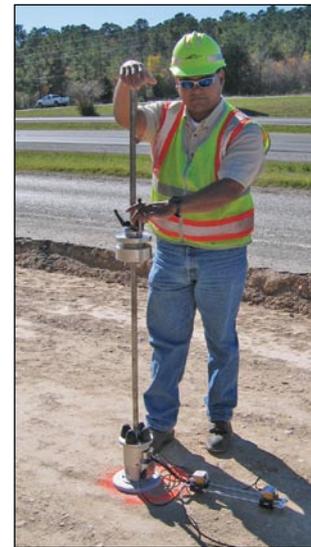
A portable FWD (PFWD) provides a compact alternative to the standard FWD for controlling microcracking. Other stiffness devices may also be able to control microcracking.

1. Satisfactory completion of three full passes that achieve 100 percent coverage.
2. Signs of cracking in the CTB. Although new cracks are rarely observed (oftentimes some transverse cracking will have already taken place during the moist-curing stage), hairline cracks imparted by the roller occasionally may be visible. If available, the FWD can be used to ensure adequate completion of microcracking by testing every station immediately before microcracking, then retesting at each station immediately after completion of the three microcracking passes. The average base modulus as backcalculated from the FWD should be reduced at least 50 percent by microcracking. If using a PFWD for controlling microcracking, target a 40 percent reduction in average base modulus.
