COMPARISON OF DRIVER YIELDING FOR RECTANGULAR RAPID-FLASHING BEACONS USED ABOVE AND BELOW PEDESTRIAN CROSSING SIGNS

This TechBrief describes the methodology and results from an open-road study sponsored by FHWA that examined driver yielding behavior at crosswalks with RRFBs positioned above the pedestrian crossing sign and at crosswalks with RRFBs positioned below the sign.

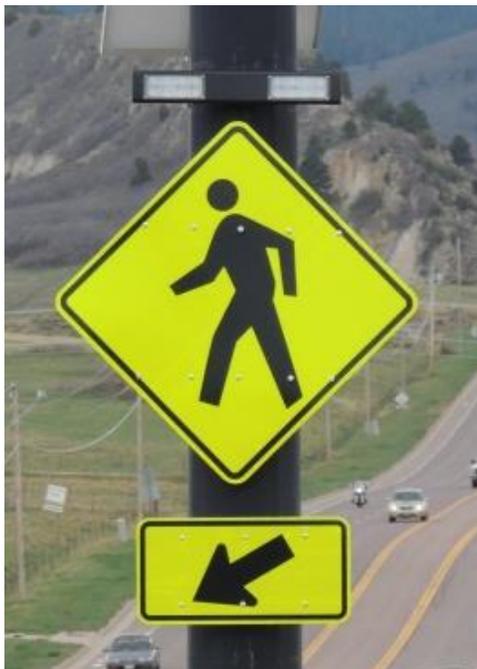
Figure 1. Photo. Example of beacon placed above sign.

Examples of study assemblies at the crosswalk are shown in Figure 1 (above position) and Figure 2 (below position). The beacon was mounted on a roadside pole to supplement either a pedestrian (W11-2) or trail (W11-15) crossing warning sign with a diagonal downward arrow (W16-7p) plaque, and located at or immediately adjacent to the marked crosswalk.

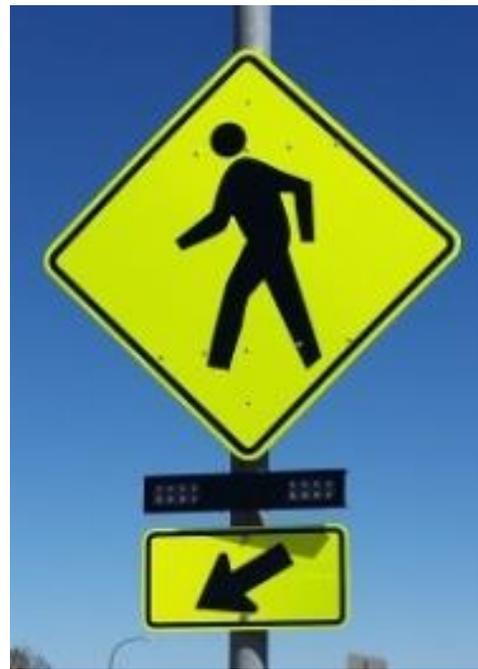
Figure 2. Photo. Example of beacon placed below sign.

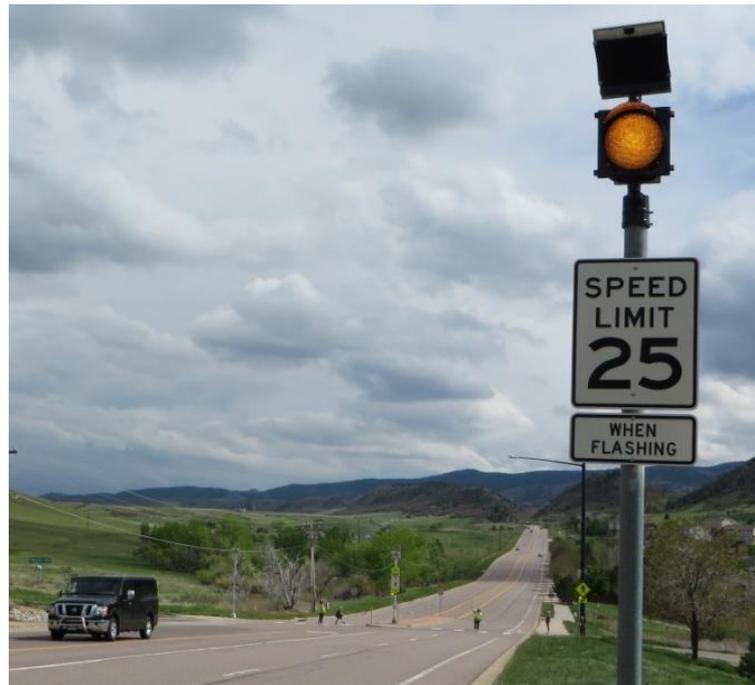
Figure 3. Photo. Example of speed limit sign assembly used at three sites in Colorado.

Three of the Colorado sites had a unique series of signs in advance of the crossing. The series started with a Pedestrian Crossing (W11-2) warning sign with AHEAD (W16-9P) plaque. Next was a SPEED LIMIT 25 (R2-1) regulatory sign with WHEN FLASHING (S4-4P) plaque and a 12-inch circular beacon. This beacon flashes when the RRFBs at the crossing are activated (see example shown in Figure 3). At the crosswalk are RRFBs with the Pedestrian Crossing (W11-2) warning sign and diagonal downward pointing arrow (W16-7P) plaque. Also at the crossing and

in the median are the STATE LAW YIELD TO (pedestrian symbol) WITHIN CROSSWALK (R1-6) sign and RRFB.
