Evaluation of Wrong-Way Driving Detection Technologies

Technical Report 0-7119-R1

TEXAS A&M TRANSPORTATION INSTITUTE COLLEGE STATION, TEXAS

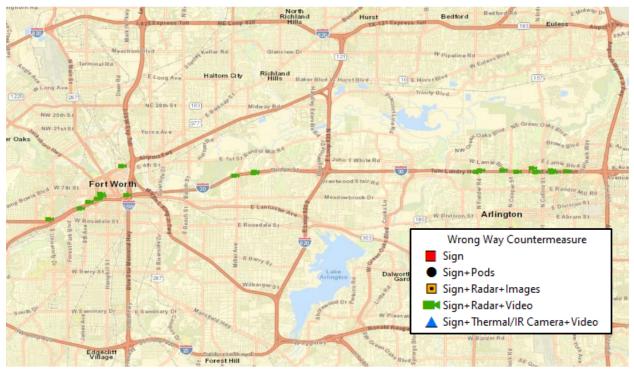
Figure 3. TxDOT FTW Detection-Based Wrong-Way Countermeasures.

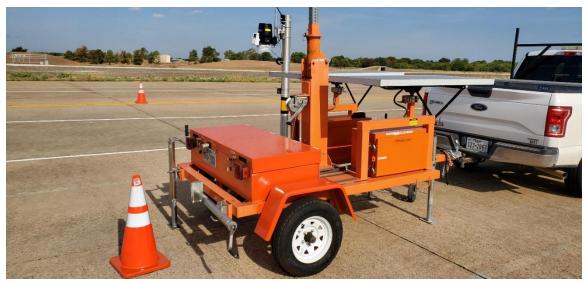
Figure 7. Example of a Portable Trailer.

- Three portable trailers to provide power and 30-ft telescoping poles (see Figure 7).
- Cellular router with cellular service to provide internet service.
- Four-port power over ethernet switch to place multi-device system components on the same local area network.
- Lift truck to aid with equipment installation.
- Various tools to aid with installation.

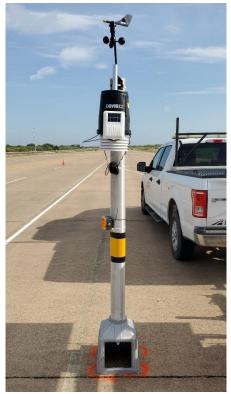
Figure 8. Leddar[™] IS16 Sensor and Weather Station.

- Ledertech[®] LeddarTM IS16 to obtain the time when the test vehicle entered the test area (see Figure 8).
- Field hardened laptop to run manufacture software or web-based applications, run TTIdeveloped software program, and check email.
- Weather station to monitor weather conditions (i.e., outside temperature, outside humidity, and wind speed during testing) (see Figure 8).
- Two vehicles (i.e., 2012 Ford Fusion and 2015 Ford F150) for testing.
- Cell phone with TextNow app to receive text messages.

Researchers also developed a software application to interface with the Ledertech[®] Leddar[™] IS16 sensor and receive a trigger output when a vehicle was detected by the sensor. The software application received the detection message from the sensor, decoded the message, and logged the detection into a file with a timestamp (i.e., date and time) and other information about the test run (i.e., run number, vehicle speed, driving path, and vehicle type).

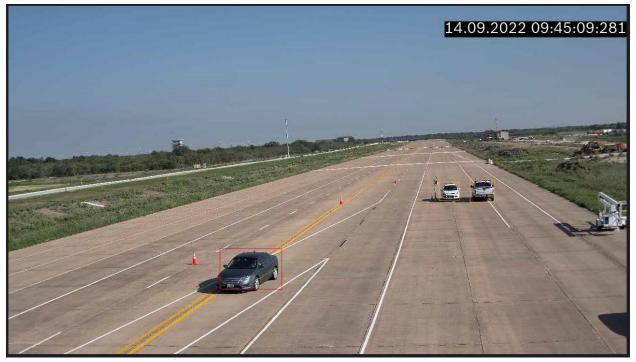
Figure 13. Example of Connect:ITS Photo with Timestamp.

The BOSCH cameras can be configured to send email alerts, but the system tested used the MH Corbin Connect:ITS edge platform for all alerting. The platform received WW vehicle detections from a BOSCH camera, sent email and SMS alerts, logged actuations, and activated a beacon light to represent sign activation (see Figure 10). The email alert contained information about the location, device, alert reason, alert parameters, operation type, event timestamp, and two still photos (each with an embedded timestamp). The SMS alert stated "WRONGWAY VEHICLE at TTI Test: TTI WWD Test." To calculate the WW vehicle detection latency, researchers used the timestamp in the first email photo because the time used by the camera was synched with the field hardened laptop time (see Figure 13).

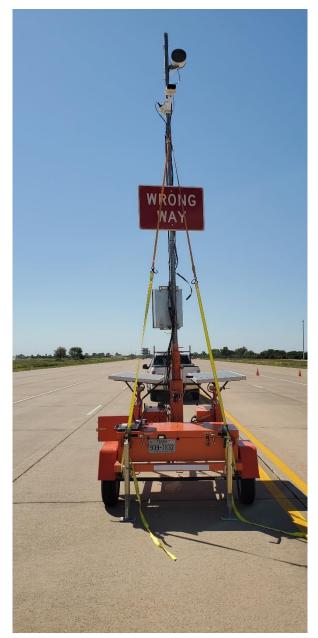
Figure 17. Carmanah[®] Equipment on Portable Trailer.

The Carmanah[®] WWD detection system utilized a combination of radar and camera technology to identify WW vehicles, activate LED lights on a WRONG WAY sign, and monitor for self-correction. Figure 17 shows the Carmanah[®] equipment on a portable trailer. Figure 18 shows the MS-Sedco TC-CK1-SBE2.0 Intersector Microwave Vehicle Motion Sensor radar and two Viion TC400GC cameras (intersection camera for monitoring [facing to the right] and freeway camera for confirmation [facing to the left]). Figure 19 depicts the Carmanah[®] device location relative to the ramp configuration and the WW entry locations.

Carmanah[®] used the radar to search for an initial alert and the freeway camera to confirm the WW vehicle detection. The radar unit used several zones to determine the vehicle direction of travel along the ramp. If two zones were activated, the system triggered the sign lights and recorded an associated timestamp. After three zones were activated, the radar logged an event as "Radar Detect" and communicated to the freeway camera to begin searching for a vehicle traveling the wrong way using image processing that looks for ray tracing of components of the vehicle (see Figure 20). The radar also sent a command to the intersection camera to capture photos and video. If the freeway camera detected a vehicle going the wrong way, the event label was changed to "Camera Validated" event (see Figure 21). If the freeway camera did not detect a WW vehicle, the event label remained as "Radar Detect."

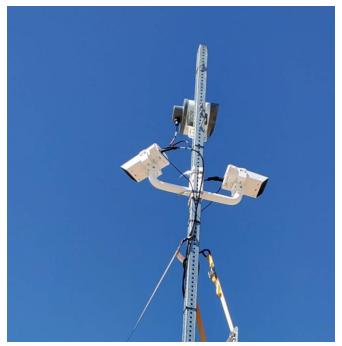
Figure 18. Carmanah[®] Radar and Camera Devices.

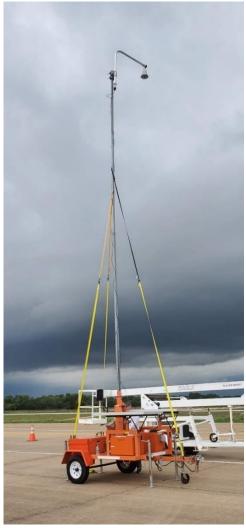
Figure 22. CUBIC[™] Equipment on Portable Trailer.

CUBICTM traditionally installs the Gridsmart camera and GS2 processor at intersections. Since the system can search for WW movements and connection to a traffic signal is not required for the system to function, researchers were able to test the system at the closed-course. Figure 22 shows the CUBICTM equipment on a portable trailer. Figure 23 depicts the CUBICTM device location relative to the ramp configuration and the WW entry locations.

The CUBIC[™] Transportation Systems Gridsmart and GS2 Processor wrong-way (WW) vehicle detection system tested used a bell-shaped fisheye camera unit that had optical video processing on an edge computing device. For testing, CUBIC[™] configured three zones to search for WW vehicles using the proprietary software. Zones drawn for WW detection must point in the incorrect direction of travel. Upon detecting a WW vehicle, the GS2 processor sends an email to the designated email addressed to alert users.

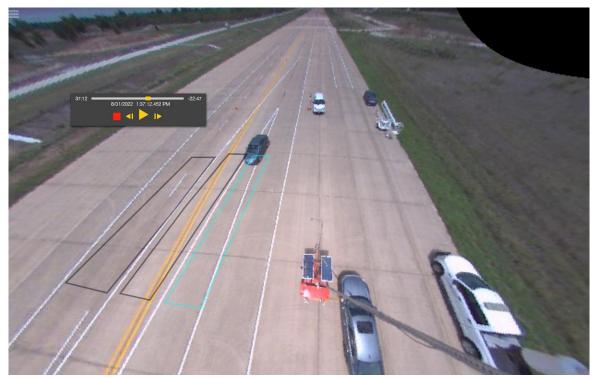
Figure 25. CUBIC[™] Detection Zones.

To detect a WW vehicle, zones drawn for the GS2 must point in the incorrect direction of travel. For the closed-course testing, CUBICTM configured three zones to search for WW vehicles using the Gridsmart App software (see Figure 25). CUBICTM does not provide an event monitoring mechanism.

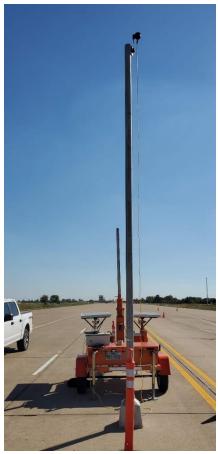
Figure 26. FLIR Equipment on Portable Trailer.

The FLIR camera is a thermal camera built for transportation applications with the ability to search for various types of incidents. Figure 26 shows the FLIR equipment on the portable trailer. Figure 27 shows the FLIR device location relative to the ramp configuration and the WW entry locations.

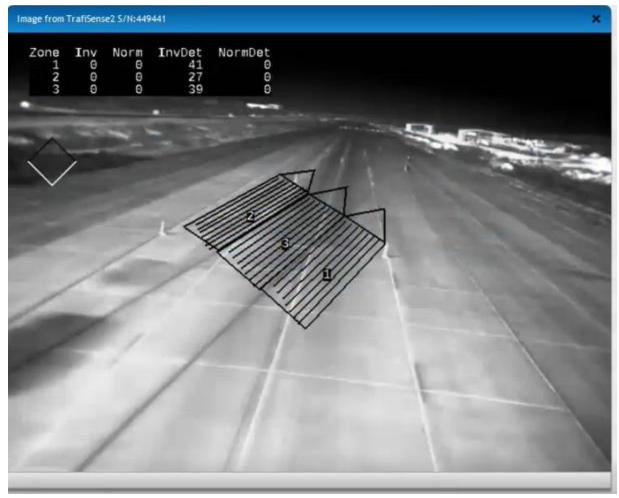
Figure 28. FLIR Detection Zones.

To detect WW vehicles, the camera must be configured using manufacturer developed software called FLUX. Multiple zones pointing in the correct direction of travel were used with an inverse direction of travel triggering an email plugin (see Figure 28). The desired recipients for the alert emails must be configured within the "inverse direction" settings for the deployed system.

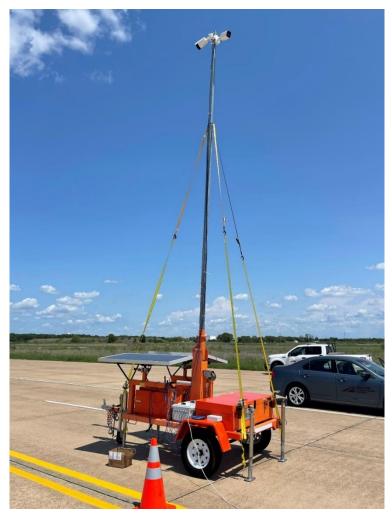
Figure 30. GovComm Equipment on Portable Trailer.

GovComm used a dual optical and thermal camera housing with an edge computing device that simultaneously processed the two video streams, using AI, to determine if a WW vehicle was present. The installation also included a rear facing camera to capture photos of the WW vehicle after entering the ramp. Figure 30 shows the GovComm equipment on a portable trailer. GovComm configured its system to activate a string of lights to represent a WRONG WAY sign activation. Figure 31 shows the GovComm device location relative to the ramp configuration and the WW entry locations.

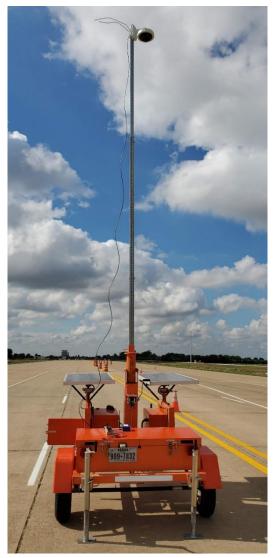
Figure 35. ISS Equipment on Portable Trailer.

ISS utilized an AXIS four-camera housing for detection. Three of the cameras monitored the ramp. ISS aimed one ramp camera upstream and one downstream for WWD event context and monitoring. The third ramp camera was pointed at the exit ramp and was used for detection of WW vehicles. The fourth camera in the housing was aimed at the frontage road. All four cameras were optical cameras. The detection camera used a wide angle lens. The other cameras used standard lenses. Figure 35 shows the ISS equipment on the portable trailer. Figure 36 shows a closeup of the four-camera housing. Figure 37 shows the ISS device location relative to the ramp configuration and the WW entry locations.

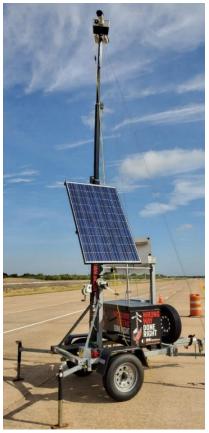
Figure 40. K&K Systems Equipment for Testing.

The K&K WW detection technology was a three-camera system (one thermal and two optical) in separate housings. Figure 40 shows the portable trailer K&K brought for testing. Figure 41 shows the K&K device location relative to the ramp configuration and the WW entry locations.

The thermal camera was the detection device, and the optical cameras were for photo capture and WW vehicle monitoring. On the thermal camera, the detection zone was drawn such that the arrows point in the incorrect direction of travel (see Figure 42). K&K uses a time threshold before signaling an alert to prevent false detections. K&K recommended a threshold of 1 second, which was the setting used for closed-course testing.

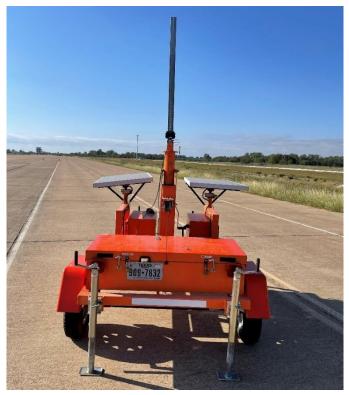
Figure 44. SICK Equipment on Portable Trailer.

SICK is a radar and lidar sensor manufacturer that is entering the WW vehicle detection market. Thus, the SICK Advanced Object Detection System WWD system tested by researchers was still under development. The SICK system utilized a single radar unit placed 6.5 ft off the ground and pointed down the ramp. The radar communicated with a cellular SIM card equipped modem to send emails and SMS messages. Figure 44 shows the SICK system on the portable trailer. Figure 45 shows the radar used for detecting the WW vehicle. Figure 46 shows the SICK device location relative to the ramp configuration and the WW entry locations.

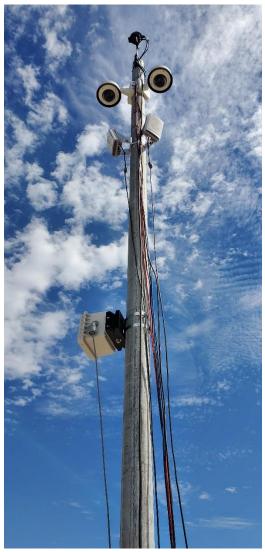
Figure 50. TAPCO[®] Equipment for Testing.

The TAPCO[®] WW detection system was comprised of one thermal camera, two optical cameras, one radar unit, and two illuminators. TAPCO[®] worked with researchers to install a pole on the runway system for testing since the portable trailers provided by TTI did not meet the TAPCO[®] deflection requirements. Figure 50 shows the TAPCO[®] detection equipment installed on the pole. A WRONG WAY sign and the system's controller cabinet were placed on a portable trailer. Figure 51 shows the TAPCO[®] device location relative to the ramp configuration and the WW entry locations.

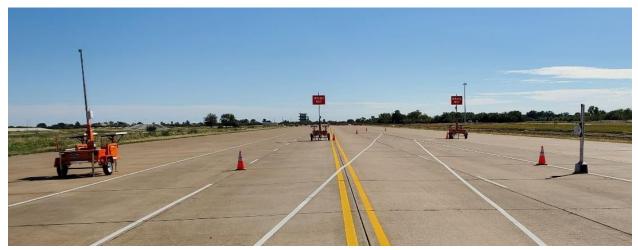
Figure 56. TraffiCalm[®] Equipment.

The TraffiCalm[®] WWD system utilized four radar units placed around the exit ramp to search for a WW vehicle (see Figure 56, Figure 57, Figure 58, Figure 59, and Figure 60). The system

also included a camera solely for recording a video to document the WWD event (see Figure 60). The camera unit was built into the controller device that acted as a wireless network hub for the radars and issued the warnings to the intended recipients. Figure 61 shows the location of the TraffiCalm[®] devices relative to the ramp configuration and the WW entry locations.

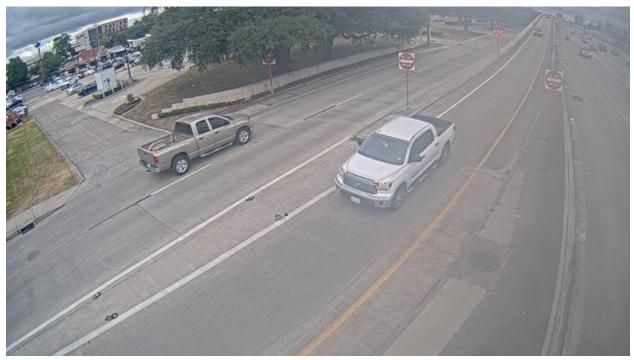
Figure 81. TAPCO[®] WWD Event Image, I69 at Kirby Dr., June 30, 2022.

In everyday operations, the thermal camera first detects a WW vehicle, and the primary controller signals the downstream (in the direction of WW movement) LED border-illuminated WRONG WAY signs to begin flashing. If the vehicle continues travel in the wrong direction, it is picked up in the sensor's alert zone and details about the WWD event, including pictures of the vehicle progressing down the ramp or frontage road the wrong direction, are sent from the primary controller to the cloud via the system's cellular radio. TAPCO[®] servers process the alert and send a warning email to TxDOT TranStar TMC operations staff and, at the same time, log event details and imagery on servers that can be accessed by TxDOT staff via TAPCO[®]'s BlinkLink[®] event management software and/or website. Figure 81 contains an image of a WWD event processed by the TAPCO[®] WWD detection and warning system.
